Failure Analysis of PCBAs

Failure analysis of PCBAs can be made more timely and cost effective through awareness of some “do’s and “don’ts ...

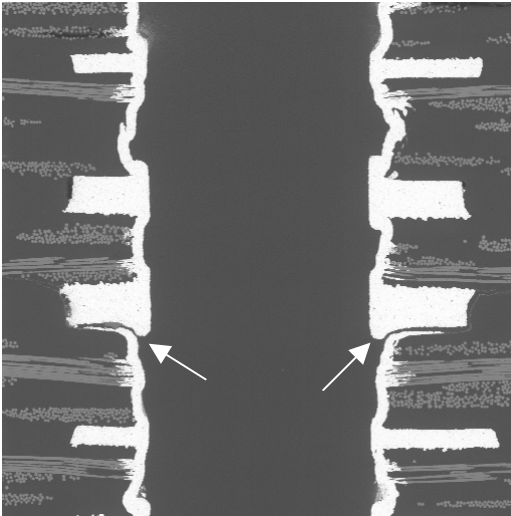
PTH via opens

The example below shows an open PTH-via that was related to a PCB quality issue.

Poor drilled hole quality, nail-heading, and thin electroplated copper all contributed to this failure.

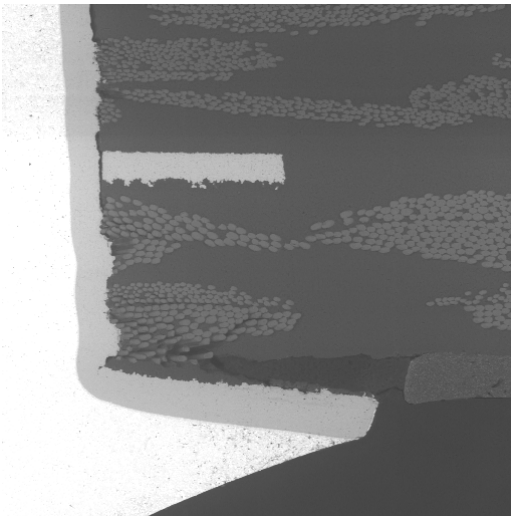
Inner layer separation

This example shows a failed inner layer connection to a PTH solder joint. The failure was related to poor inner layer strength caused by lack of etchback treatment during PCB fabrication.

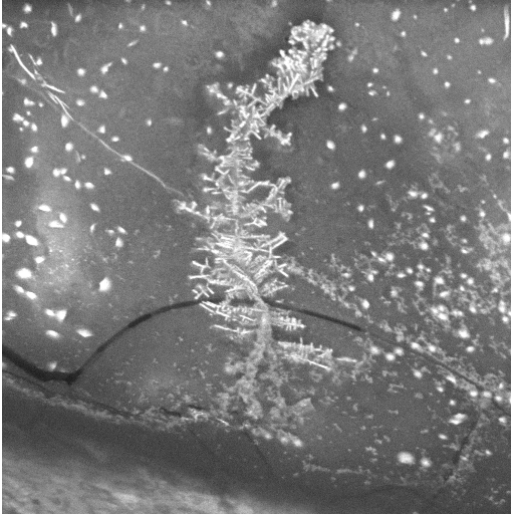
Electromigration

This Pb-dendrite grew between two QFP leads. Residual chloride from an OA flux, condensed moisture, and voltage bias created the conditions for this electromigration failure.

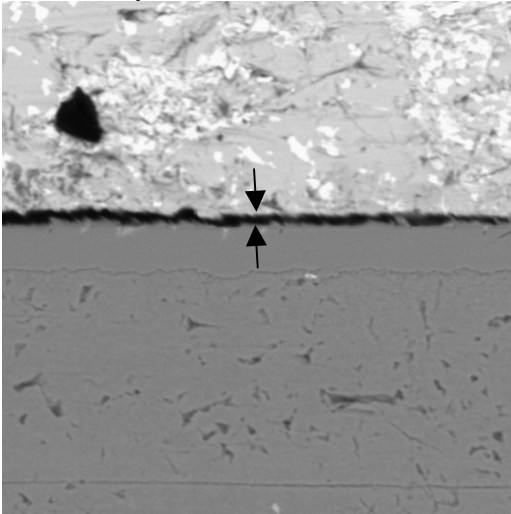
Black Pad Syndrome

This BGA solder joint failed at the interface between the Sn-Ni IMC layer and a P-rich EN layer.

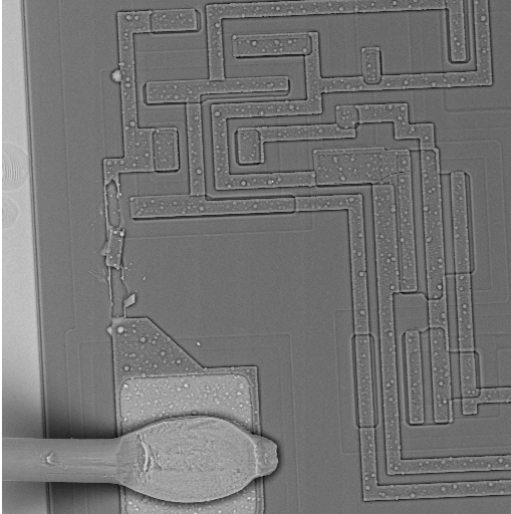
Electrical Overstress and ESD

This example shows a fused metal run on the input of an IC. Energy and pulse width of the event that caused this failure can be estimated from the location and type of damage.

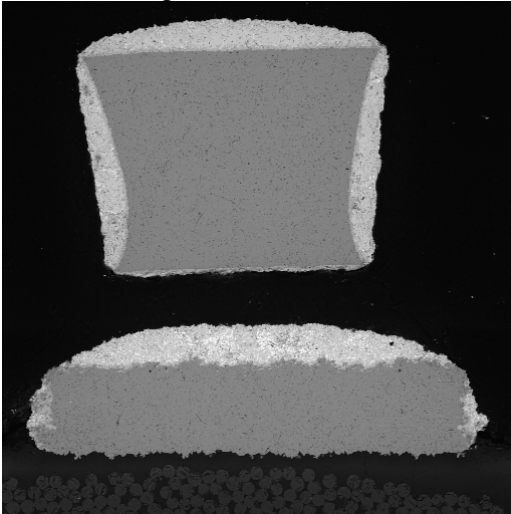
Component Solderability

This example shows a dewetted QFP lead. The solderability issue was attributed to excessive organics in the tin-lead coating on the QFP leads.

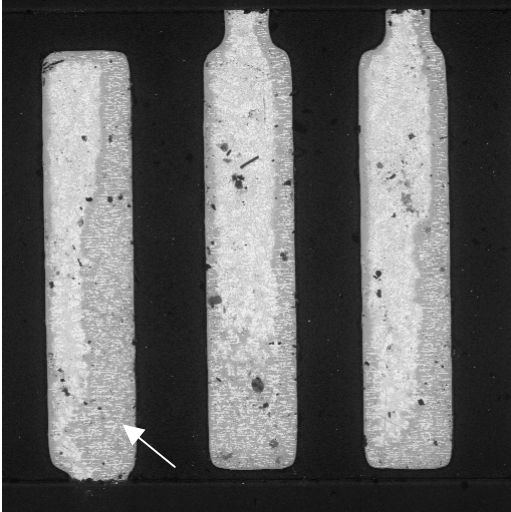
Exposed IMC on HASL PWBs

Poor quality HASL finishes on PWBs can cause severe solderability problems during reflow soldering operation. Exposed copper-tin IMC oxidizes and becomes very difficult to wet during reflow.
