Images of Failures in Microelectronics Packaging and Assembly

Ed Hare, Ph.D./[SEM Lab, Inc.](http://www.semlab.com)

IMAPS NW - Feb. 11th 2004
Redmond, WA

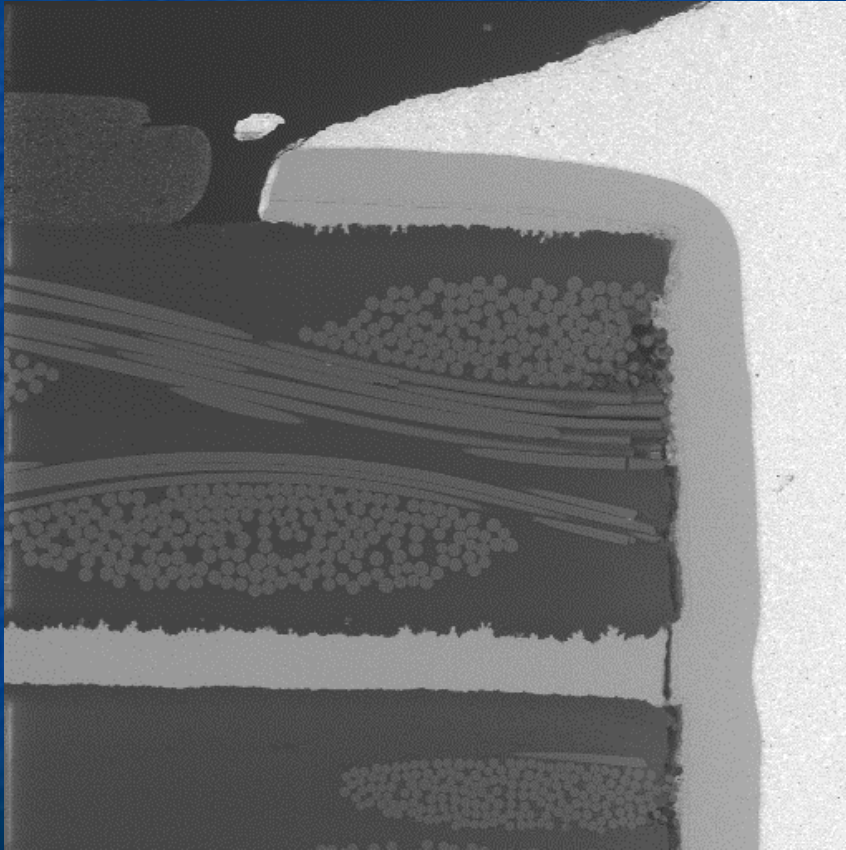
Inner Layer Separation

- Between laminate copper and electroless copper
- Found Ca & S residues at failed interface

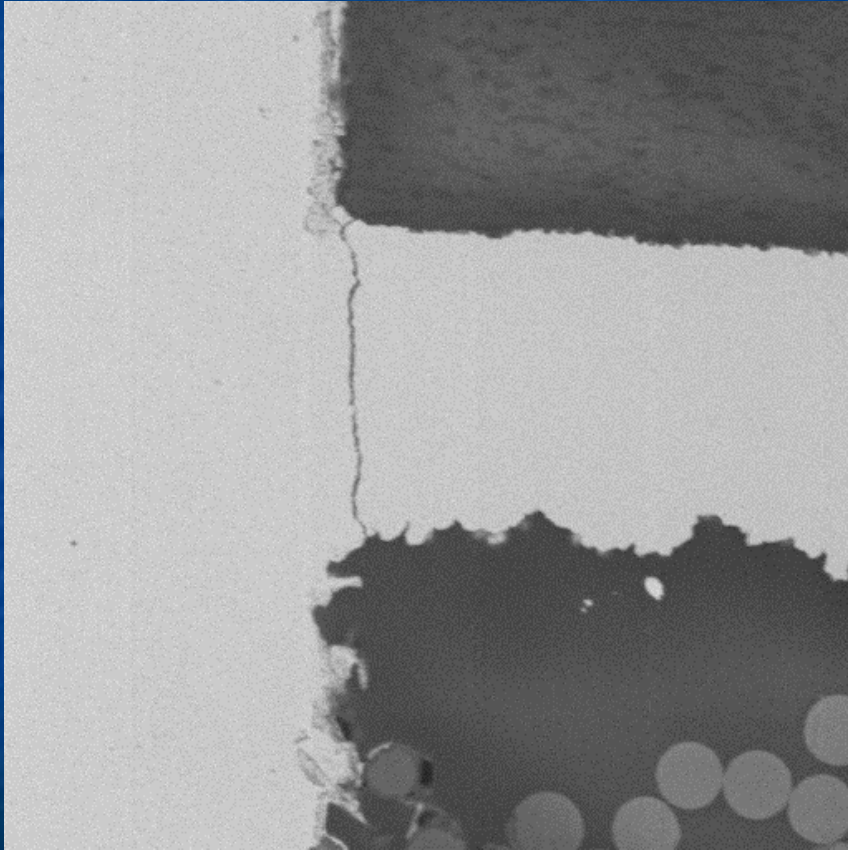
Inner Layer Separation

- QC coupon mount from PWB fabricator
- “lines of demarcation”
- Missed during routine QC examination

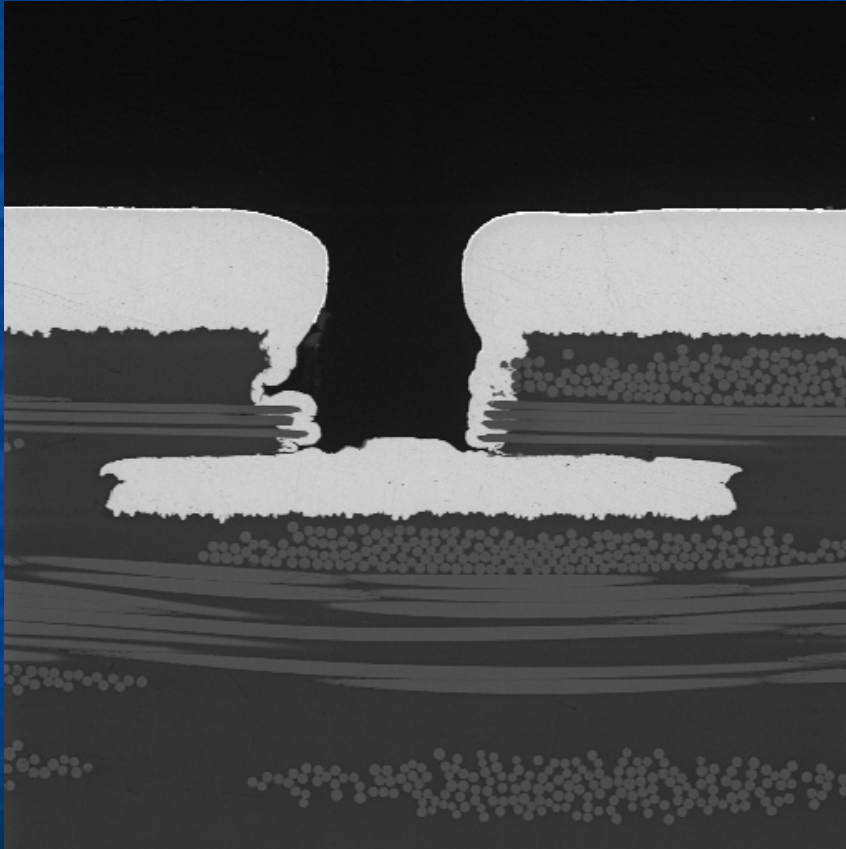
Microvia

- This is a poorly fabricated microvia
- There is little or no copper plating connecting to the layer-2 pad

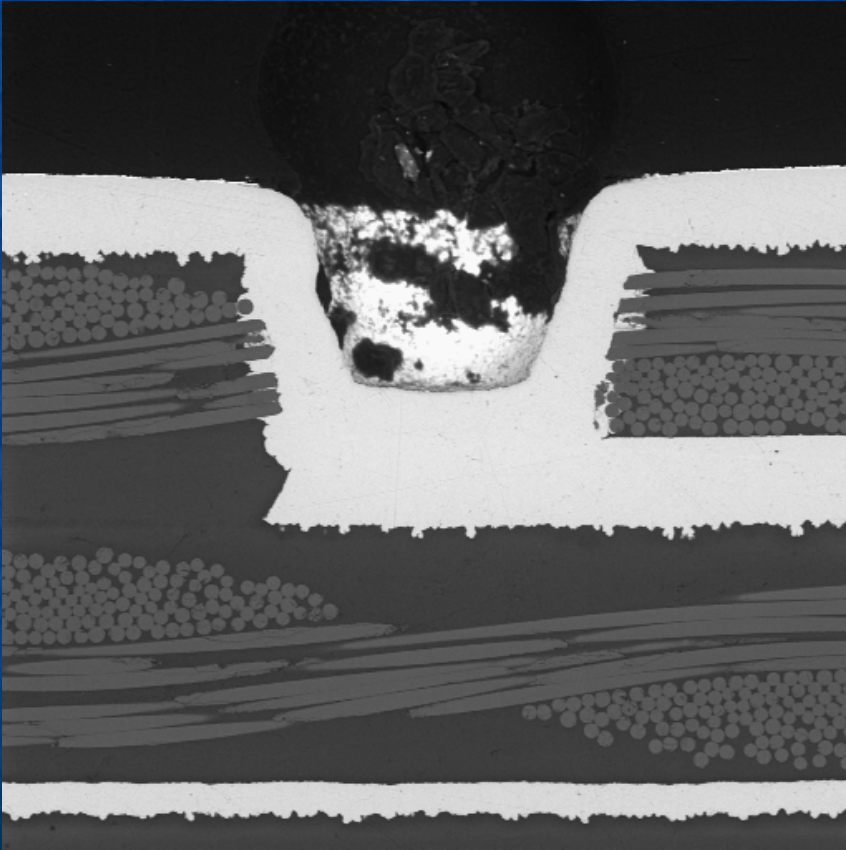
Microvia

- This is a “good” microvia
- There is uniform copper plating connecting to the layer-2 pad

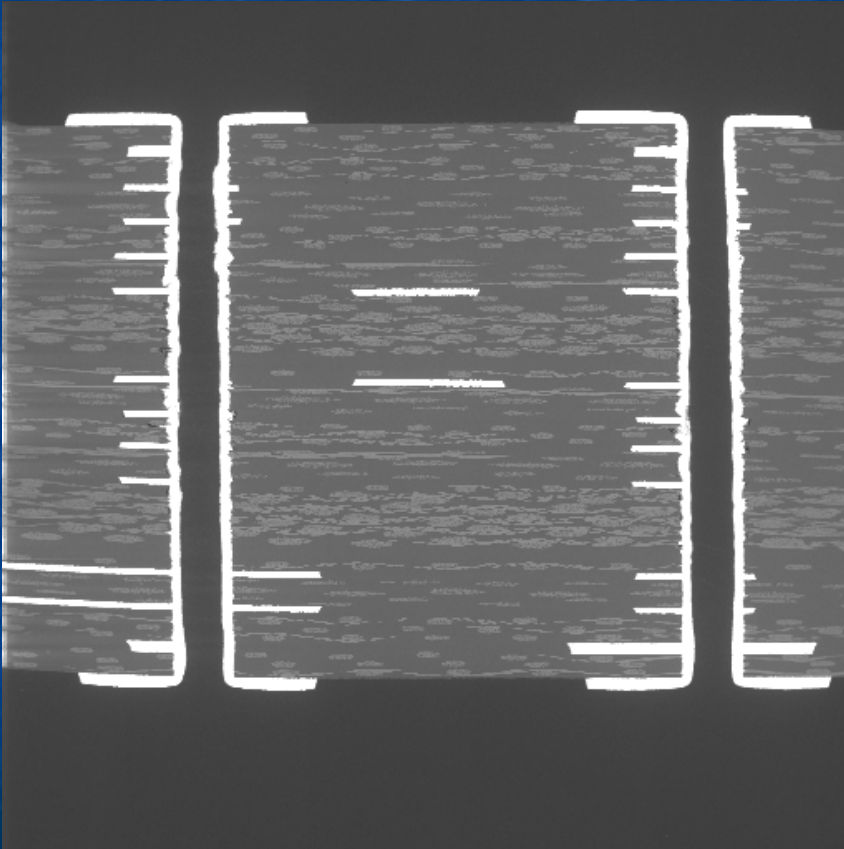
Drill Breakout

- The inner layer lands probably should have been larger diameter in this design
- This condition fails Class 3 criteria in IPC-A-600 (min. annular ring 0.001 in)

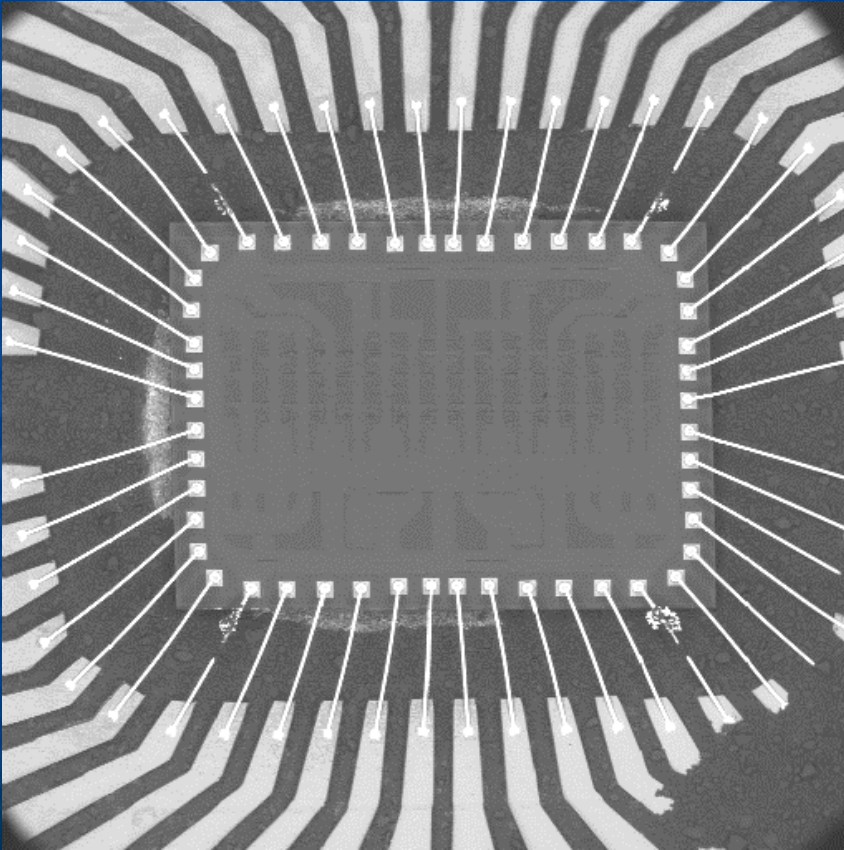
EOS Failure

- All four Vcc wire bonds are fused open
- There is no damage on the die
- Excessive current failure likely due to latch-up

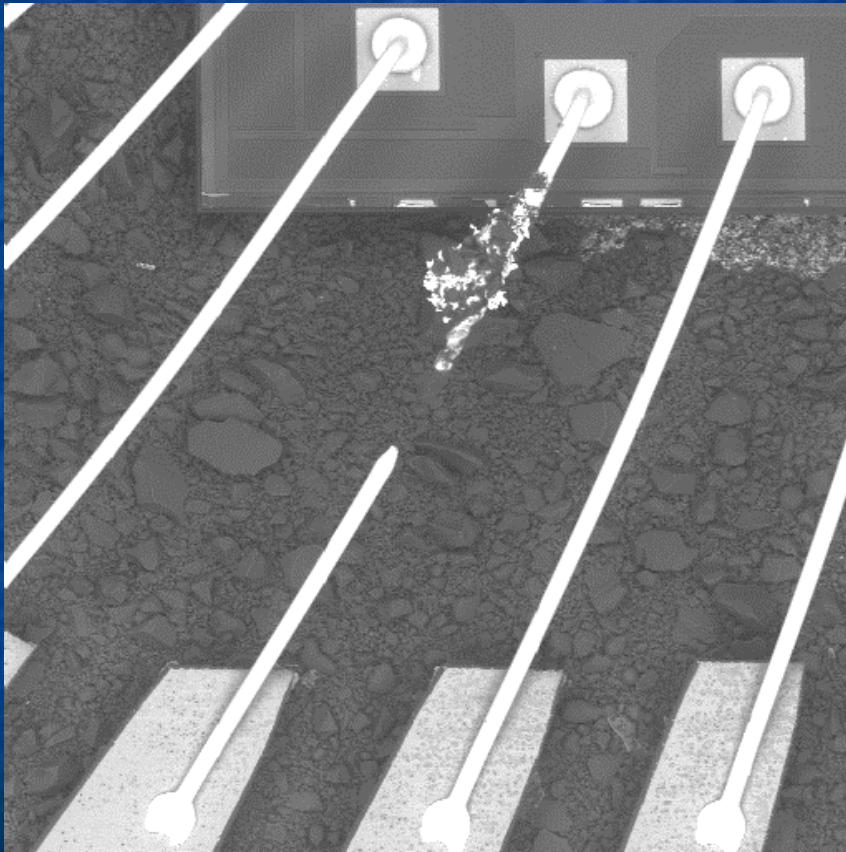
EOS Failure

- Vcc wire bond is fused open
- Fusing current of 1-mil gold wire is \sim 0.75 amps

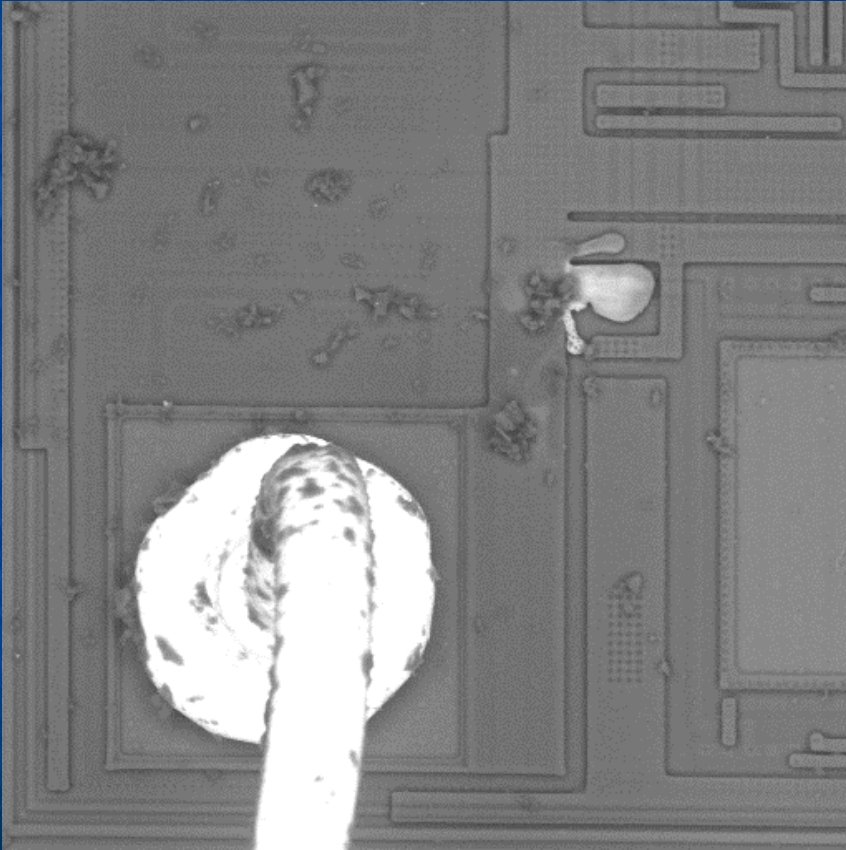
EOS Failure

- A short segment of metallization was fused open
- Likely caused by a voltage transient

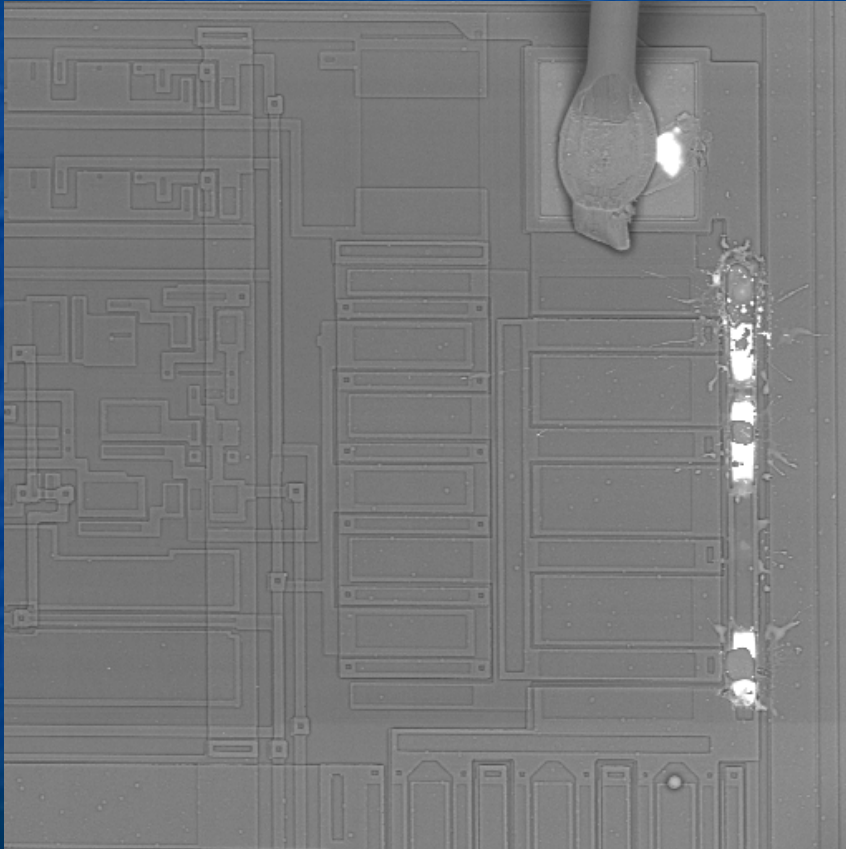
EOS Failure

- A short segment of metallization was fused open
- Likely caused by a voltage transient

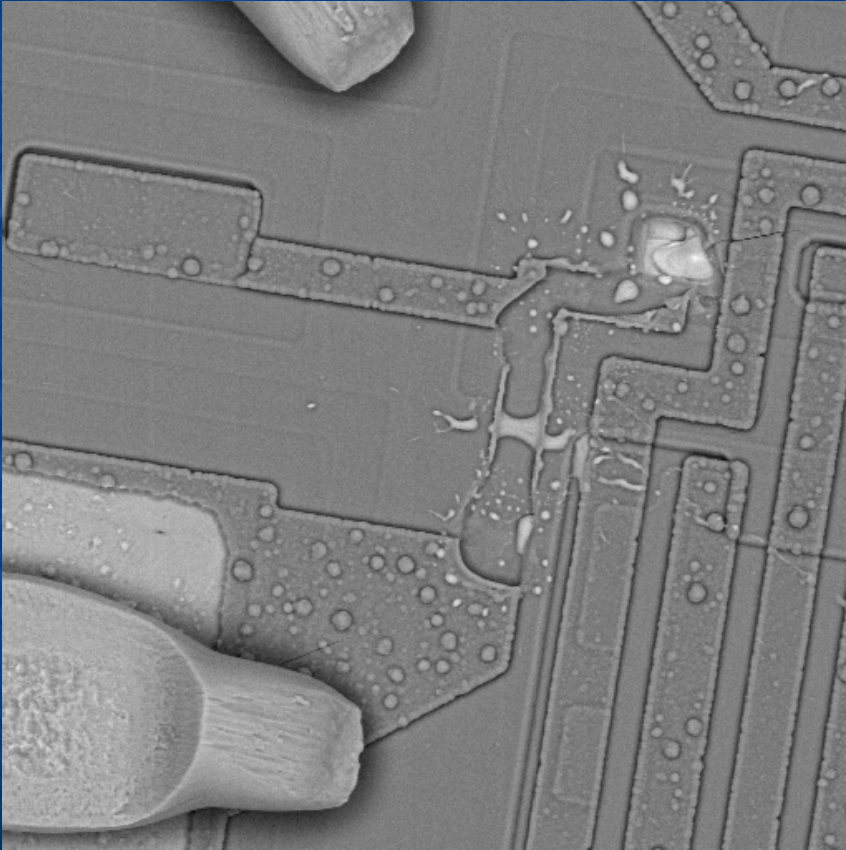
EOS Failure

- A short segment of metallization was fused open
- Likely caused by a voltage transient or ESD

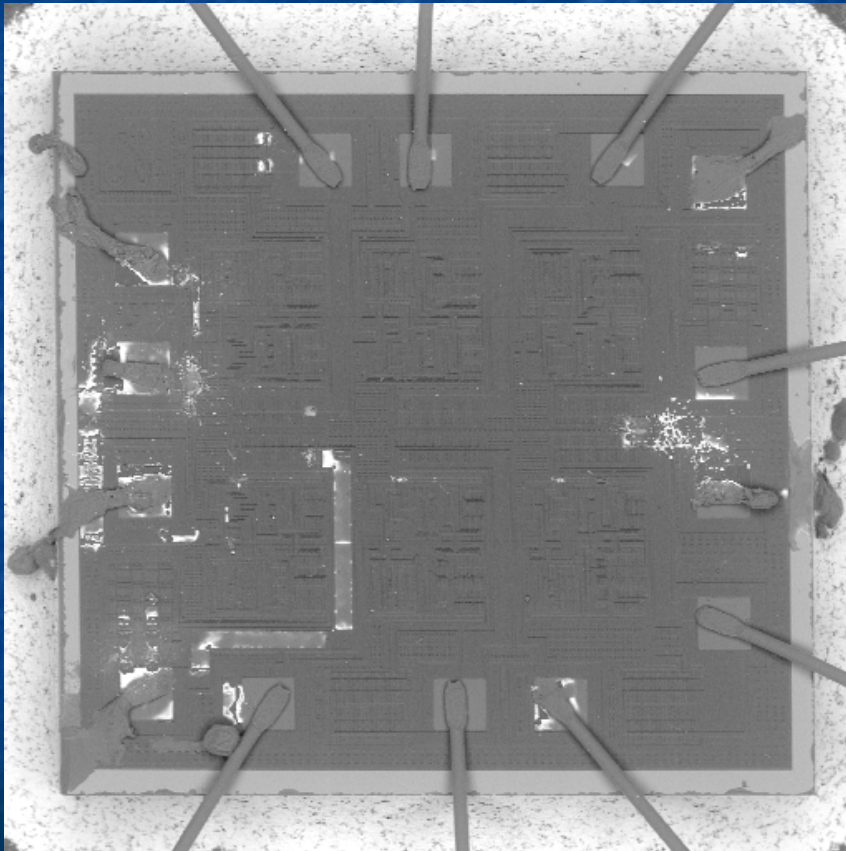
EOS Failure

- Gross electrical overstress damage

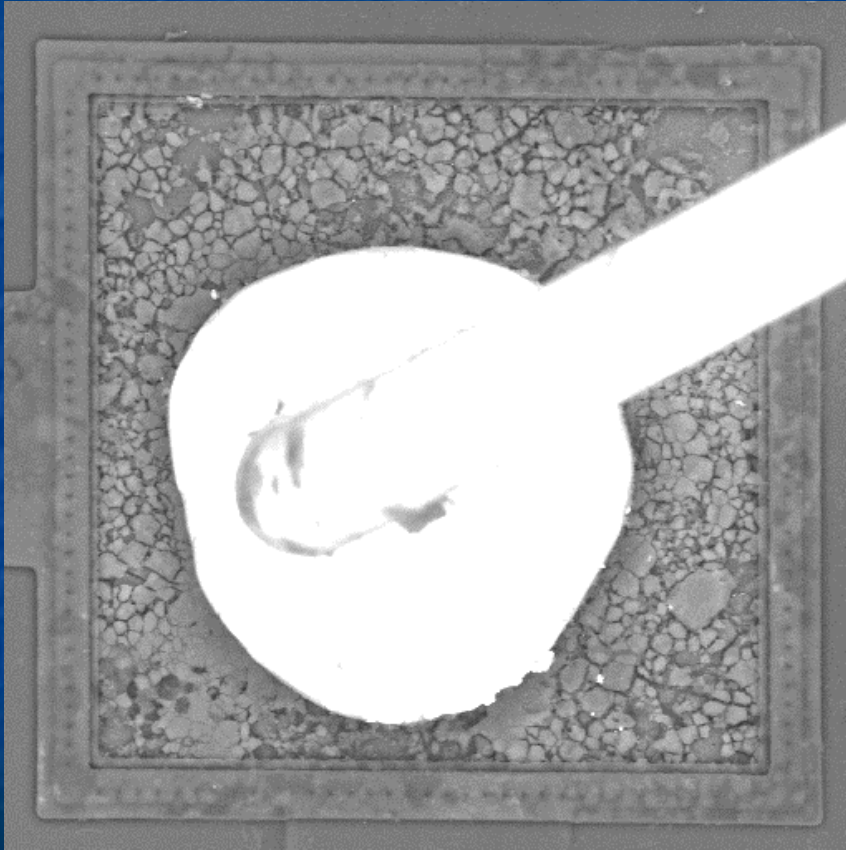
Bond Pad Corrosion

- Contributing causes –
 - * moisture
 - * “pop-corn” damage
 - * internal delam
 - * P contamination

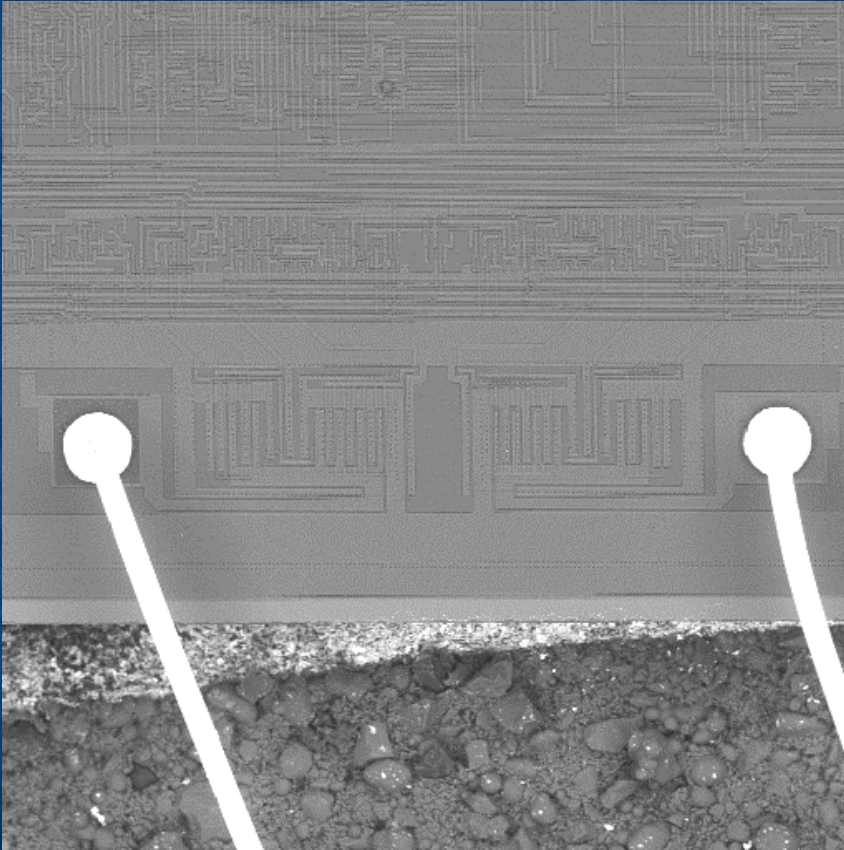
Bond Pad Corrosion

- How to avoid –
 - * MSD control
- Use CSAM imaging and F/A to diagnose

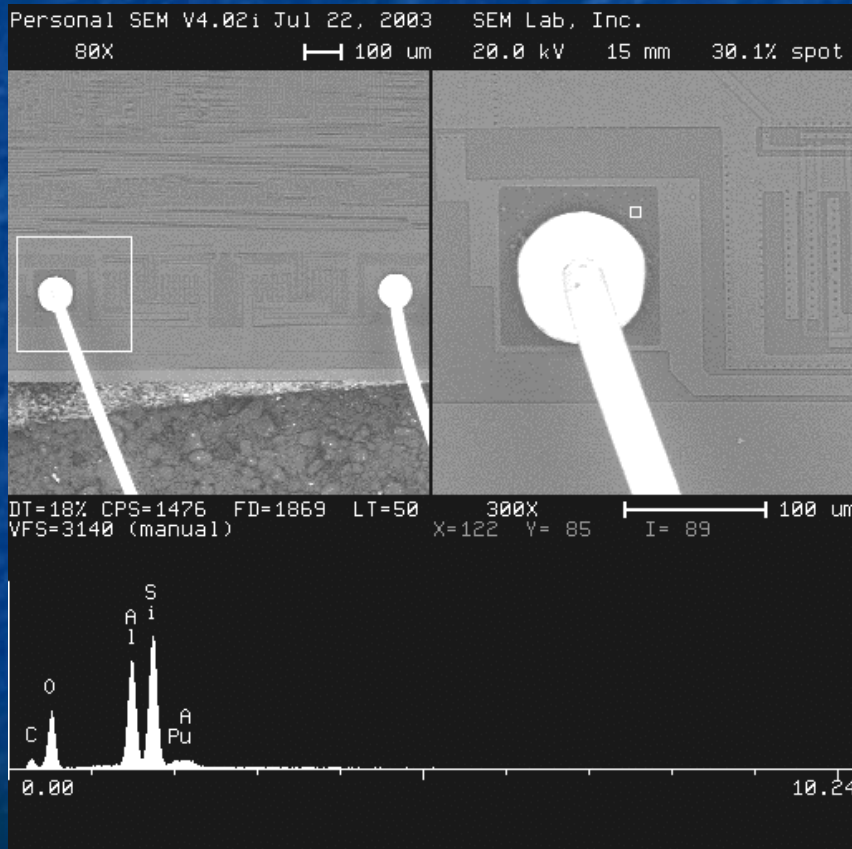
Bond Pad Corrosion

- Trace of P
- P due to molding compound or residual from IC fab

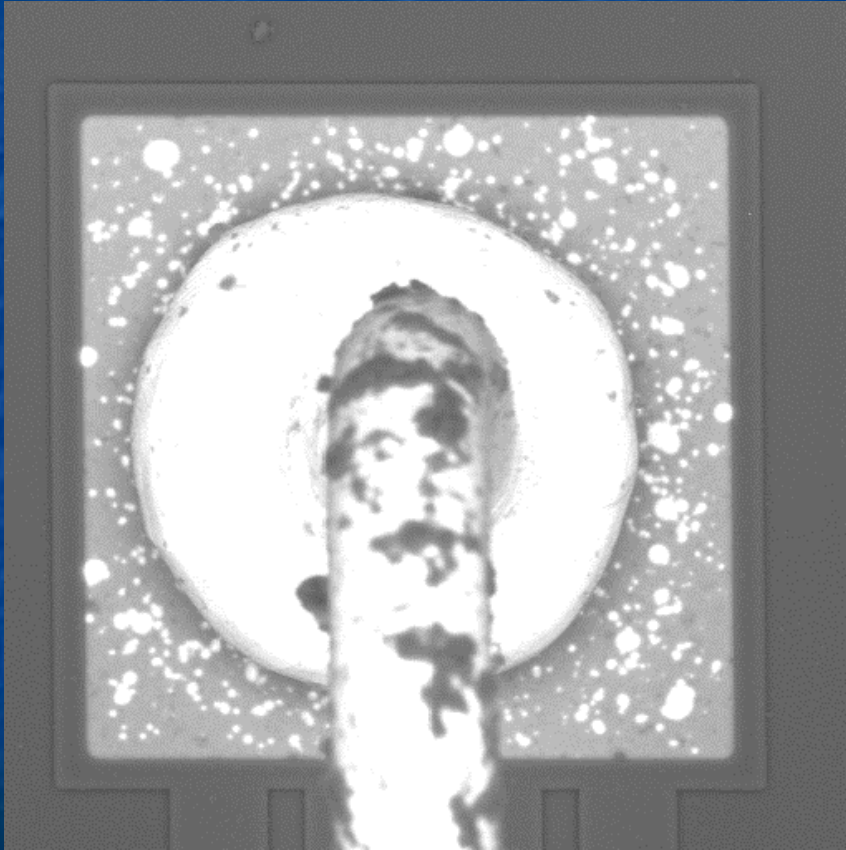
Bond Pad Corrosion

- Bright spots are Ti-W barrier layer where Al is missing

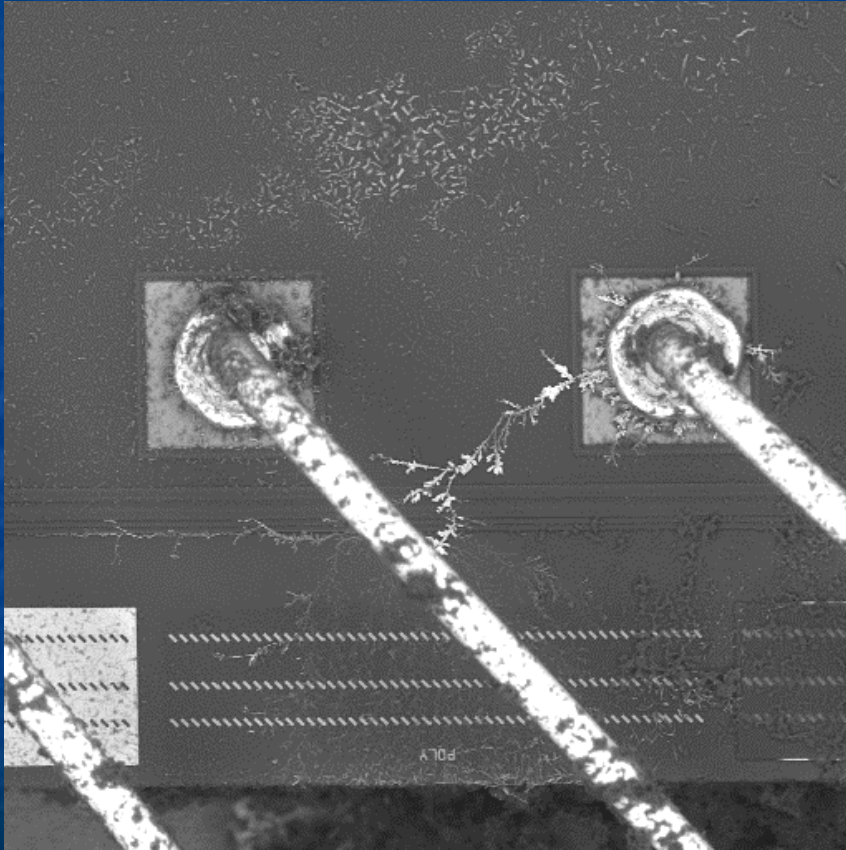
Dendritic Growth on IC Die

- Silver and copper dendrites
- For all the same reasons as bond pad corrosion

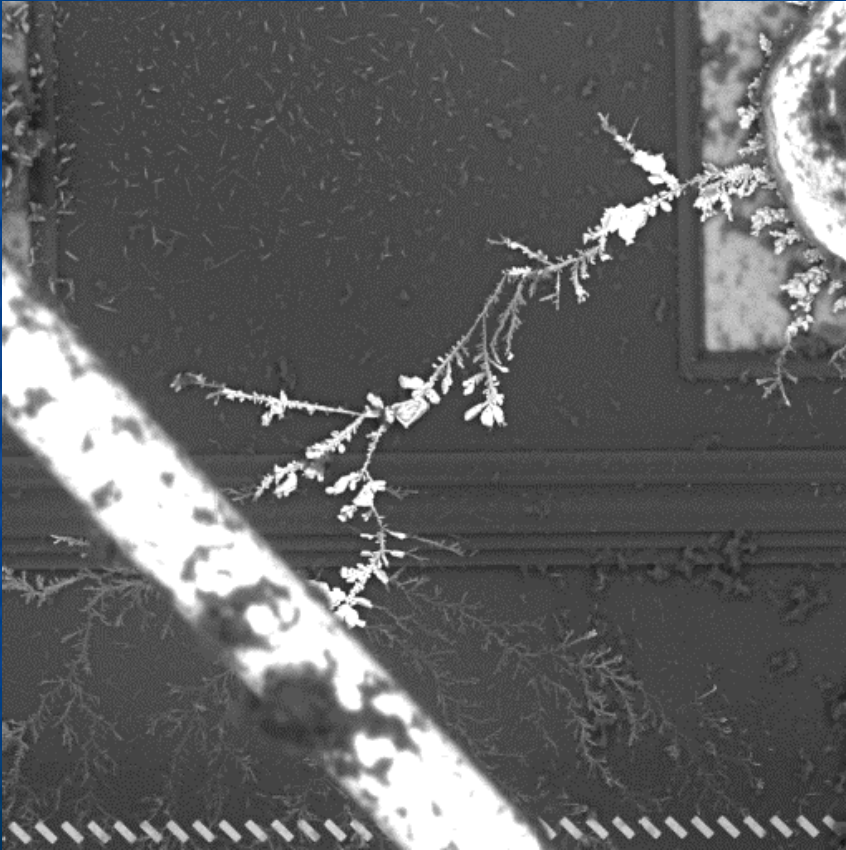
Dendritic Growth on IC Die

- ... or most of the same reasons as bond pad corrosion
 - moisture
 - ionic contamination
 - bias
 - internal delam

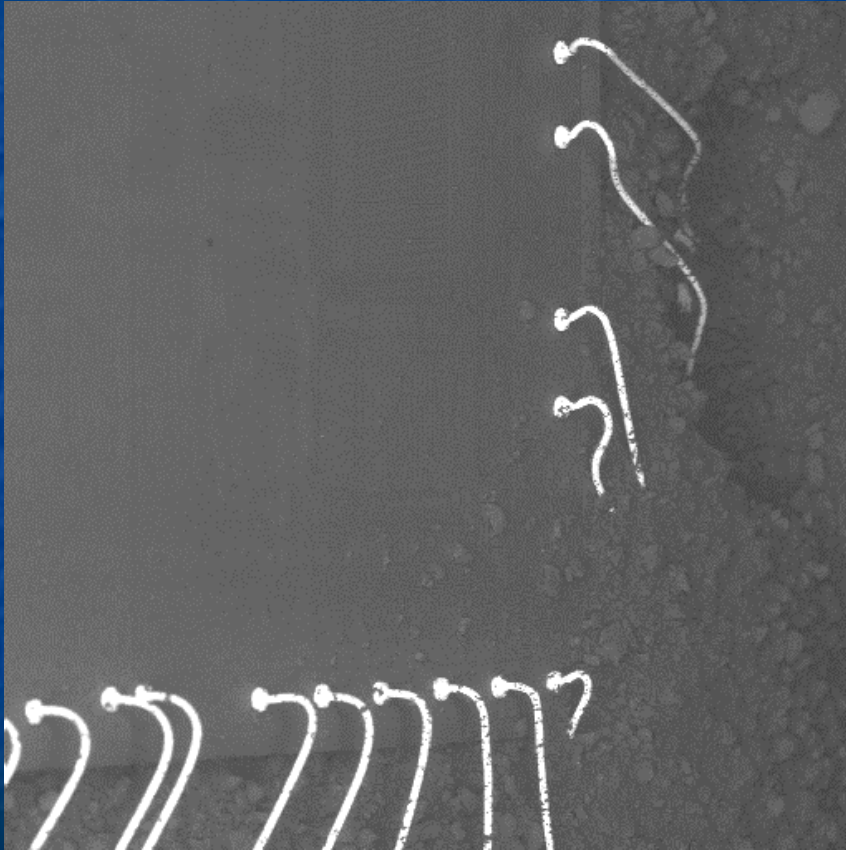
Bond Wire Sweep

- Bond wires are swept by the injection molding compound

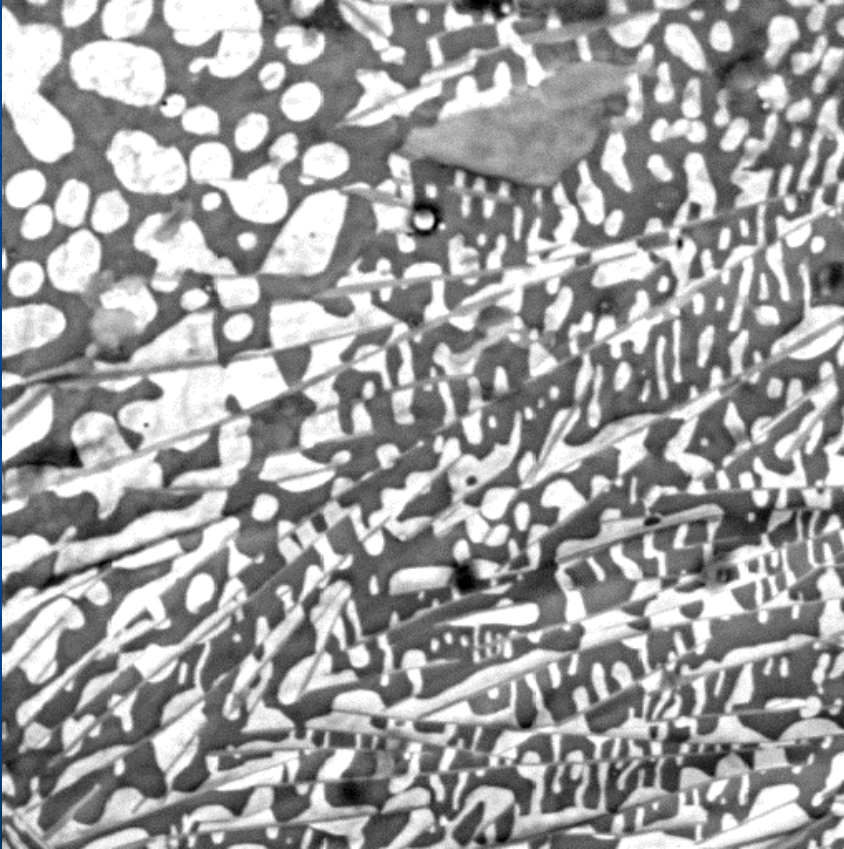
Gold Embrittlement

- This is gold-embrittled eutectic Sn-Pb solder
- AuSn₄ & AuSn₂ platelets dispersed throughout the microstructure

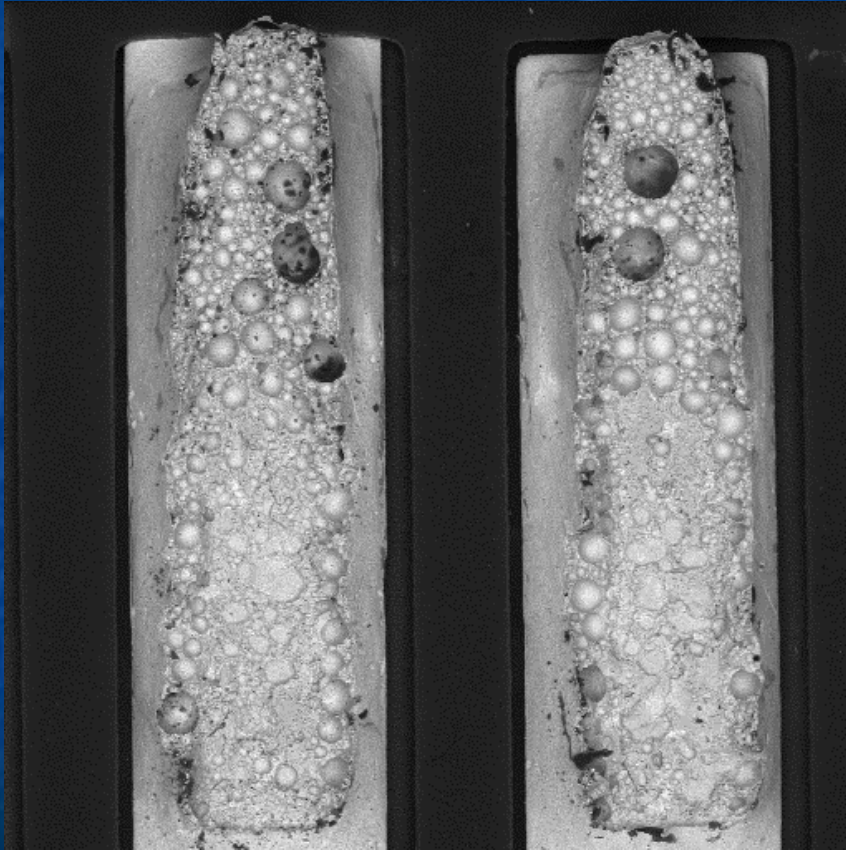
Gold Embrittlement

- Theory – the gold-embrittlement caused voiding!
- AuSn4 & AuSn2 platelets trap volatiles

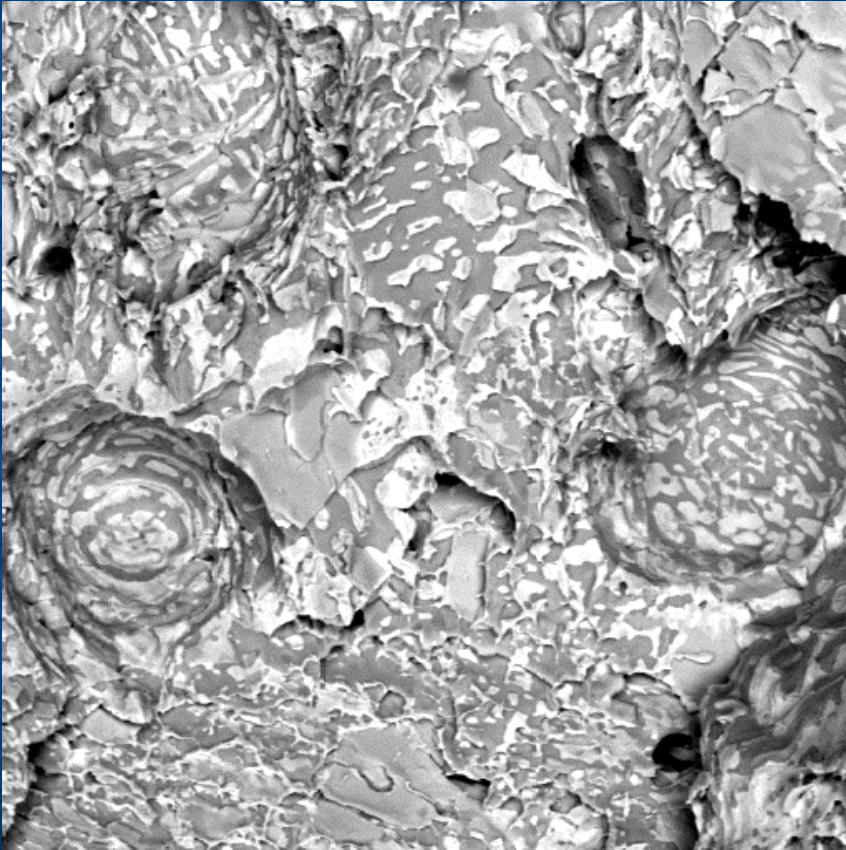
Gold Embrittlement

- Theory – the gold-embrittlement caused voiding!
- AuSn_4 & AuSn_2 platelets trap volatiles

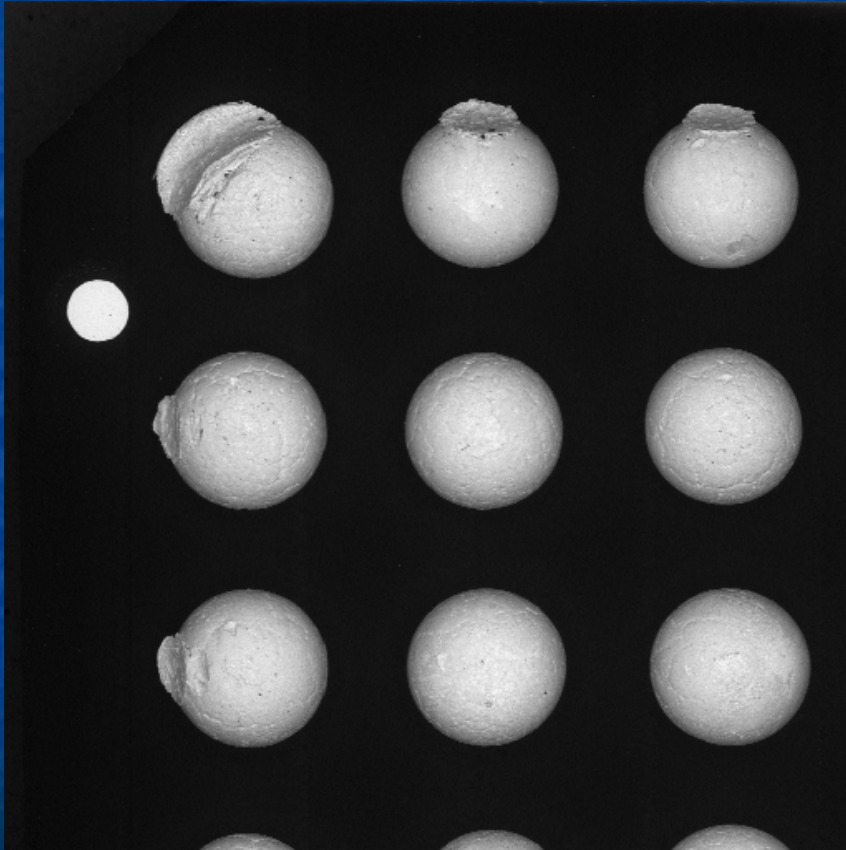
BGA Mechanical Damage

- Probably tool damage
- Most extreme cases had missing balls

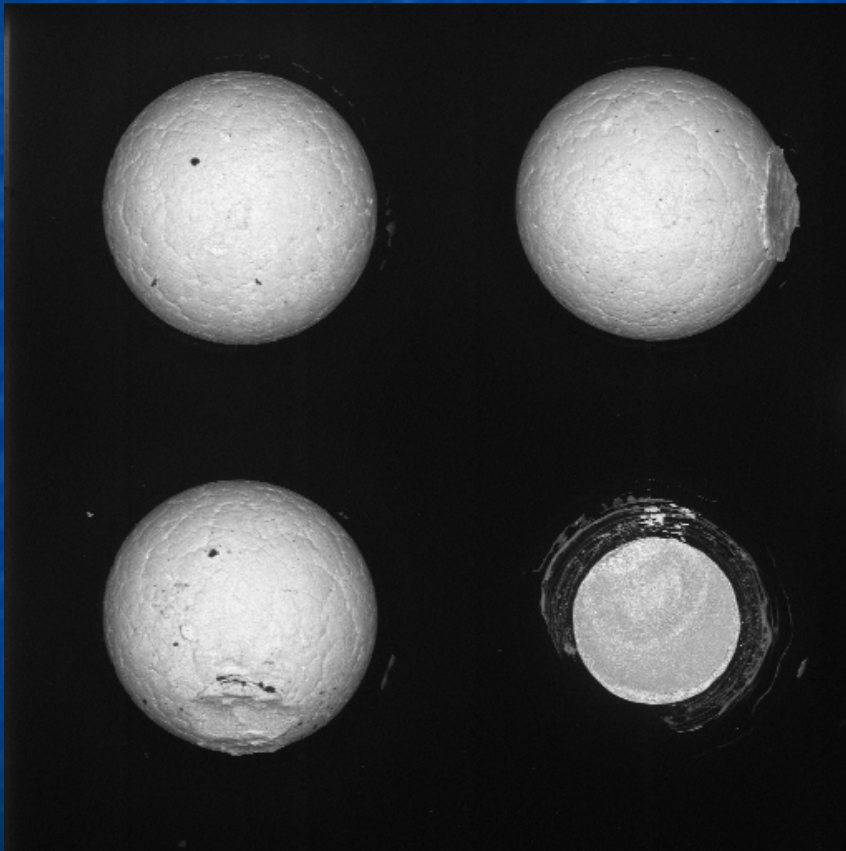
BGA Mechanical Damage

- Corner has a missing ball

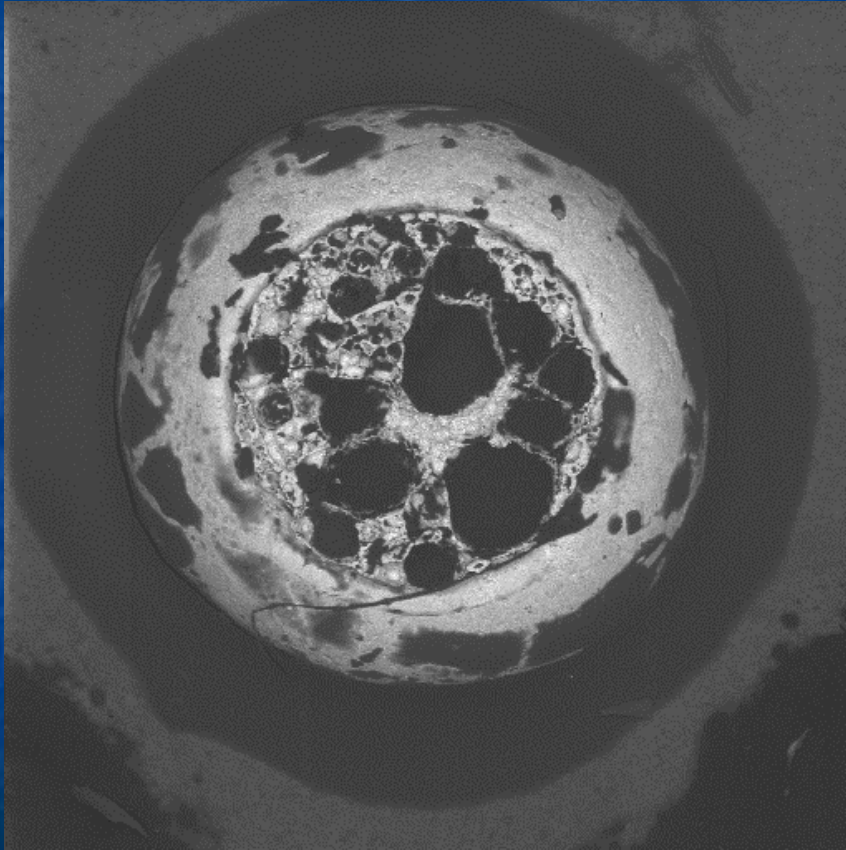
BGA Solder Joint Failure

- BGA solder joint failed at the BGA substrate
- Entrapped material includes flux and mask constituents
- Probably flux and mask are chemically incompatible

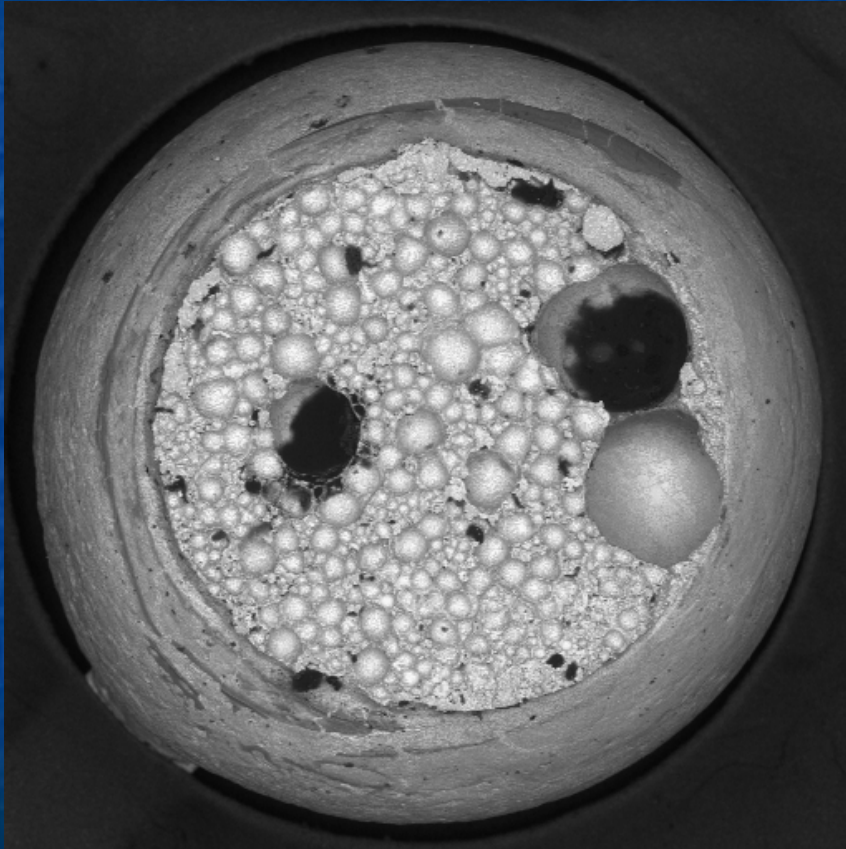
BGA Solder Joint Failure

- This is a different example
- Entrapped material likely debris from plastic trays

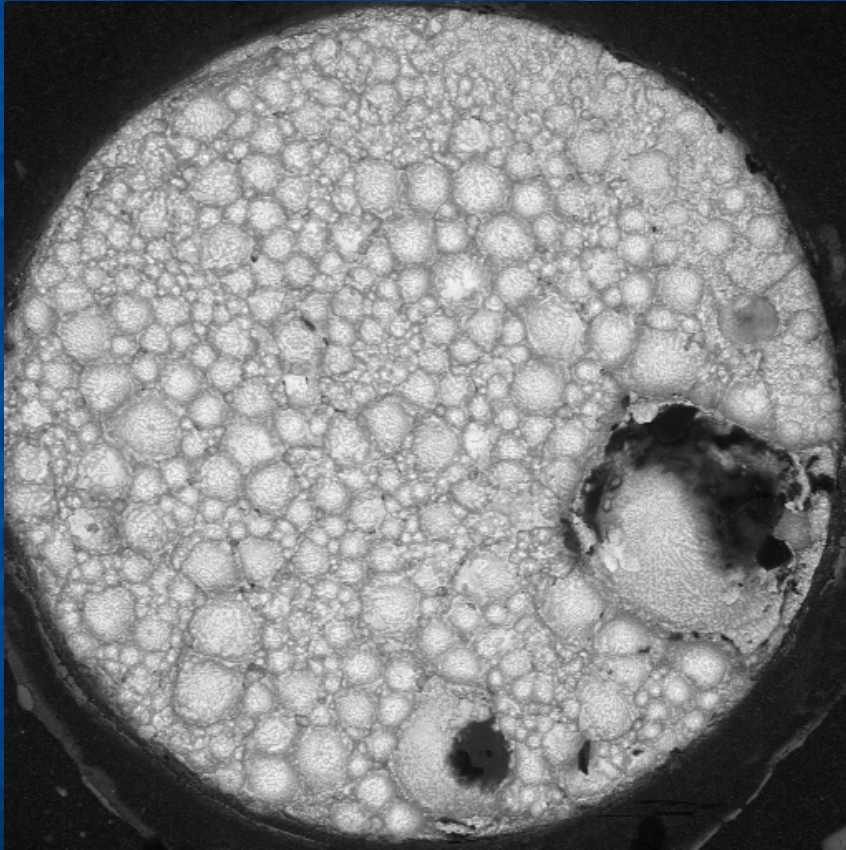
BGA Solder Joint Failure

- This is the fracture surface at the BGA substrate (different location)
- IPC specifications allow up to 25%

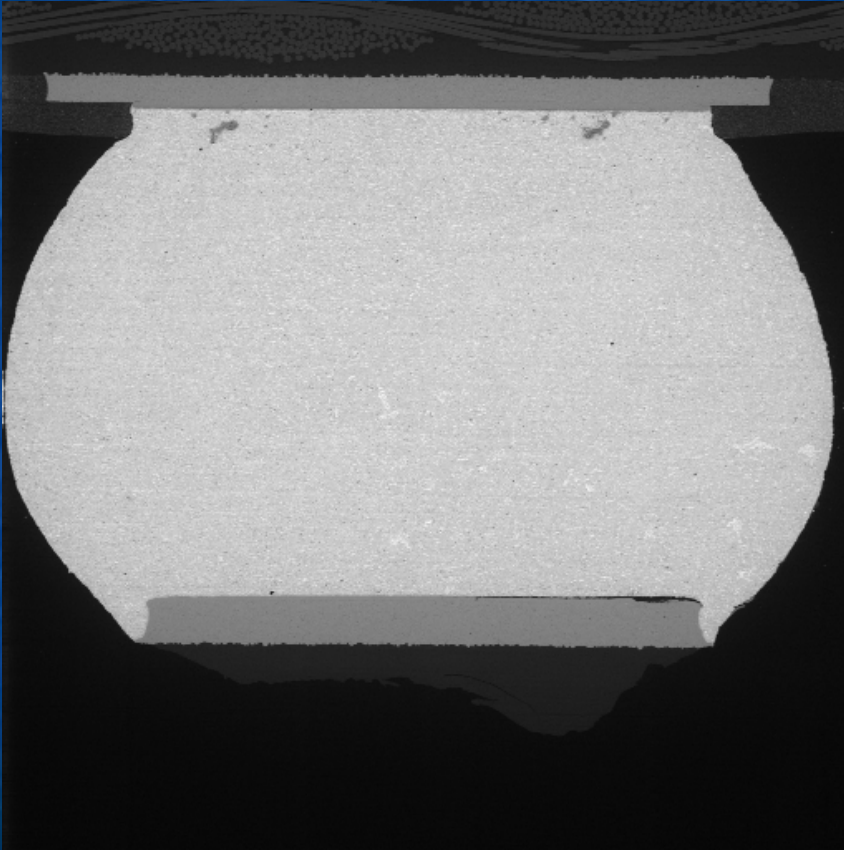
ENIG Black Pad Syndrome

- Brittle fracture at the solder/PWB pad interface
- More specifically between the Ni_3Sn_4 IMC layer and the P-rich EN

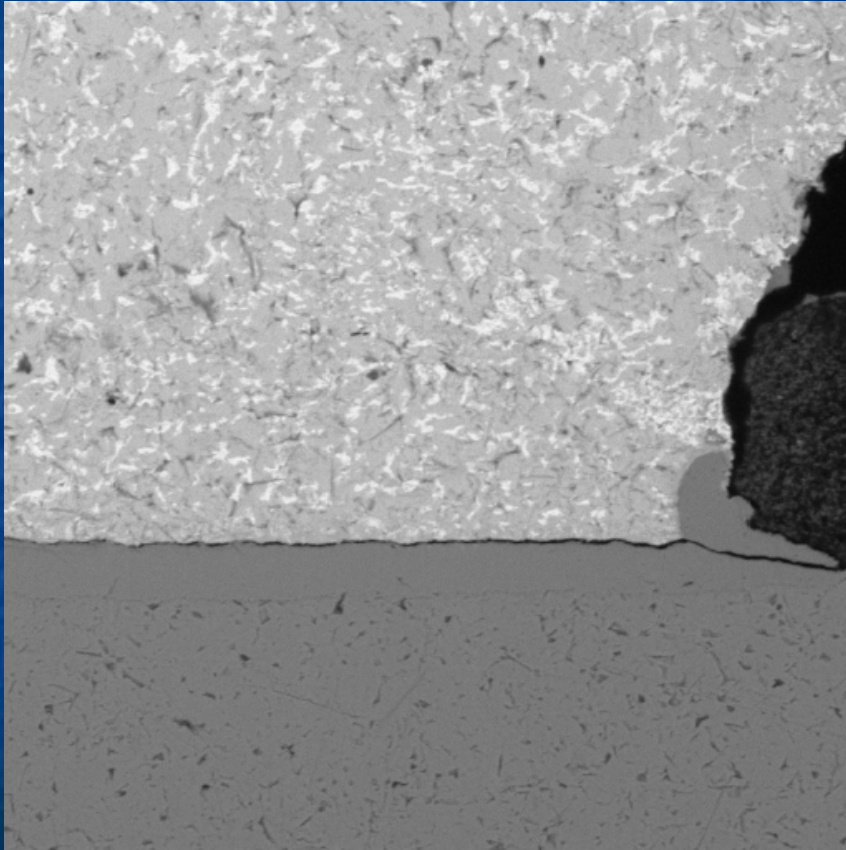
ENIG Black Pad Syndrome

- Very fine line brittle fracture at the solder/PWB pad interface

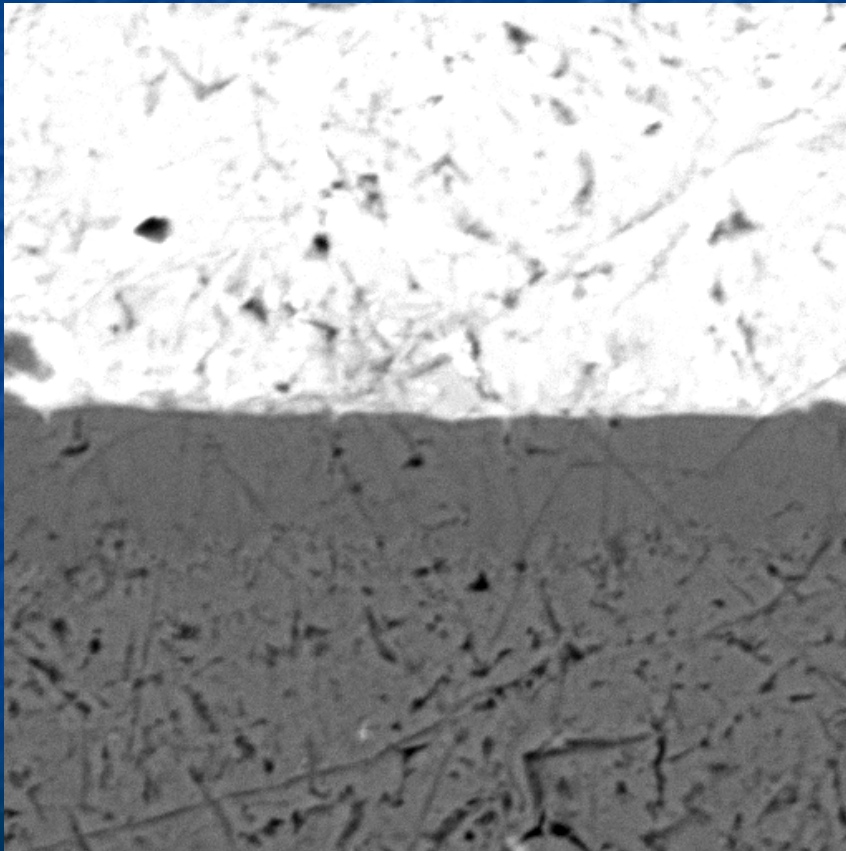
ENIG Black Pad Syndrome

- Very thin (~ 0.25 micron) P-rich EN layer in contact with the Ni_3Sn_4 IMC layer

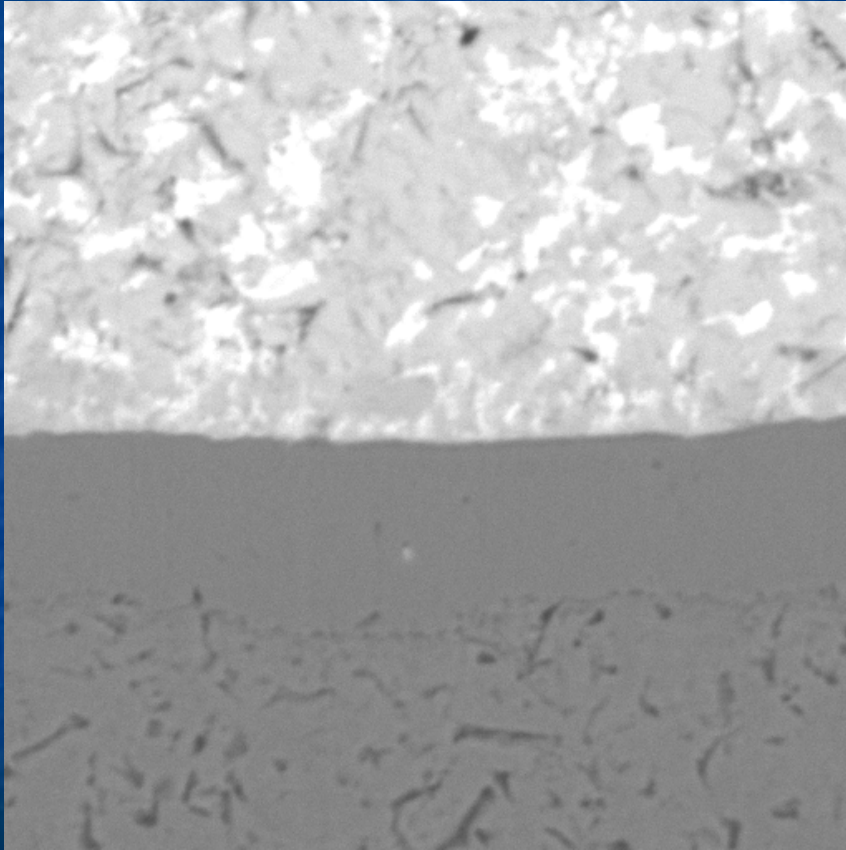
ENIG Black Pad Syndrome

- 2nd example
- Very thin (~ 0.25 micron) P-rich EN layer in contact with the Ni_3Sn_4 IMC layer

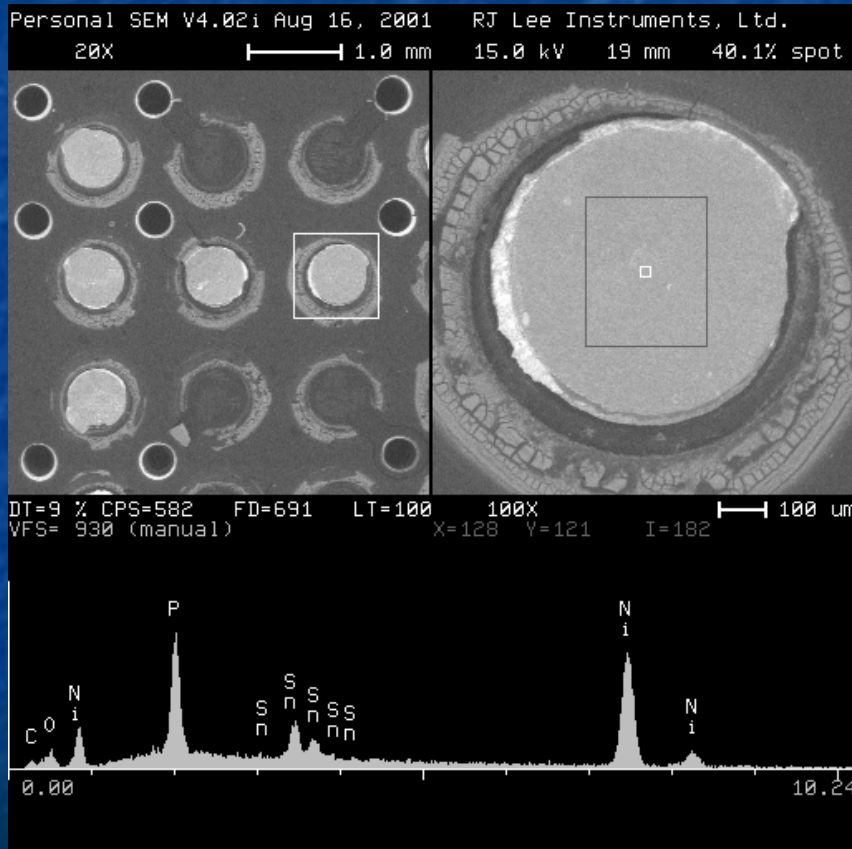
ENIG Black Pad Syndrome

- ~ 18 wt% P at the fracture surface versus 7 – 9 wt% P for EN bulk
