Images of Failures in Microelectronics Packaging and Assembly

Ed Hare, Ph.D./[SEM Lab, Inc.](http://www.semlab.com)

IMAPS NW - Feb. 11th 2004
Redmond, WA

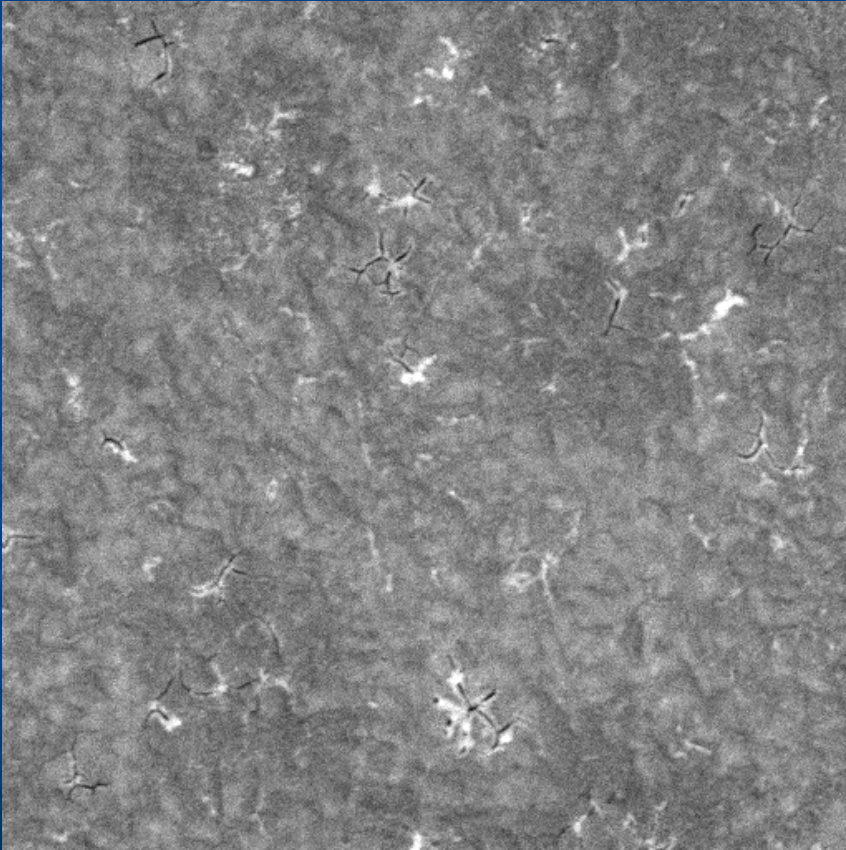
ENIG Black Pad Syndrome

- IG spiking
- Hyper-etching of EN in IG bath

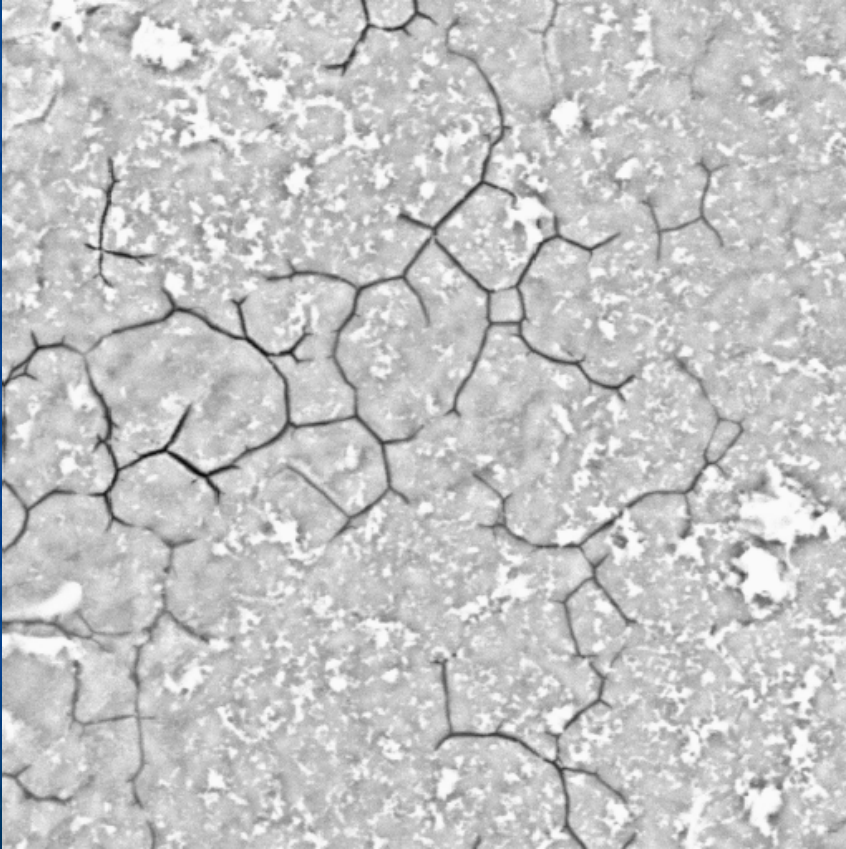
ENIG Black Pad Syndrome

- 2nd example
- IG spiking
- Hyper-etching of EN in IG bath

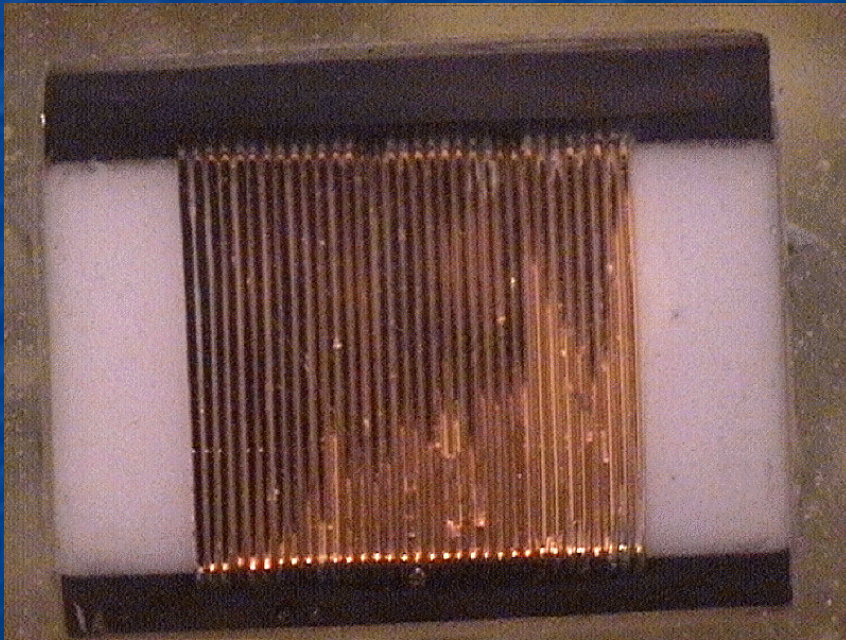
Failed SMD Inductor

- Discoloration of magnet wire
- Open circuited coil

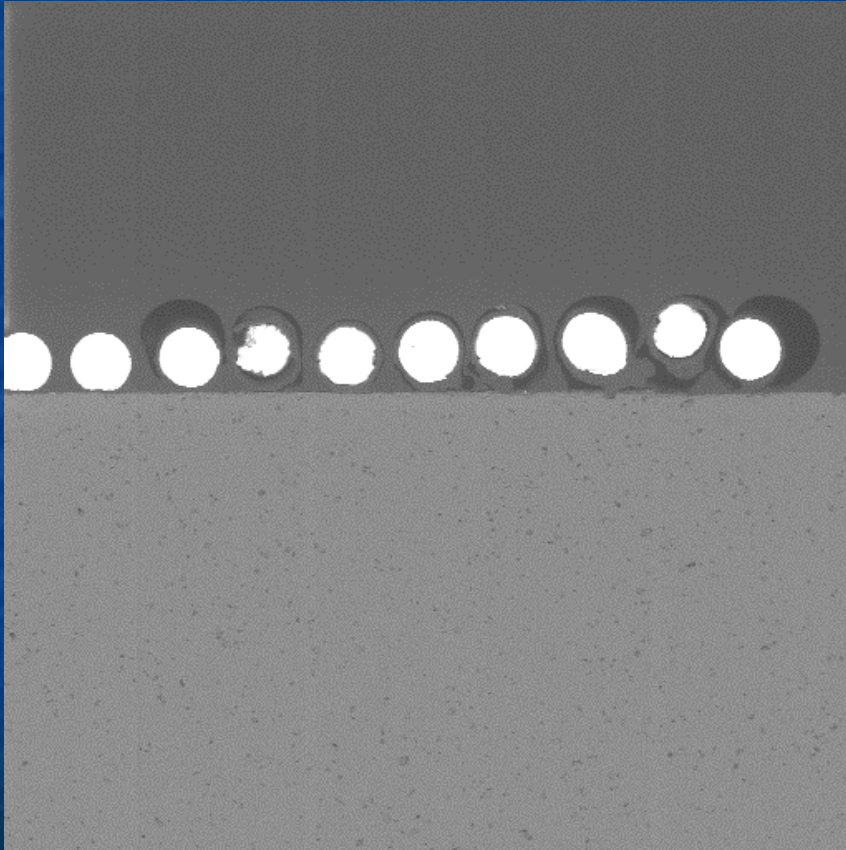
Failed SMD Inductor

- Encapsulant voids around magnet wire
- Magnet wire cross-section reduced due to corrosion

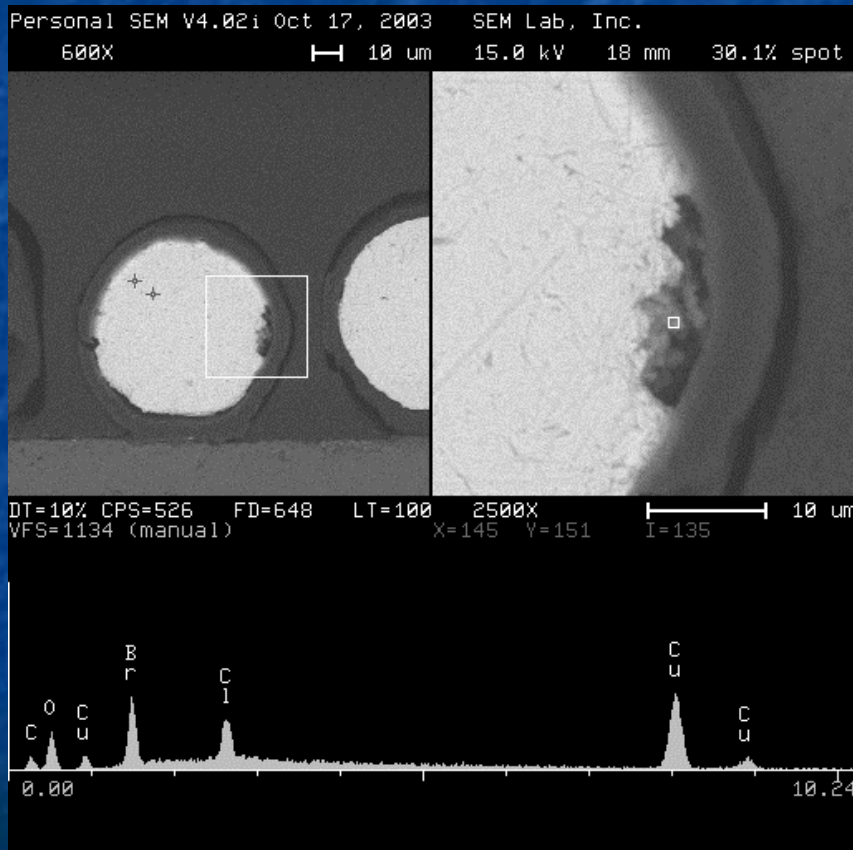
Failed SMD Inductor

- Corrosion due to Cl & Br from activated flux that wicked into the coil

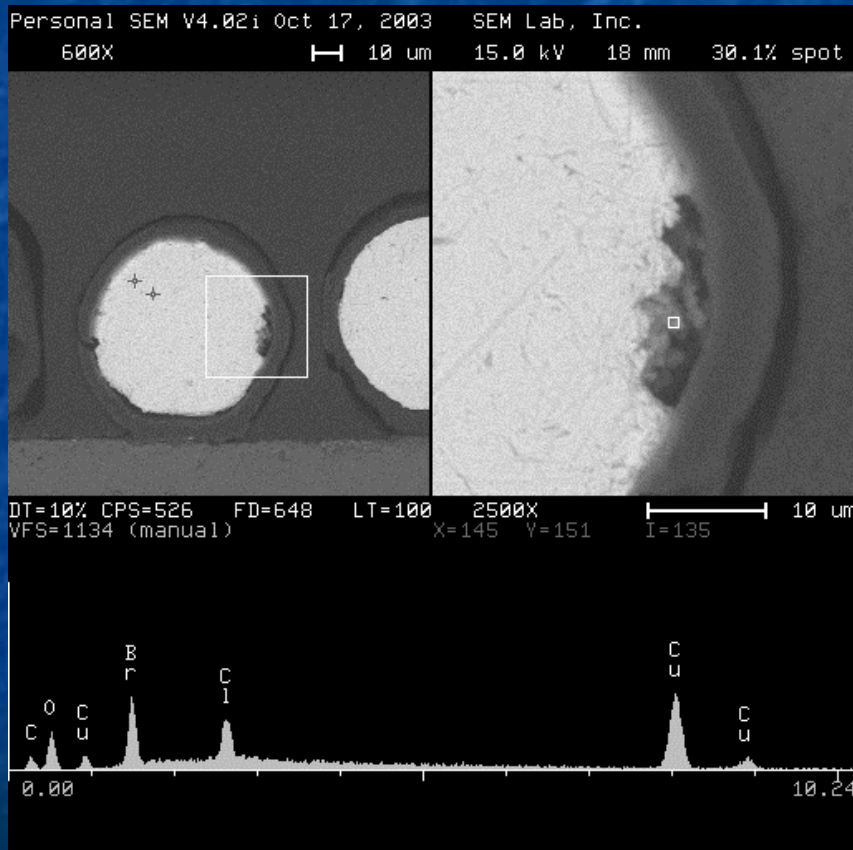
Failed SMD Inductor

- Corrosion due to Cl & Br from activated flux that wicked into the coil

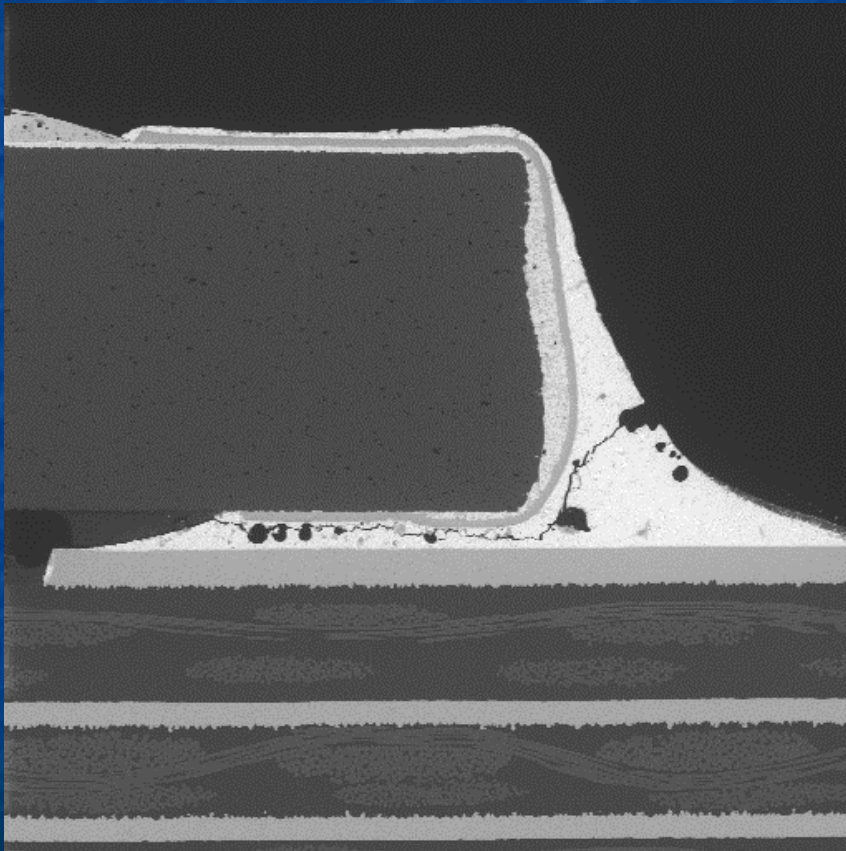
Failed Resistor Network Joint

- Classic thermal fatigue failure
- Voids may be a contributing factor

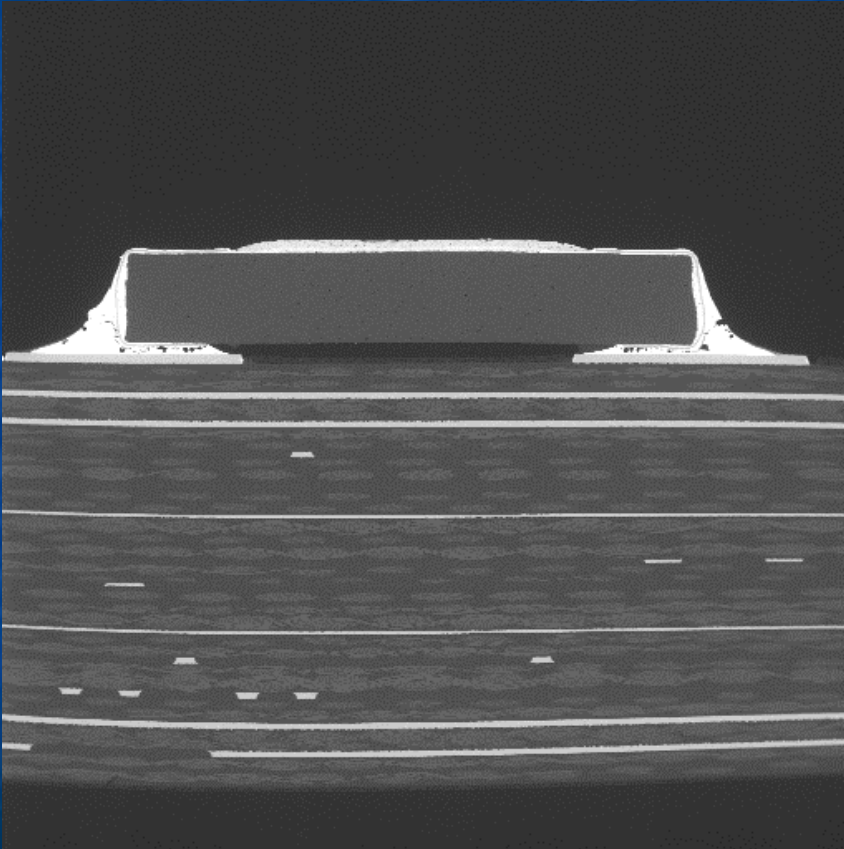
Failed Resistor Network Joints

- Classic thermal fatigue failure
- Thermal expansion mismatch too large
- Failed after ~ 5 years of service

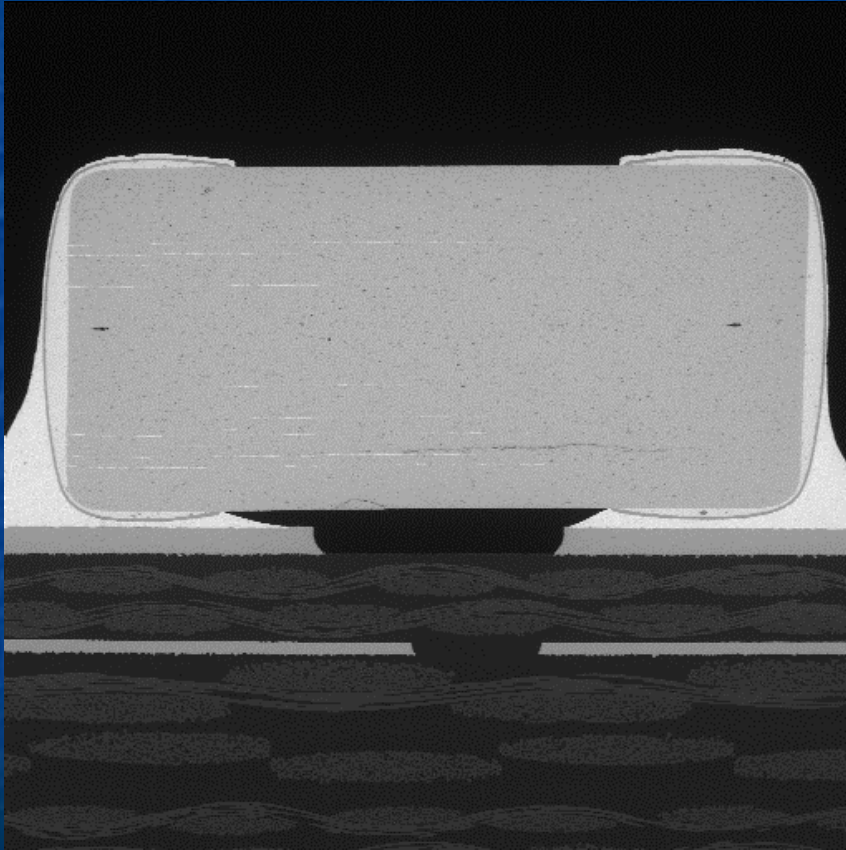
MLCC Knit Line Failure

- MLCC manufacturing defect
- Crack propagates and crosses plates causing electromigration short

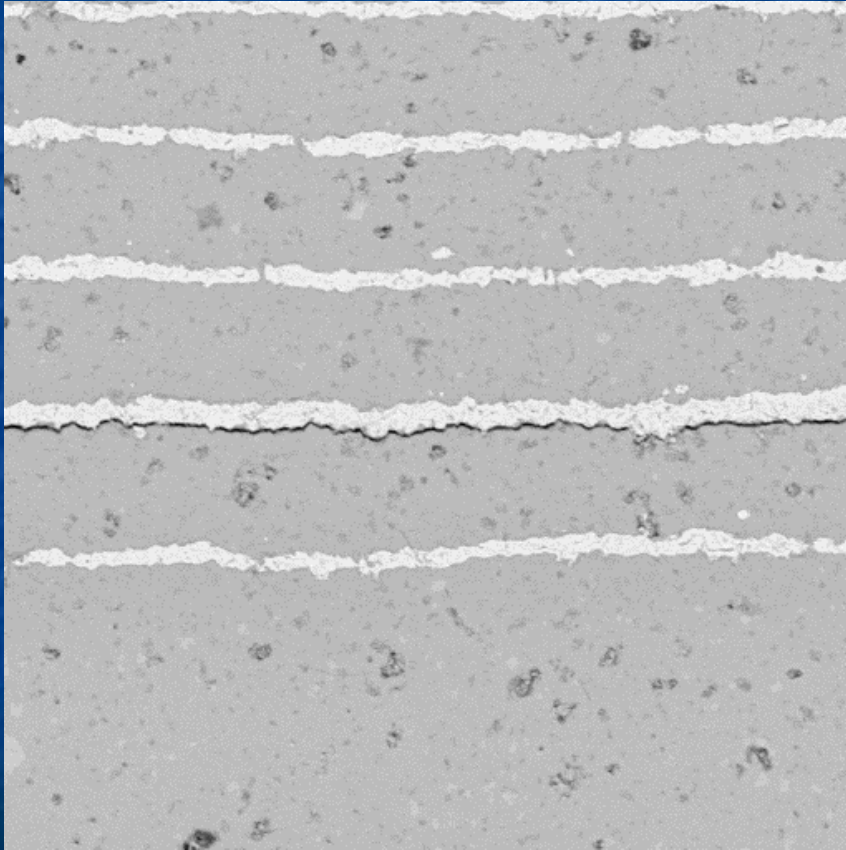
MLCC Knit Line Failure

- Delamination between plate and dielectric

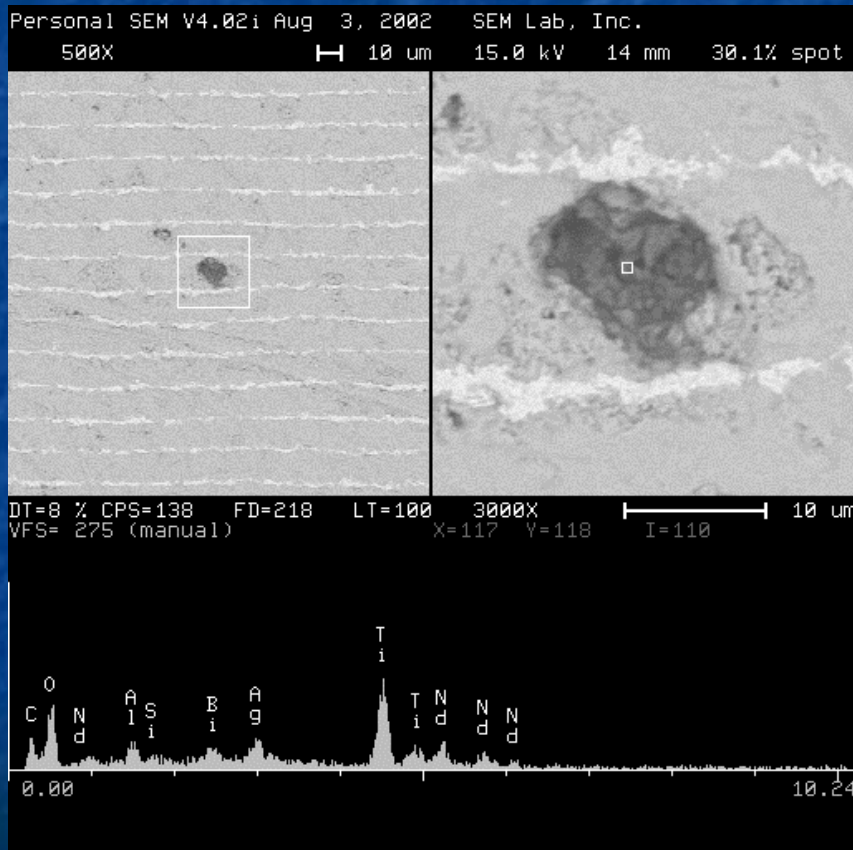
MLCC Dielectric Voids

- Void bridges plates and creates electromigration path

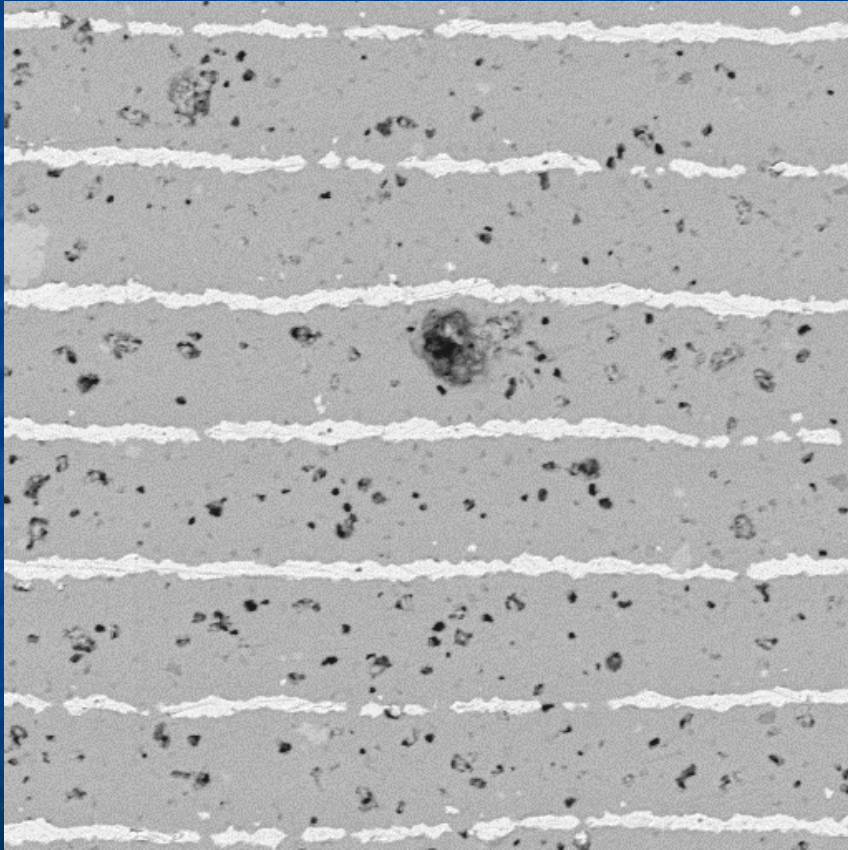
MLCC Dielectric Voids

- Another example of MLCC dielectric voids

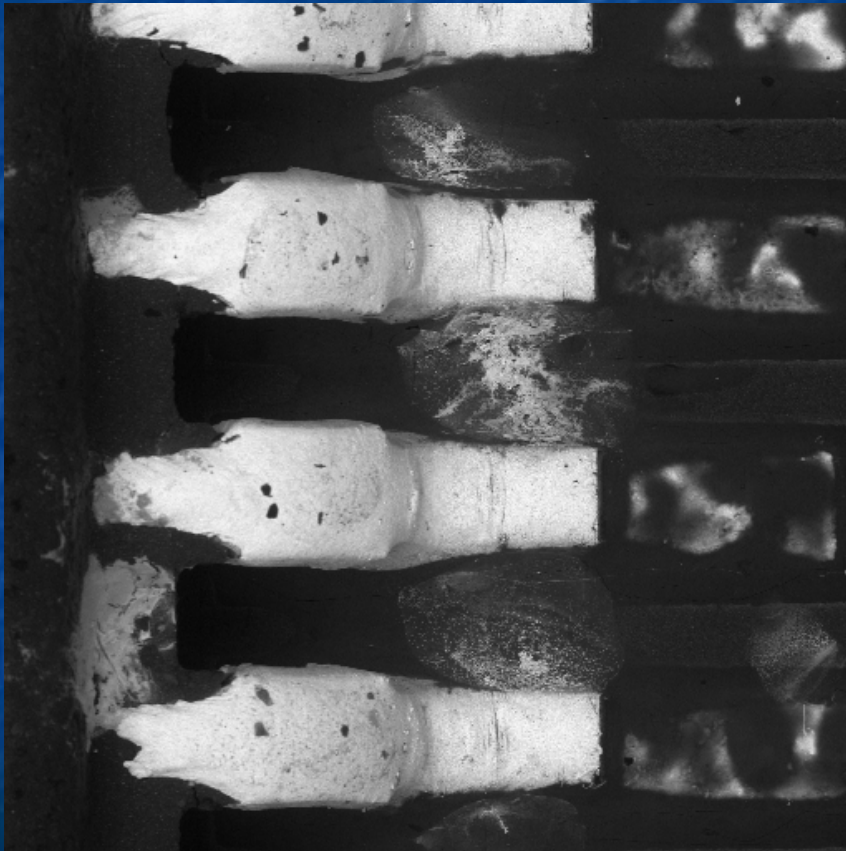
TSOP Electromigration Failure

- Electrical leakage failures
- No Clean Flux, but likely activated flux used in touch up

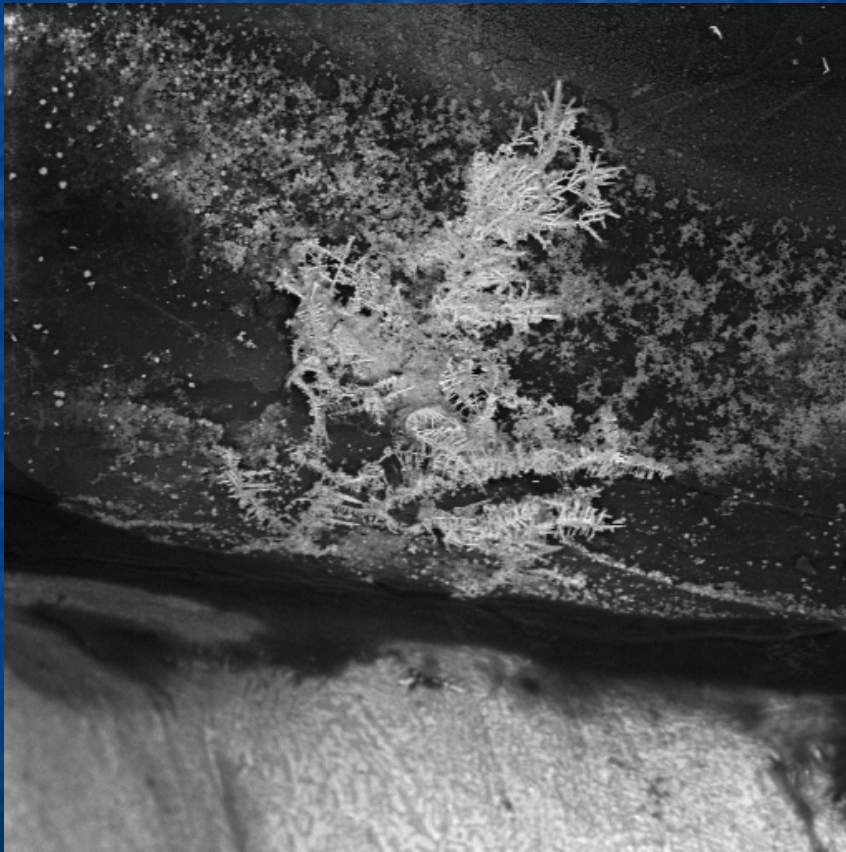
TSOP Electromigration Failure

- Pb dendrites grow between signals and short them out
- Never mix No-Clean flux and activated flux

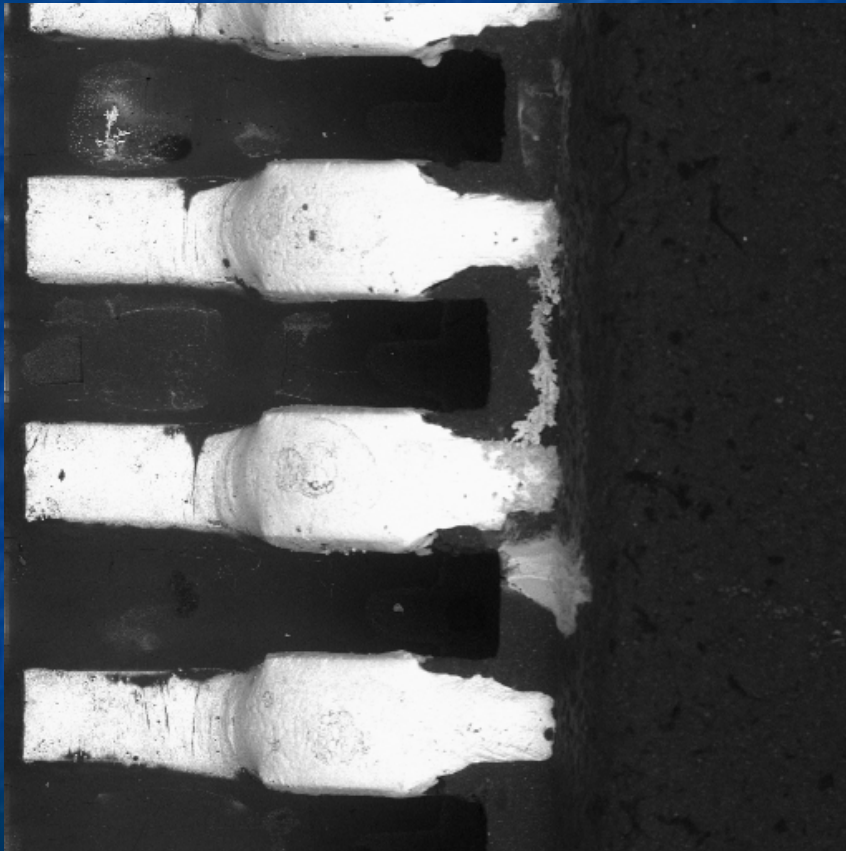
TSOP Electromigration Failure

- Its even growing across the mold flash up by the package body!

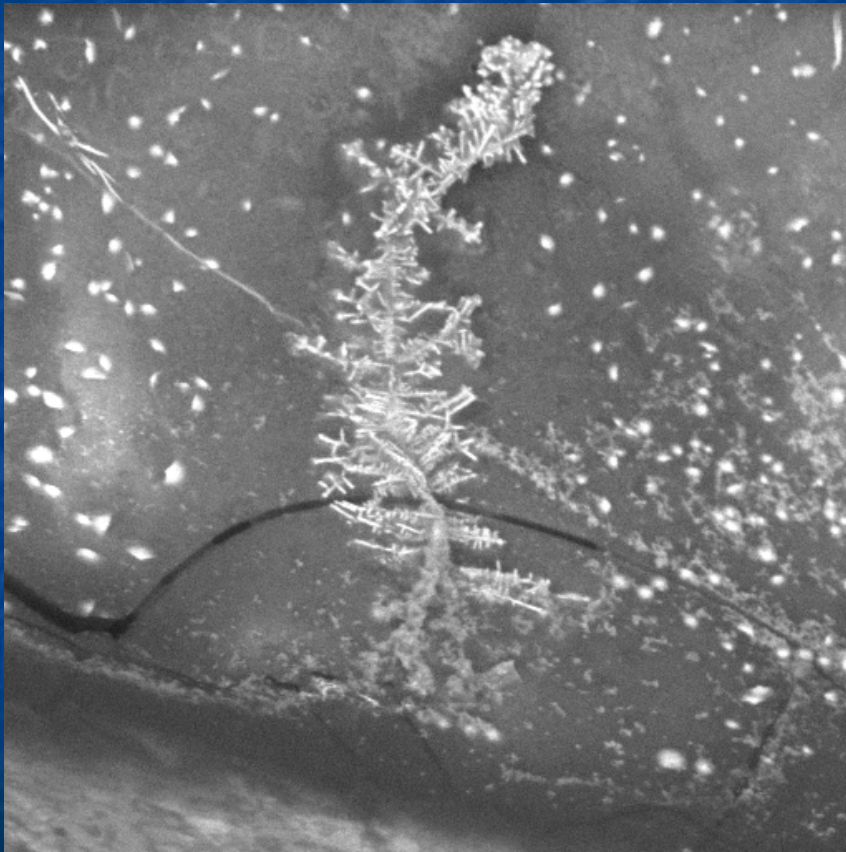
TSOP Electromigration Failure

- There is nothing quite like a pretty picture of a Pb-dendrite
