# Solder-Flux-Associated Failures in Electronic Assemblies

*Failure mechanisms, evidence limits, and process controls*

Ed Hare, Ph.D.  
SEM Lab Inc.  
Failure Analysis and Materials Characterization

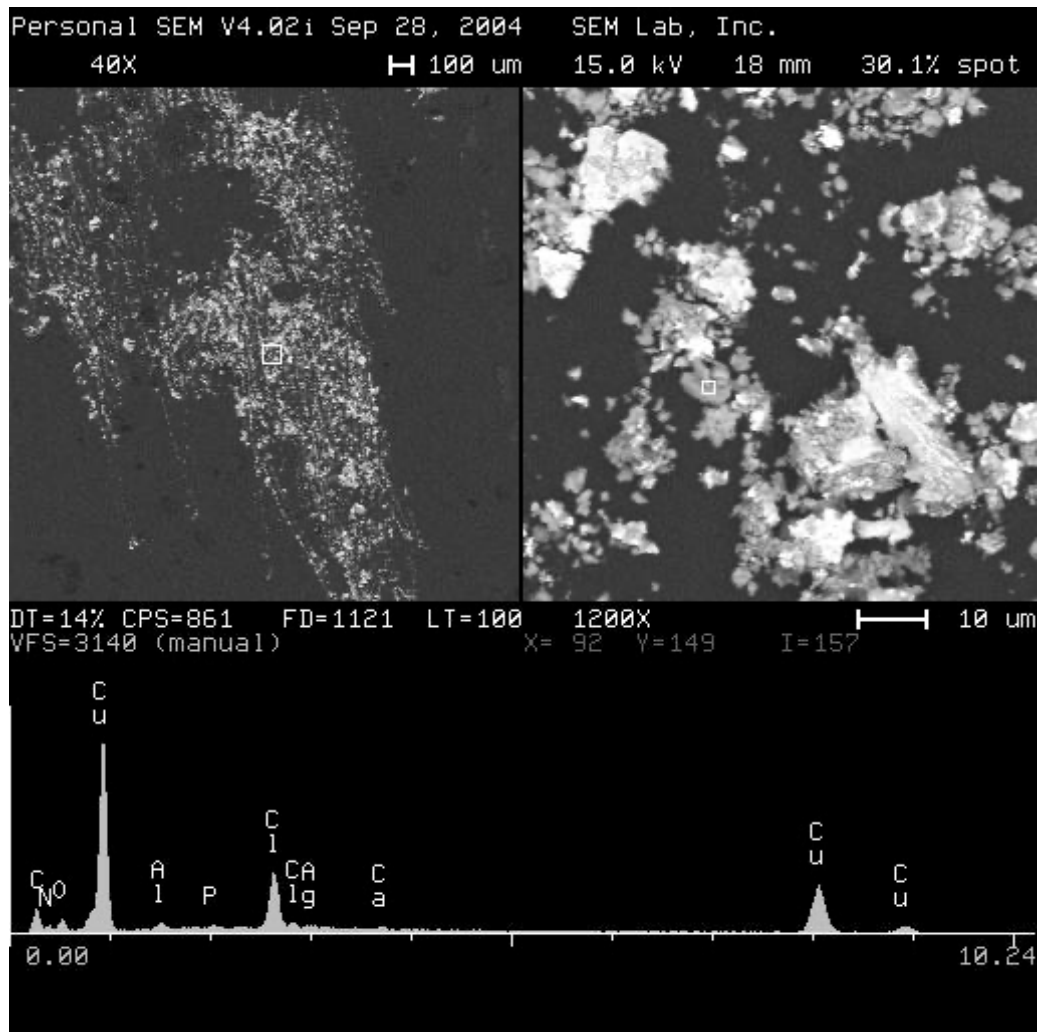
Case 1027 documented corrosion of immersion silver and the underlying copper. The corrosion product contained residual chloride together with detergent and hard-water indicators. The evidence therefore points to a cleaning-system problem rather than a simple flux-product diagnosis: activated residue, detergent removal, rinse-water quality, and drying were parts of the same process.

**Figure 1. Case 1027: corrosion product at site 2 and its elemental spectrum. Chloride supports chloride-driven copper corrosion; phosphorus and the aluminum/calcium signal indicate that detergent and rinse-water residues also contributed to the local chemical environment.**

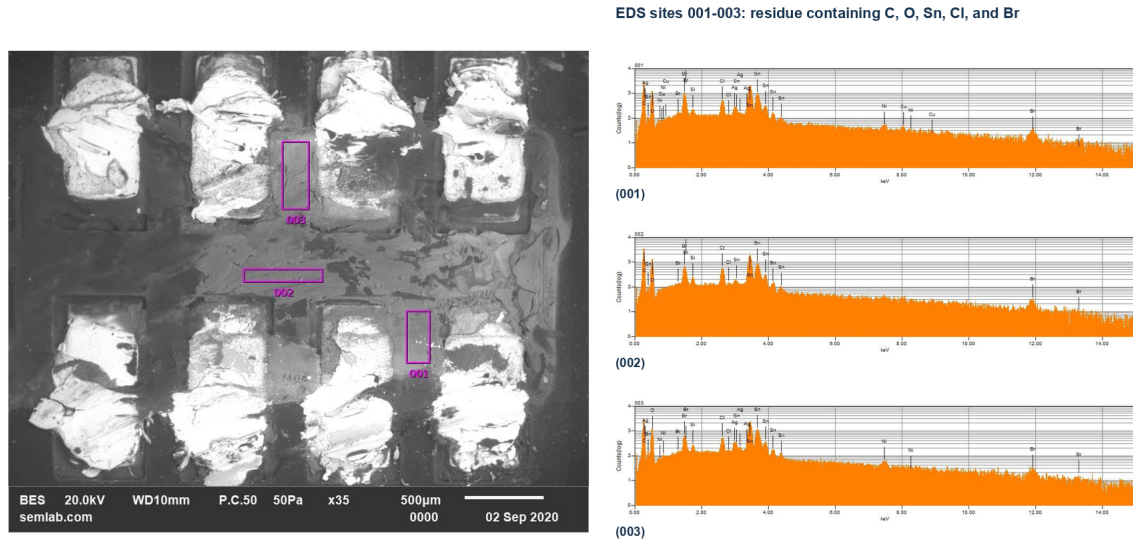
## Case 2898 - linked micrograph and EDS spectra

Case 2898 involved resistor networks with variable leakage between signals. Flux residue, corrosion products, and halide contamination were present under and around the devices. The reported leakage varied with ionic concentration, humidity, applied bias, time, and temperature. Hydration increased surface conduction; drying suppressed the symptom without removing the contaminant. A dry acceptance test could therefore pass an assembly while the underlying process defect remained.

**Figure 2. Case 2898: backscattered-electron image with EDS sites 001-003. The spectra collectively show residue containing carbon, oxygen, tin, chlorine, and bromine. The image establishes residue location and chemistry; the case electrical history establishes the moisture-sensitive leakage response.**

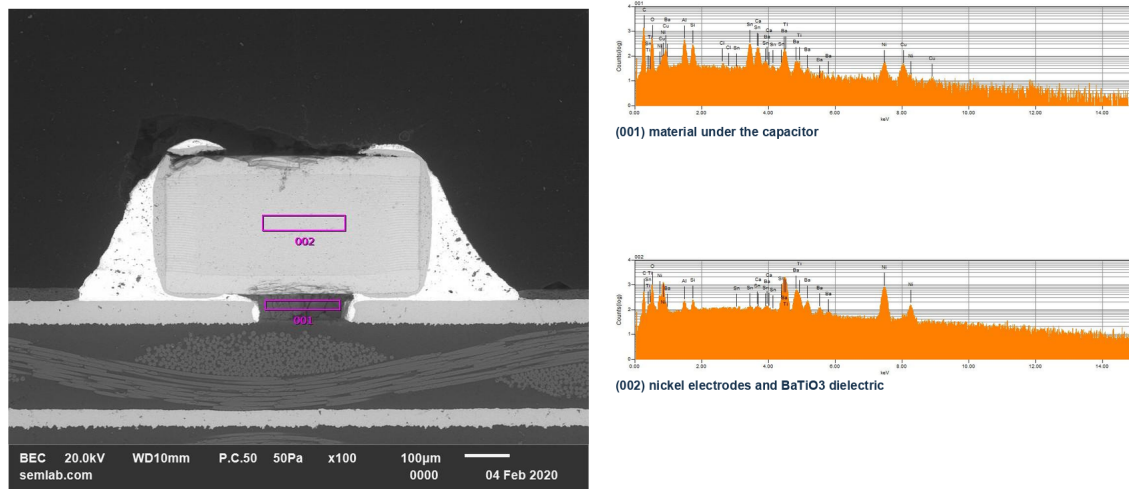
## Case 2857 - linked micrograph and EDS spectra

Case 2857 provides direct evidence beneath a failed capacitor. The material beneath the component occupied the same restricted region in which an external migration path could bridge the terminations. The investigation concluded that trapped solder-flux residue was the most likely cause of the reported external electromigration shorts. End-cap adhesion was a separate construction weakness that could aggravate the condition but did not replace the external path as the principal explanation.

**Figure 3. Case 2857: cross-section and corresponding spectra. (001) Material retained beneath the capacitor. (002) Nickel electrodes and barium-titanate dielectric. The geometry places retained material between the component and board where cleaning and drying access are restricted.**

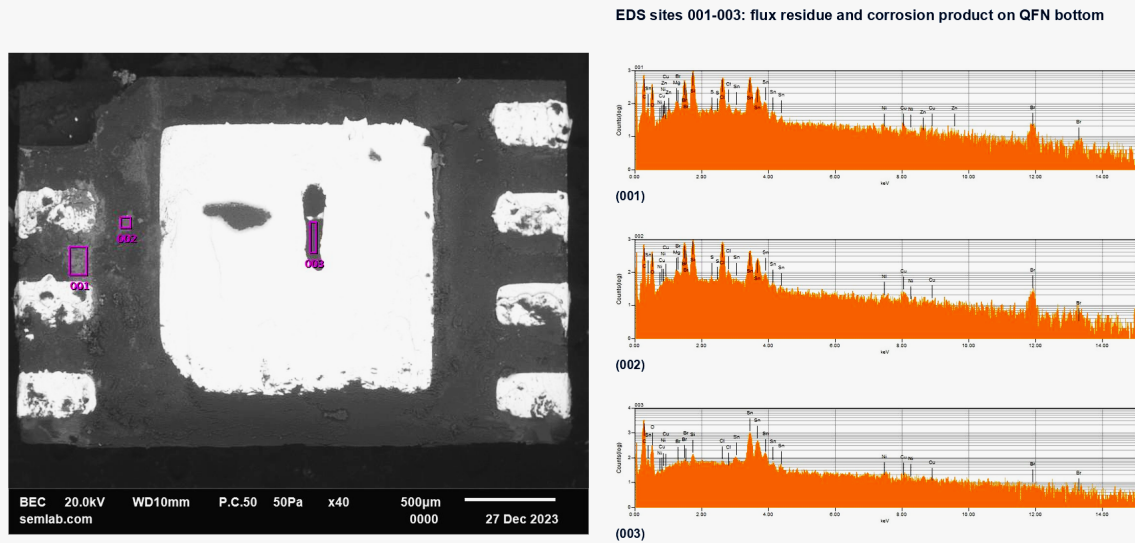
## Case 3087 - linked micrograph and EDS spectra

Case 3087 documented corrosion and electrochemical migration beneath QFN devices. The process used no-clean SMT paste followed by a more active wave flux. The report concluded that existing paste residue could retain later activators and prevent their removal during cleaning. This failure mode is governed by the complete sequence: material compatibility, second-side exposure, component geometry, wash exchange, and drying. Qualification of each flux in isolation does not qualify the combined process beneath the product's actual packages.

**Figure 4. Case 3087: QFN bottom surface with linked EDS spectra. Sites 001-003 collectively represent flux residue and corrosion product on the package bottom. The family preserves the spatial relationship between the affected surface and the corresponding chemistry.**

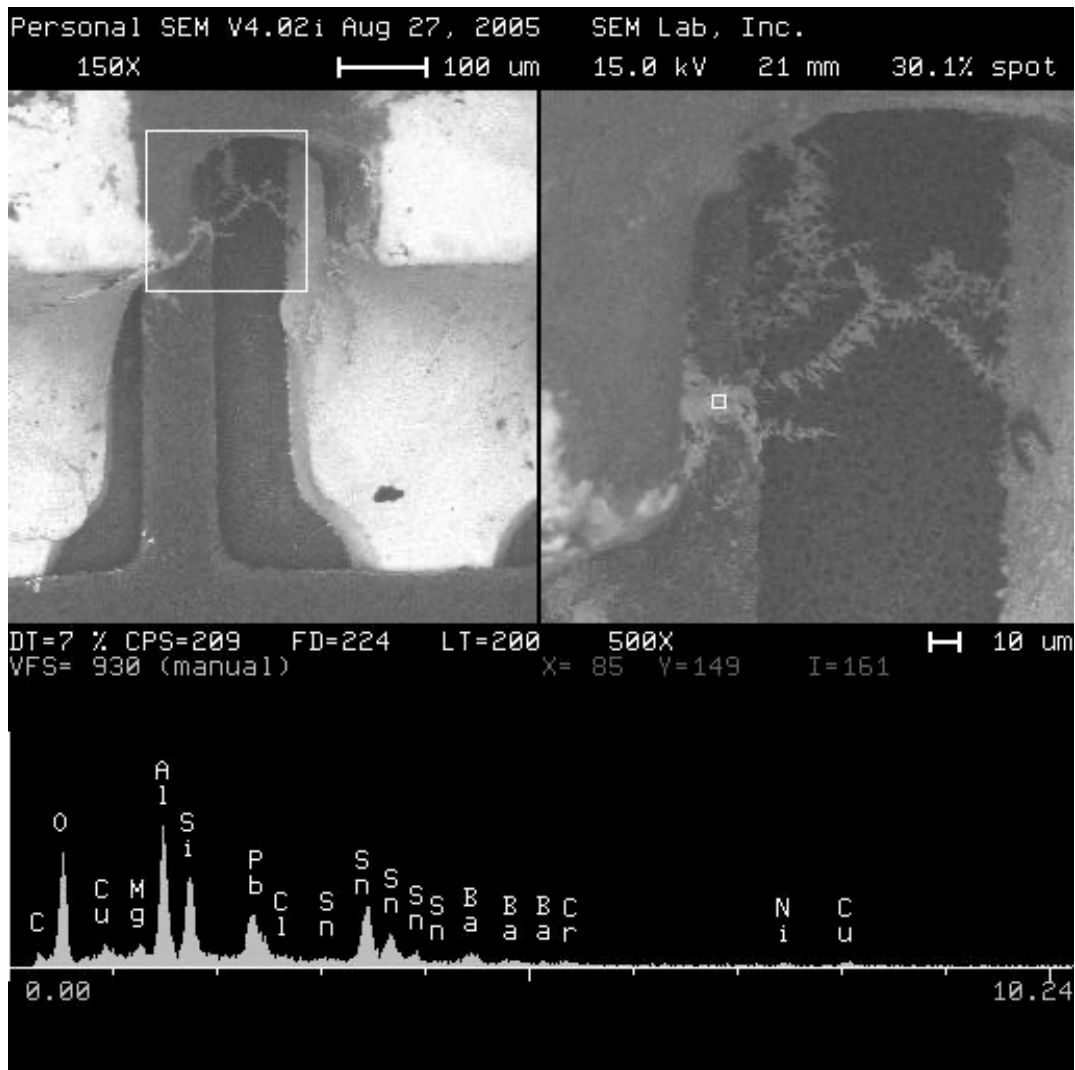
Case 1187 showed tin-lead electromigration paths on the resistor network and board surface. The report identified residual chloride, moisture or condensation, and electrical bias as the required conditions. The dendritic morphology matters because it moves the evidence beyond a generic residue observation: conductive material had grown across the insulating region between biased conductors.

*Figure 5. Case 1187: electromigration dendrites between pins 2 and 3 on the board surface. The overview establishes the conductor spacing; the higher-magnification view shows the dendritic path.*

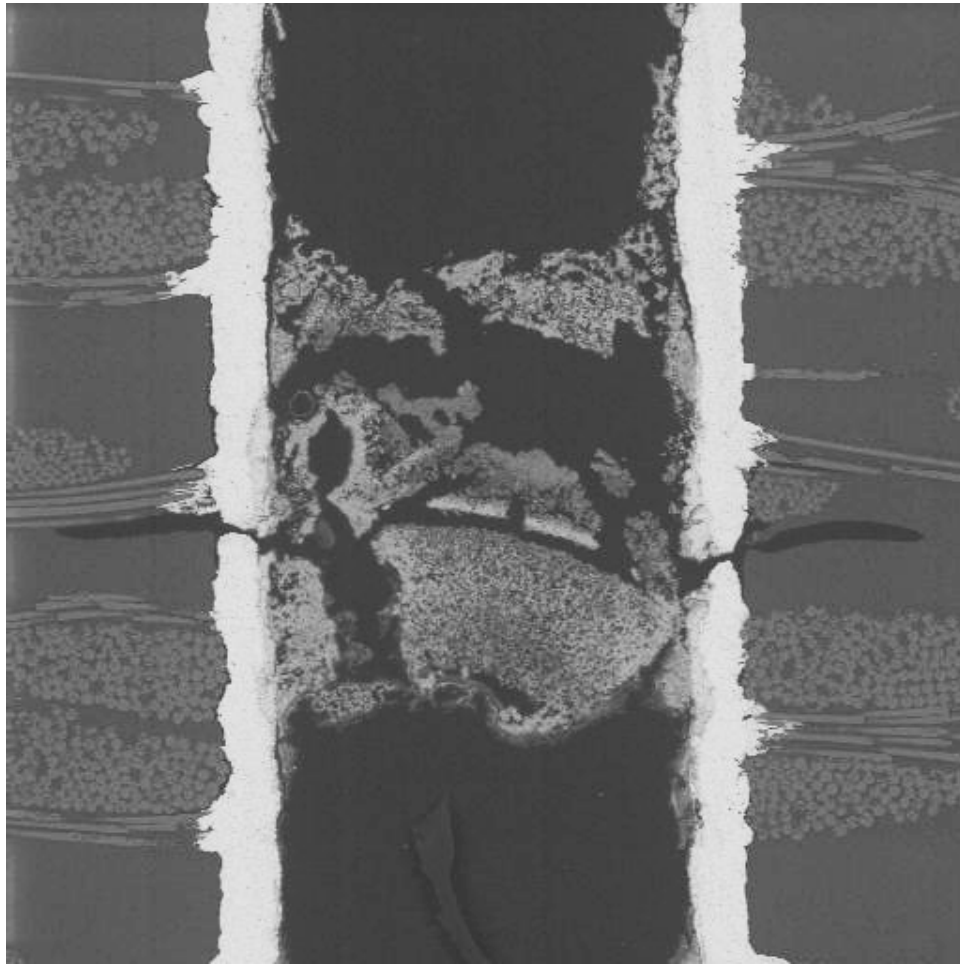
Case 1080 demonstrates why flux-related evidence must be integrated with the underlying construction. A plating defect partly plugged a via and produced thin plating. Flux became trapped in the hole, and copper corrosion developed near the barrel fracture. The failure was not accurately described as flux alone: the plating defect created the vulnerable geometry, while retained reactive material and corrosion contributed to loss of continuity.

**Figure 6. Case 1080: via microsection showing copper corrosion product near the barrel fracture. The image supports a combined mechanism involving a plating defect, flux entrapment, and corrosion.**
