# HASL Finish on PWBs

# Poor Sn-Pb HASL

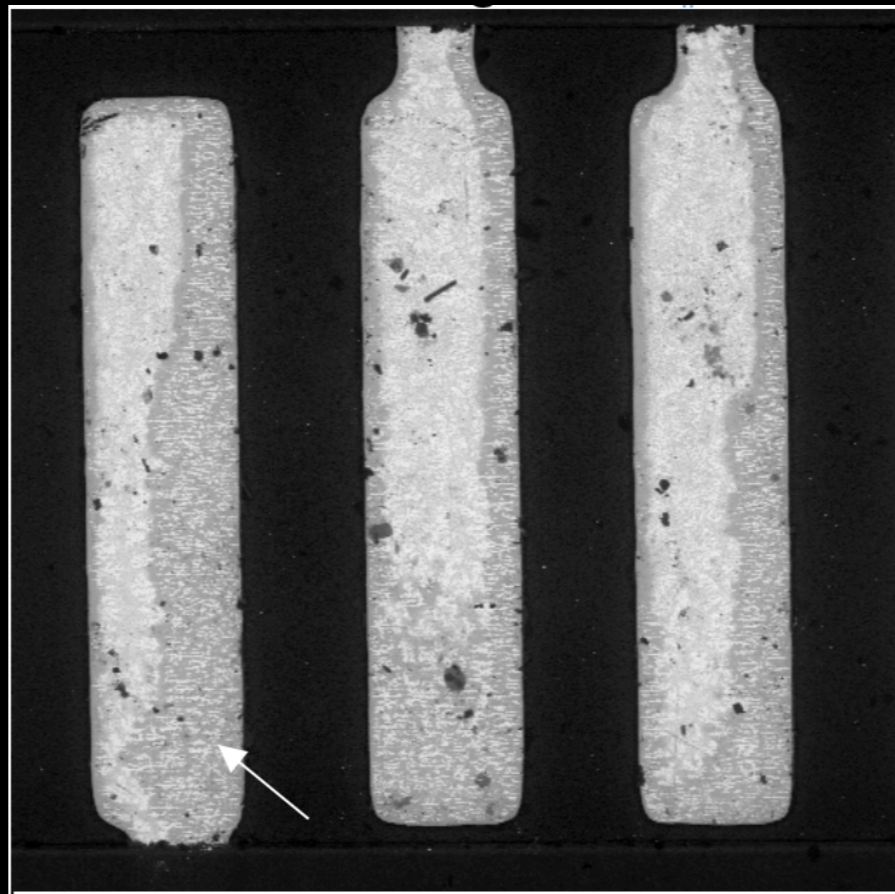
## BSE SEM image of Sn-Pb HASL finish

Poor quality HASL finishes on PWBs can cause severe solderability problems during reflow soldering. Exposed copper-tin IMC (arrow) oxidizes and becomes very difficult to wet during reflow.

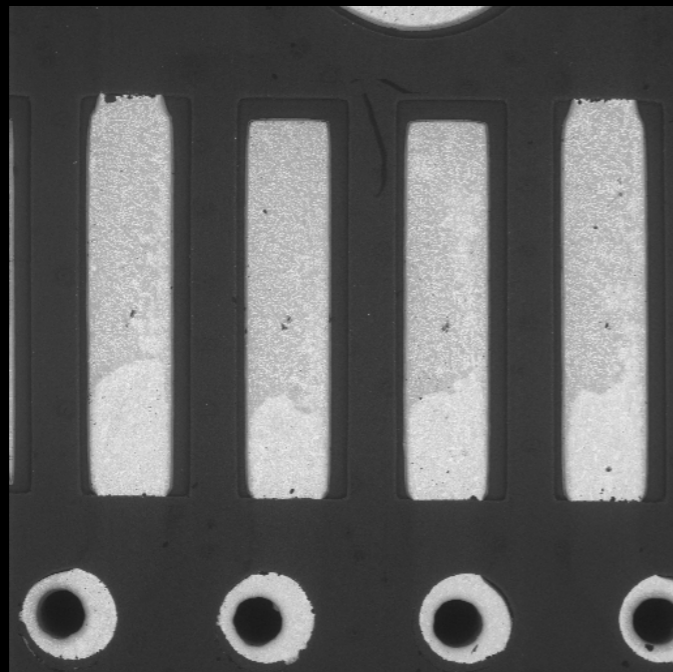
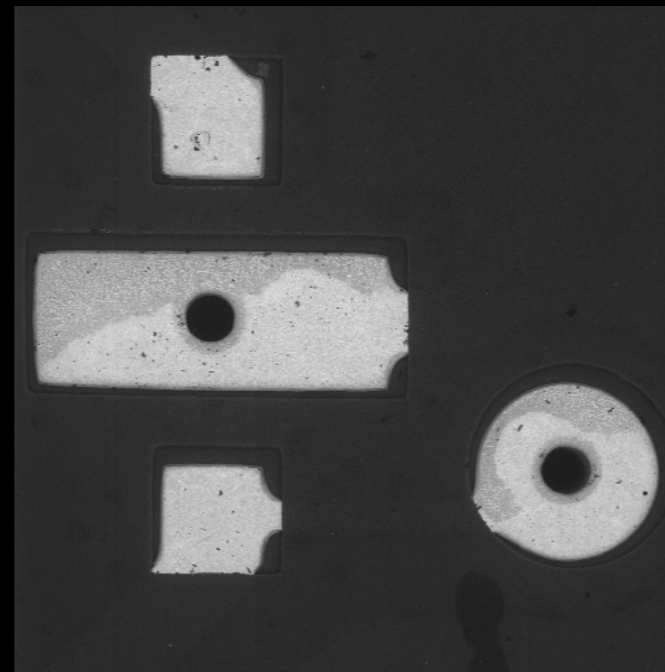
- knife air pressure
- plated copper solderability
- solder pot temperature
- velocity of extraction from solder pot

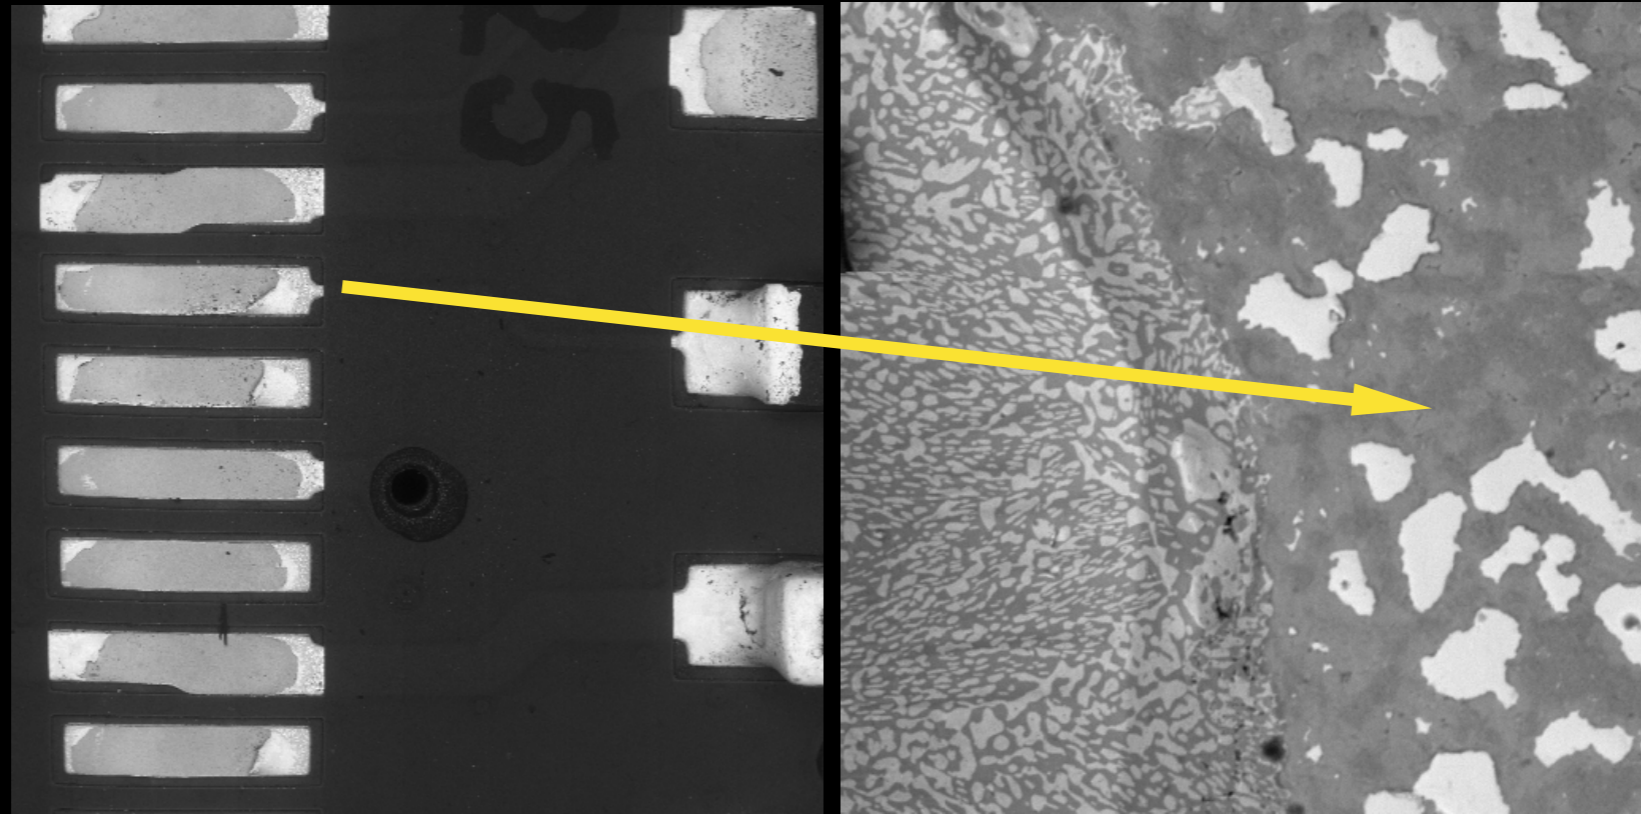
SMT connector leads failed in a brittle interfacial fracture mode during shock & vibration tests

Non & dewetted areas at the corners of the pads show oxidized Cu-Sn IMC typically caused by bad HASL on the PWBs

- **Check HASL finished PWB coupons/bare boards on new board lots**
- **SEM/EDS, microsections, and XRF are appropriate techniques**
- **Know that optical inspection can miss this type of condition**

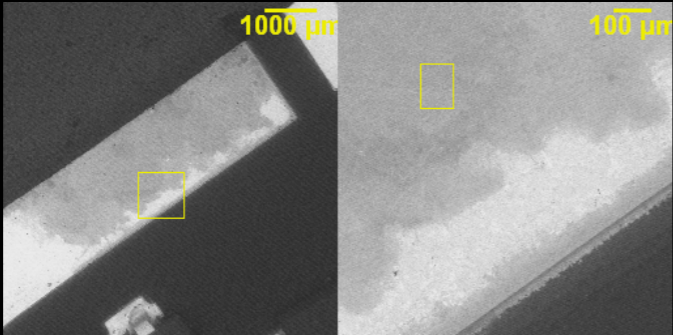
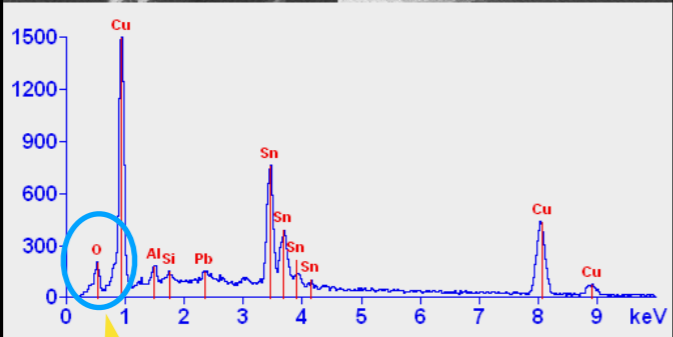
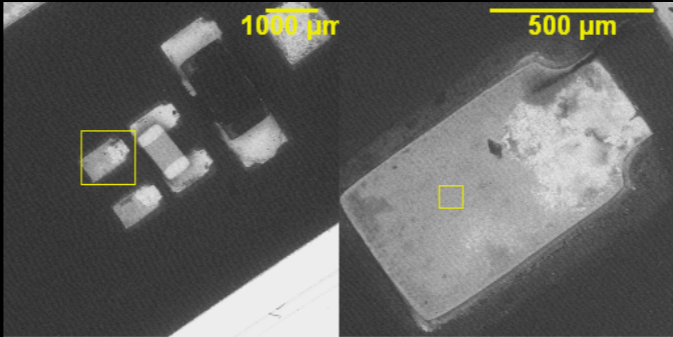
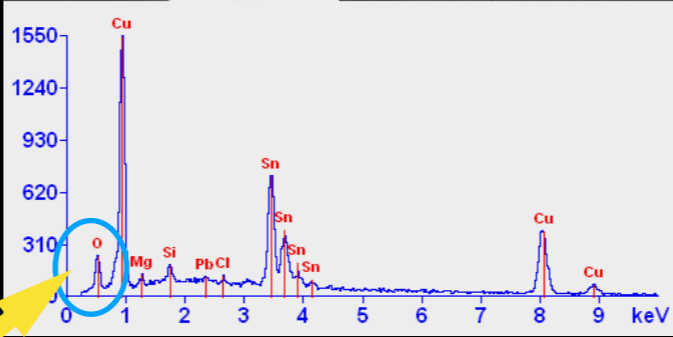
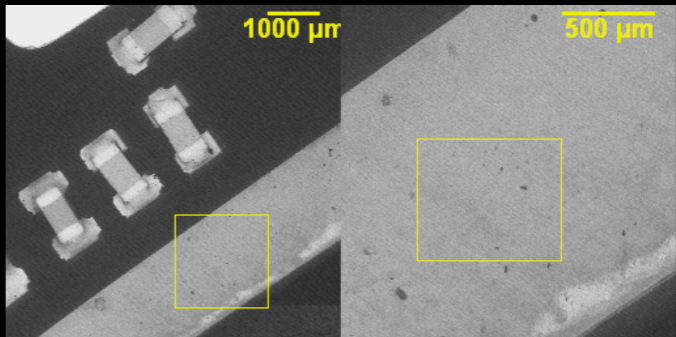
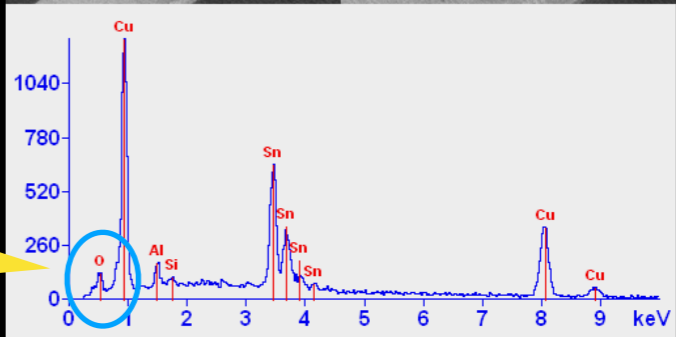
# Exposed Cu-Sn intermetallic is readily oxidized

Oxidized

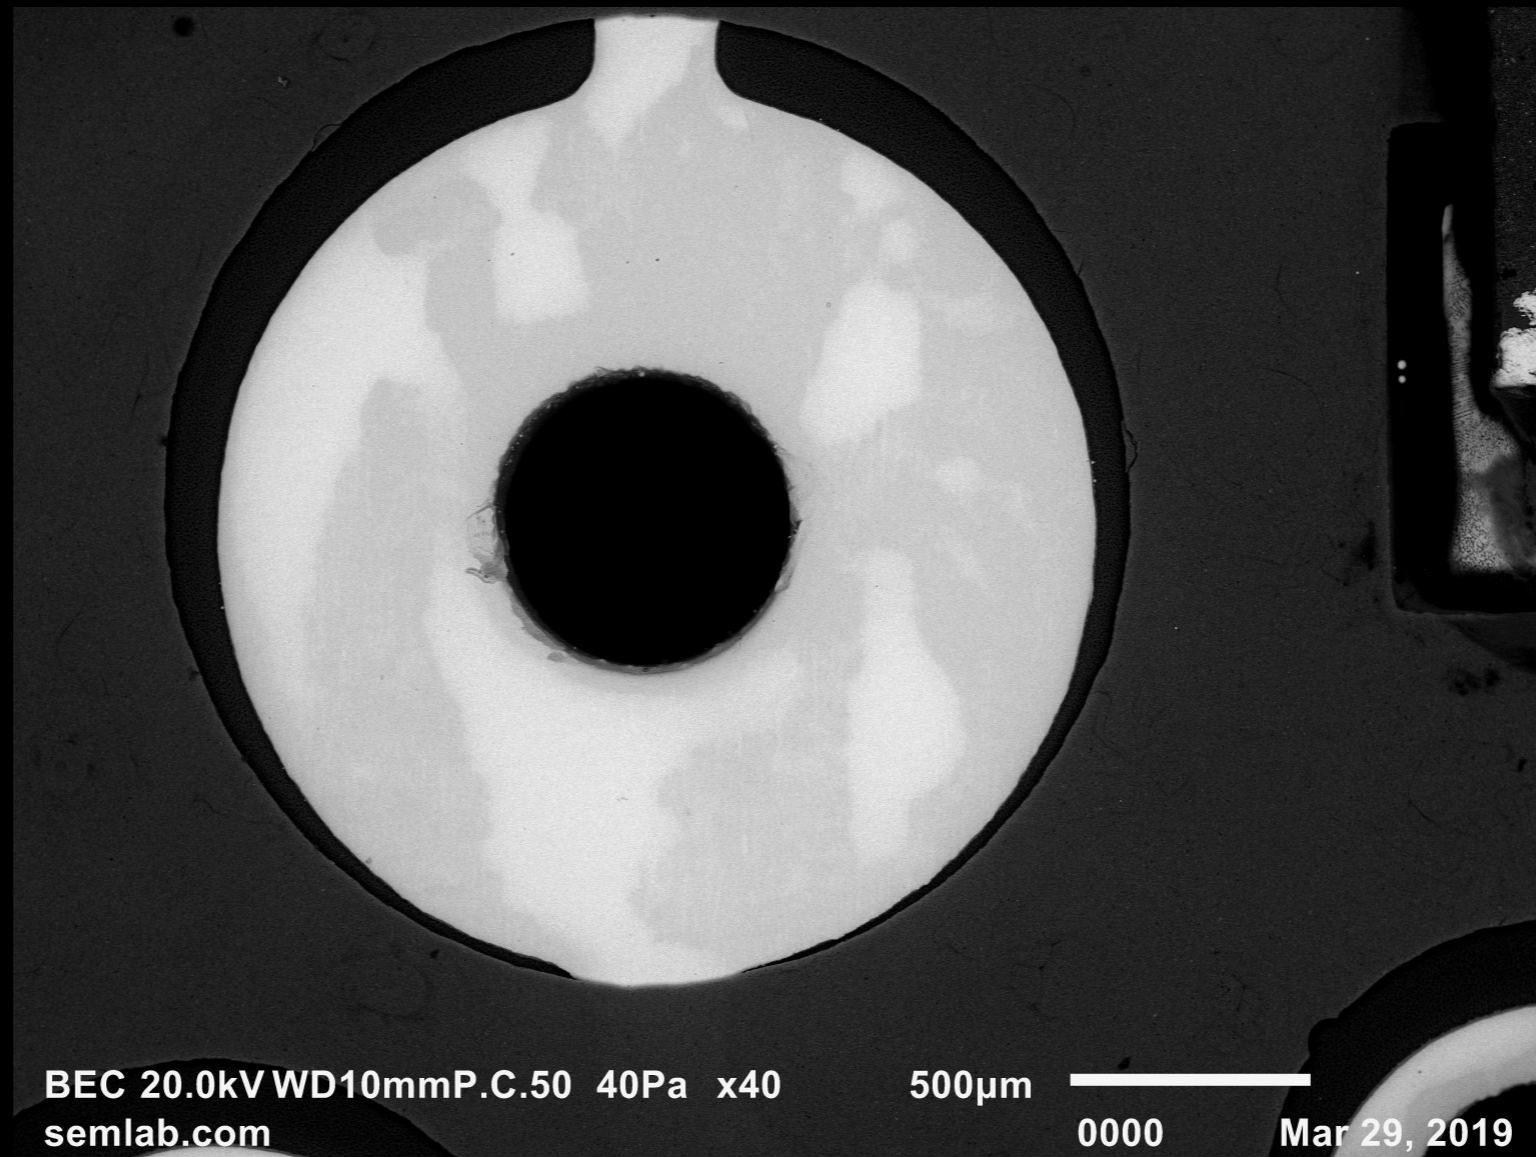
Lead Free HASL has the same issue as Sn-Pb HASL
