# PWB Failure Analysis

# Hi-Pot Failure

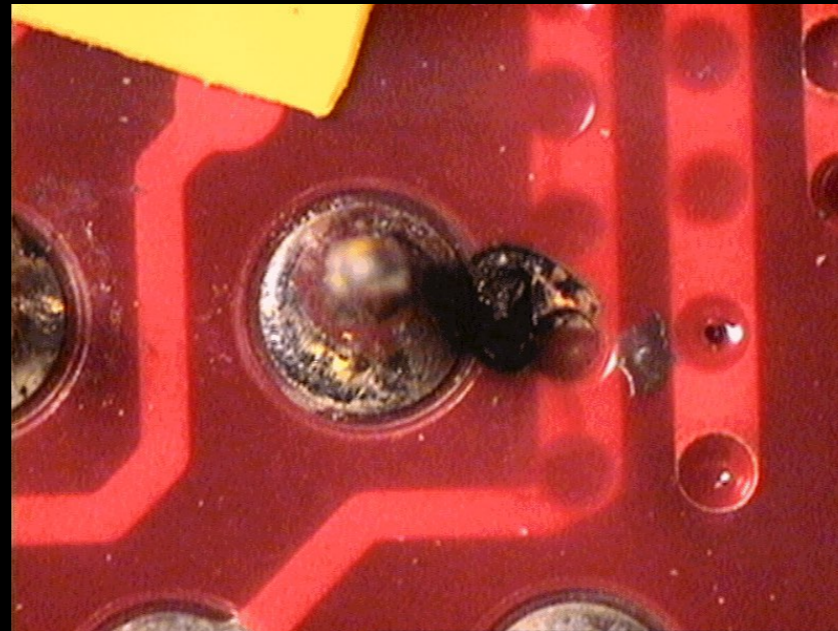
Exposed copper at the knees of the plated-through-hole vias providing sites for arc over failure

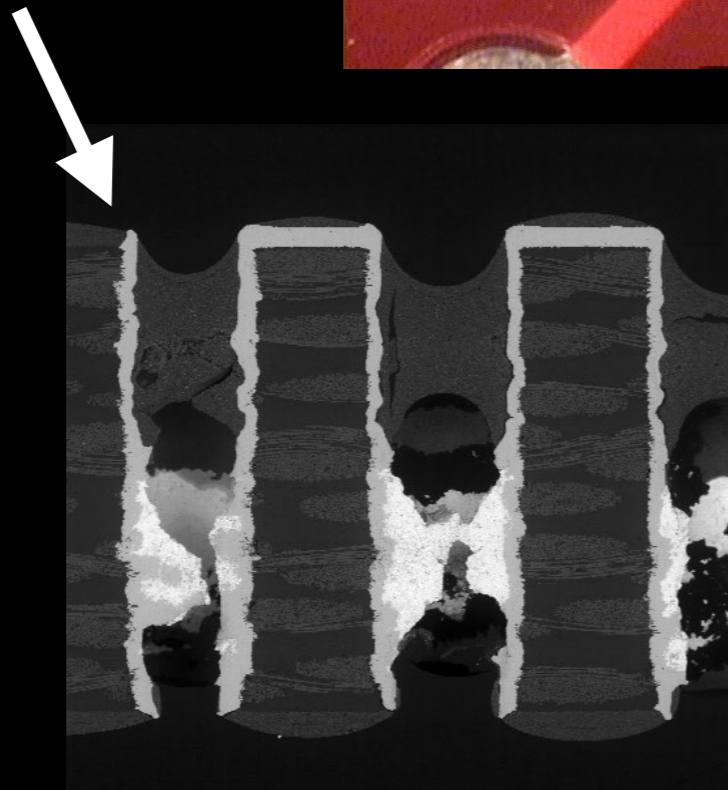
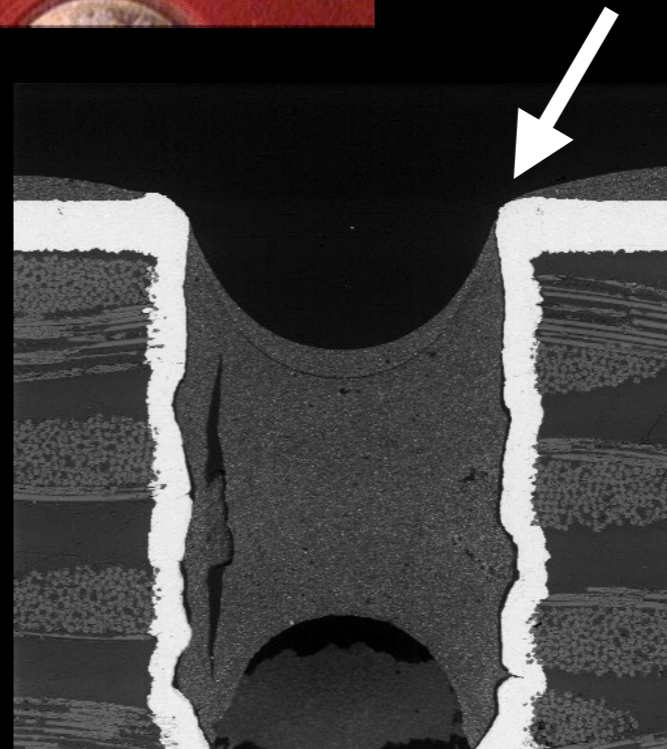
Drill breakout that creates sharp exposed copper features when combined with the knee coverage problem

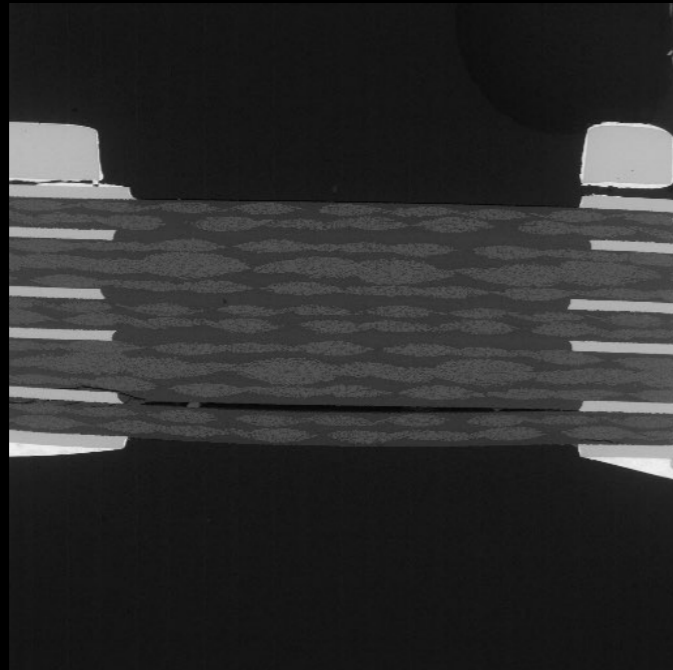
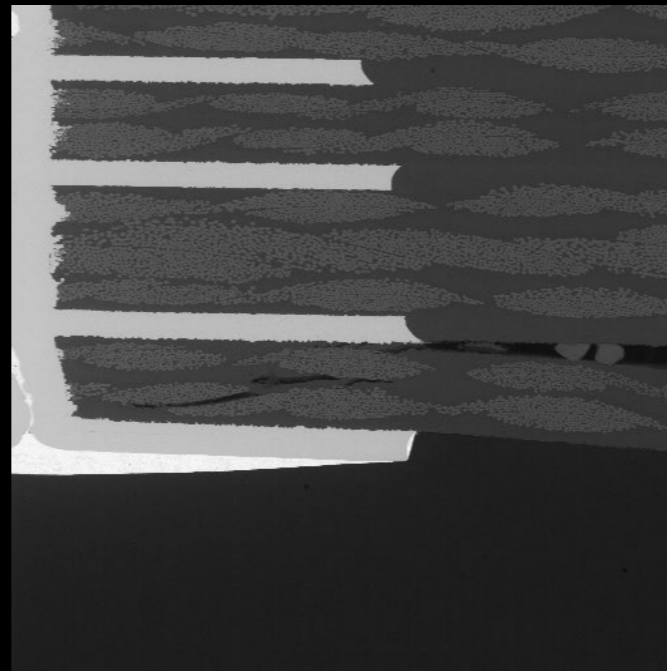
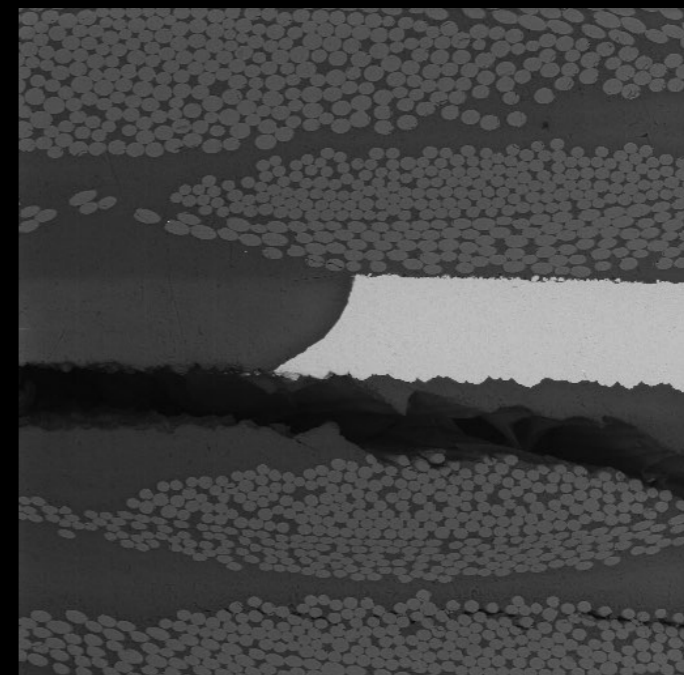
**Delamination occurred as a result of a contaminant (e.g. hydrocarbon oil) trapped at the interface between the B-stage and the copper-clad laminate during PWB lay-up.**

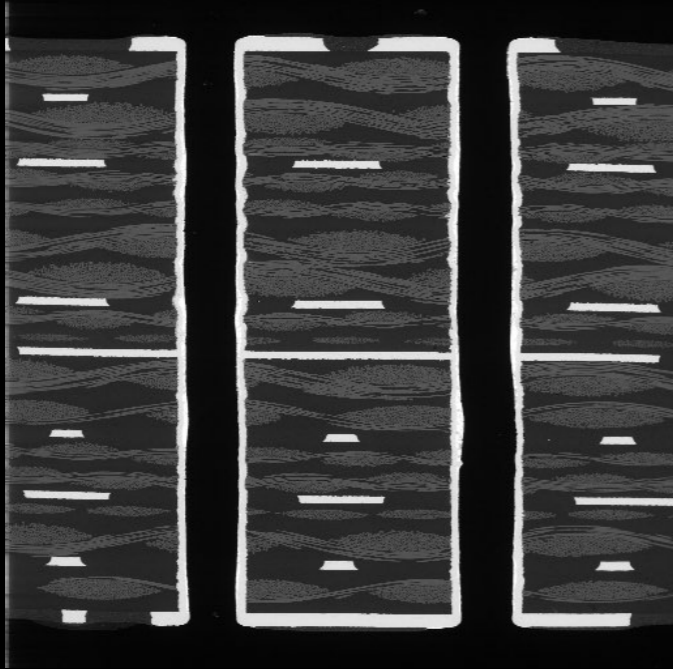
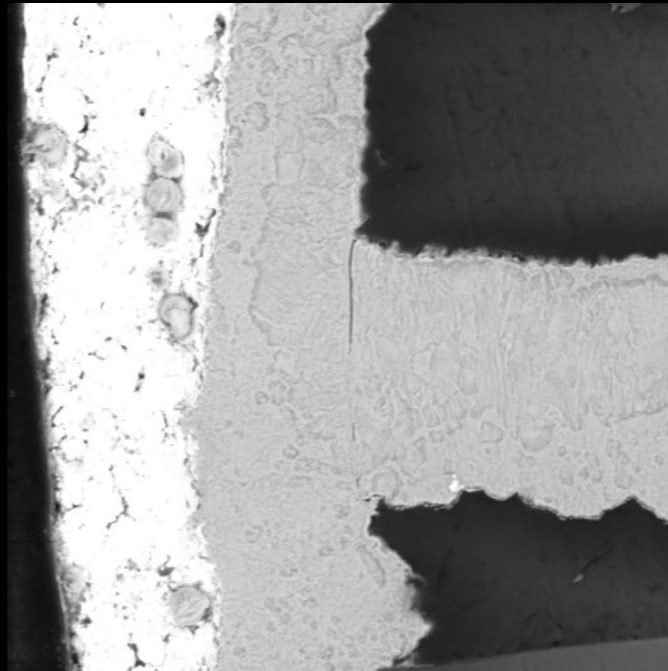
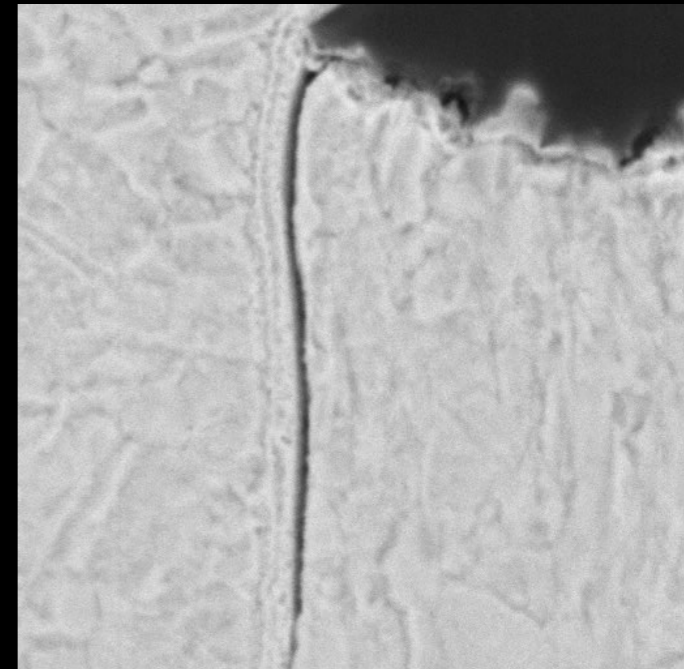
**Causes internal opens**

**Inadequate de-smear during fab**

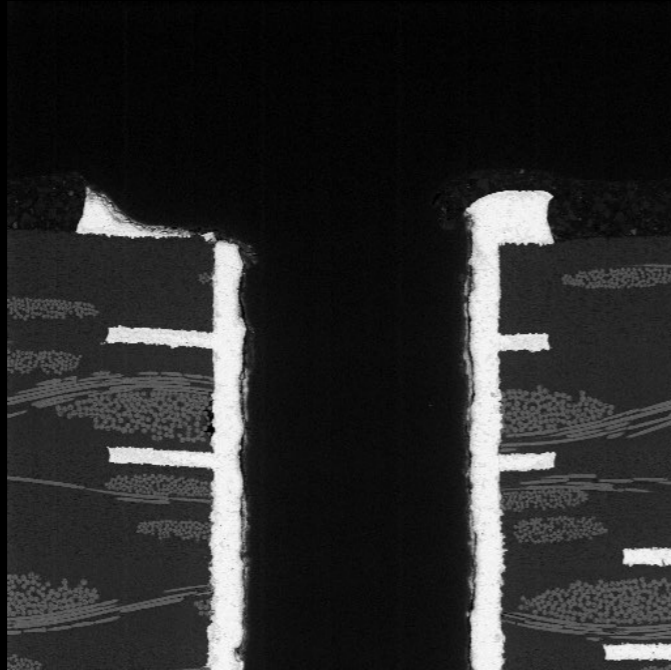
Activated flux was left on this PTH

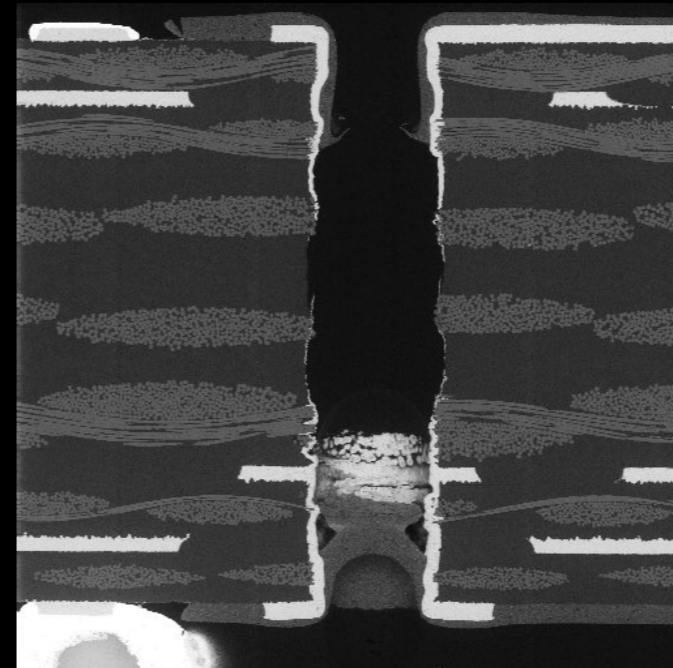
Activated flux was left in this PTH

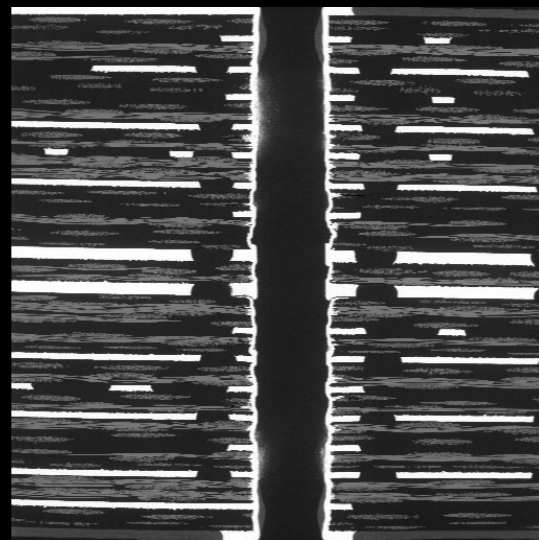
PTH copper too thin

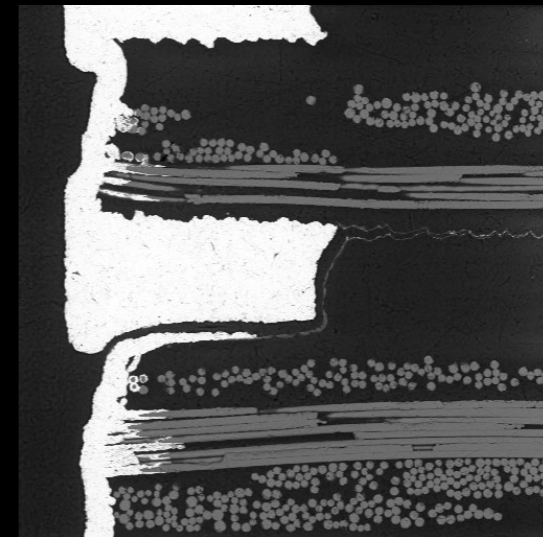
Open PTH caused by thin copper, poor drilled-hole quality, and Z-axis thermal expansion

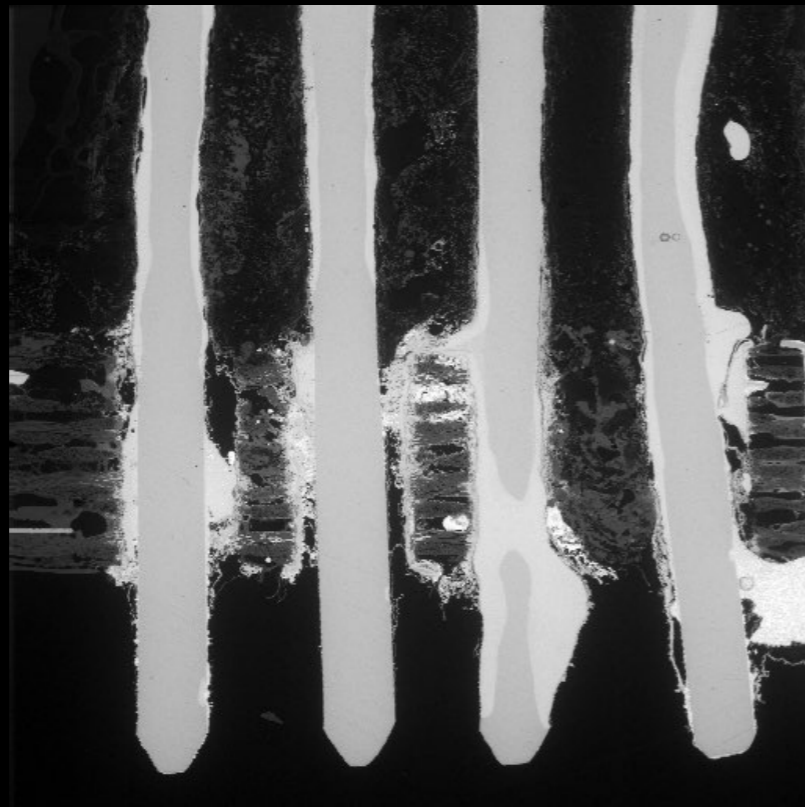
Adjacent leads shorted

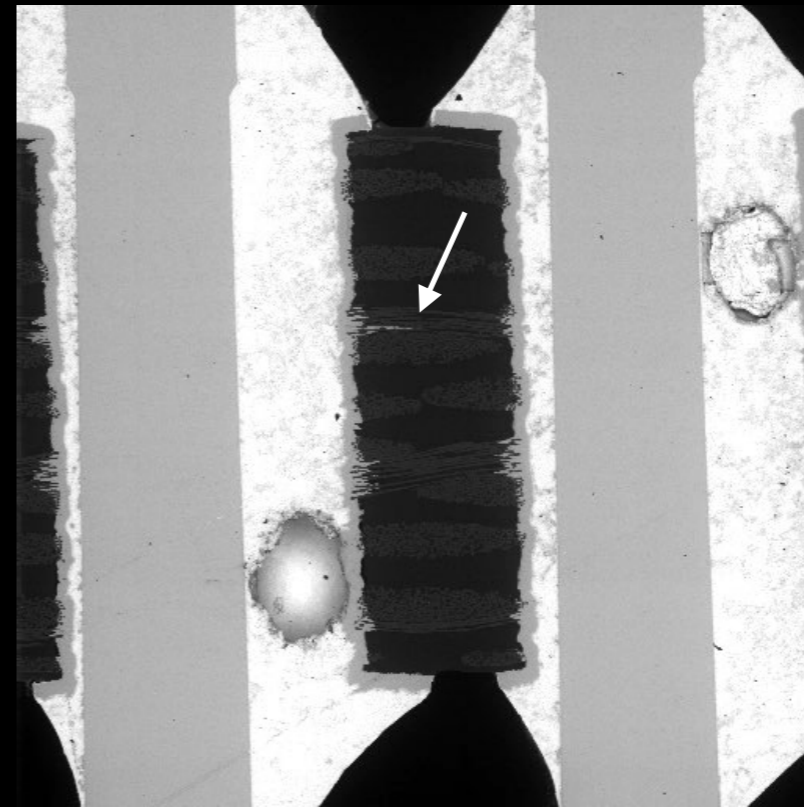
Nearby isolation space shows copper migration
