Failure Analysis of BGAs

Ed Hare, Ph.D. – February 21, 2007

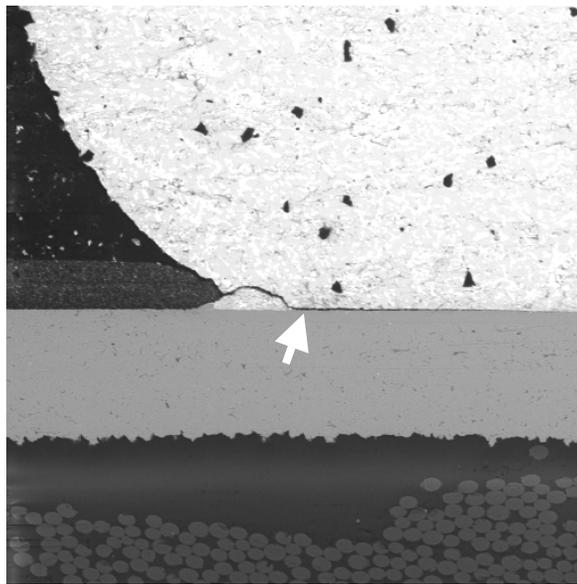
Figure 1 - Microsection of partially fracture BGA solder joint [362X, BSE SEM image, ref. SLI-465].

“Black Pad Syndrome” is sometimes referred to as “Dark Line Defect” most likely because the P-rich layer appears dark in BSE SEM images of solder joint microsections (e.g. Fig. 1). The P-rich layer appears dark in these images because of the low atomic number of phosphorous ($Z = 15$), which makes it less efficient at backscattering electrons than nickel ($Z = 28$). The base phosphorous concentration in electroless-nickel is typically 7 – 9 wt%. The phosphorous concentration in the P-rich layer can be as high as 30 wt%. Fig. 2 shows a fracture surface of a BGA solder joint that shows “hyper-etching” of the EG grain boundaries, which is a characteristic of BPS. The concentration of phosphorous at the surface was measured as ~ 28 wt% based on EDS spectra. The BGA solder joint lifted cleanly along with the Ni-Sn intermetallic compound layer off of the underlying pad leaving only the P-rich EN that is characteristic of BPS.

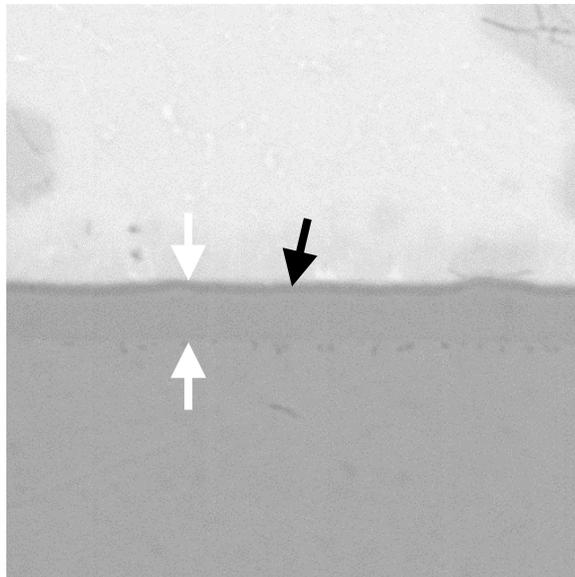
Figure 2 - "Dark line defect" in Pb-free BGA solder joint microsection [2549X, BSE SEM image, ref. SLI-1393]

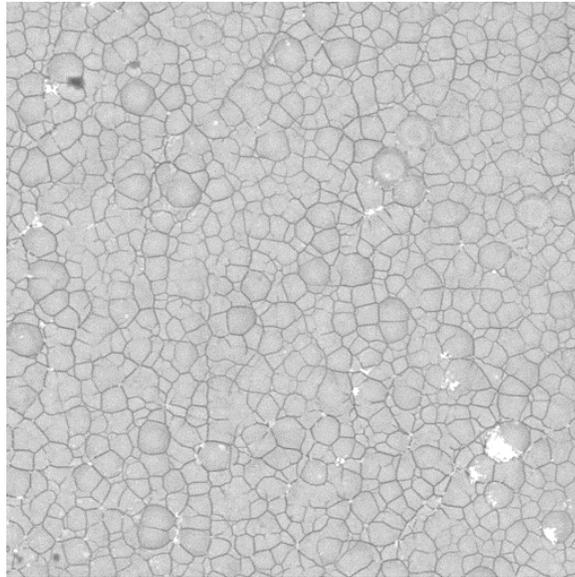
Figure 3 – BGA fracture surface showing "Hyper-etched" EN [852X, BSE SEM image, ref. SLI-983]. The phosphorous concentration at the surface was ~ 28 wt% based on EDS data.

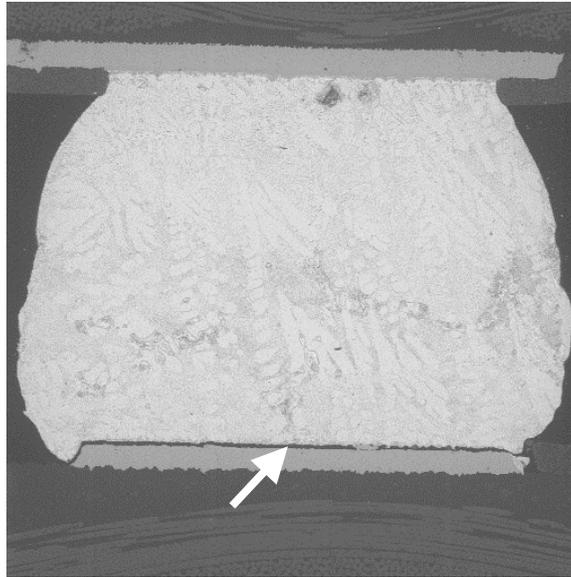
Brittle fracture can occur at PWB or BGA substrate pad interfaces even in the absence of BPS. The example shown in Fig. 4 shows brittle fracture that was most likely caused by mechanical shock (i.e. drop). The reason for this is that even if the interface isn't weakened by a mechanism such as BPS the ball/pad interface can be the "weakest link" when high enough strain rates are involved that strain relief due to creep in the bulk solder is not possible.

Figure 4 - Brittle failure of Pb-free BGA solder joint at PWB/ball interface [92X, BSE SEM image, ref. SLI-1283].

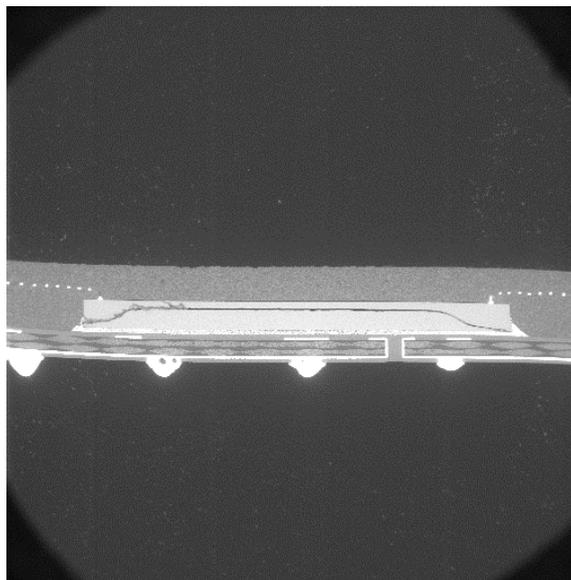
Die cracking is illustrated on Fig. 5. This BGA is one of several failed devices where the failure was detected at elevated temperature testing. The device was actually functional at room temperature because the crack path missed the active device area. The crack was most likely due to bending stresses caused by thermal expansion mismatch or mechanical bending.

Figure 5 - BGA section showing die crack [13X, BSE SEM image, ref. SLI-1345].

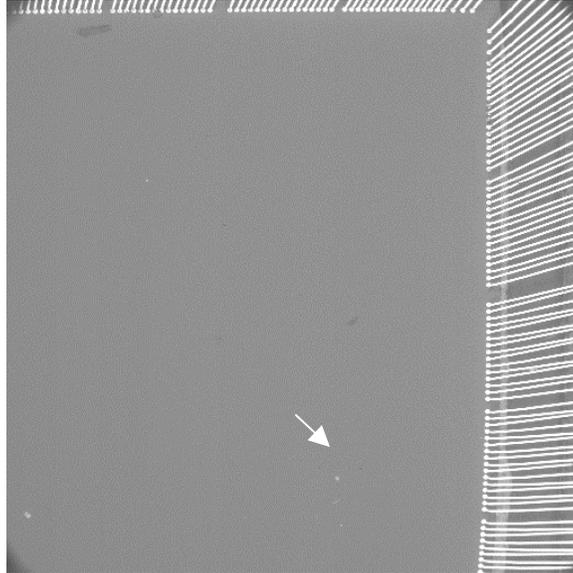
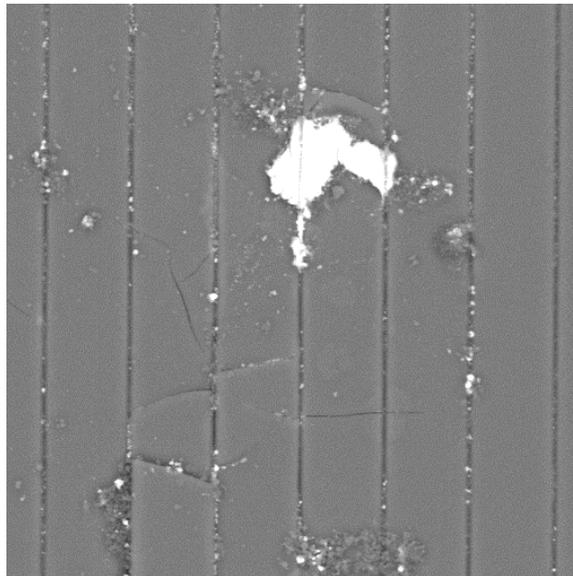
Figures 6 & 7 show a die level fault on a BGA where device power was shorted to device ground. The damage appeared to have been caused either by inadvertent mechanical contact with the die surface or possible due to injection stresses molding that exceeded the strength of the die passivation layer.

Figure 6 - Decapsulated BGA showing location of short at die level [14X, BSE SEM image, ref. SLI-1301].

Figure 7 – Short site on the BGA die from Fig. 6 [683X, BSE SEM image, ref. SLI-1301].

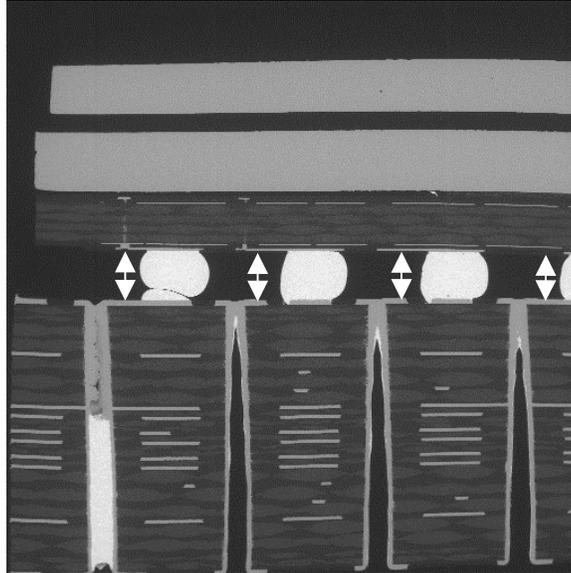
Figure 8 - Warpage related solder joint open at corner ball [16X, BSE SEM image, ref. SLI-1044]. The residual warpage was measured as 27%.

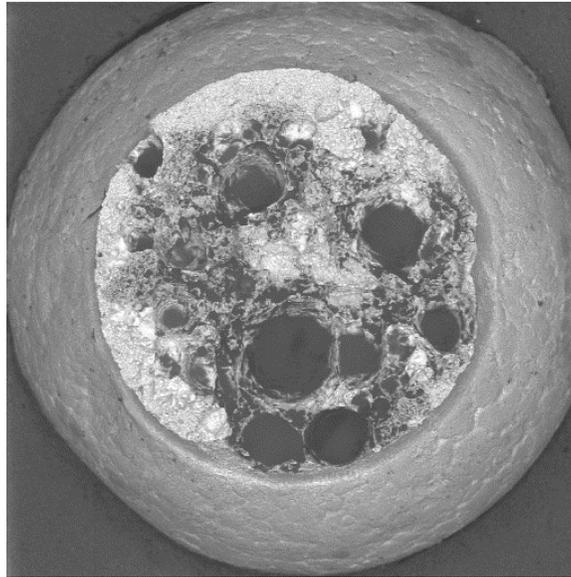
Solder voiding is a frequently reported problem for BGA solder reflow. Fig. 9 shows a case where the voids appeared to be the primary factor in separation of the ball from the BGA substrate pad during “drop” testing of a hand-held electronic device. The voids entrapped flux and may suggest that an inadequate reflow profile (i.e. time-temperature profile) was used during board level assembly. The large thermal mass associated with BGAs can lead to reflow problems as the BGAs tend to lag most of the other components on the assembly in terms of peak temperature during reflow.

Figure 9 - BGA solder joint fracture surface with flux entrapment [137X, BSE SEM image, ref. SLI-882]. This solder joint failed at the BGA substrate/ball interface during a drop test in a hand-held electronic device.
