## Failure Analysis of LEDs

Ed Hare, Ph.D.  
October 15, 2004

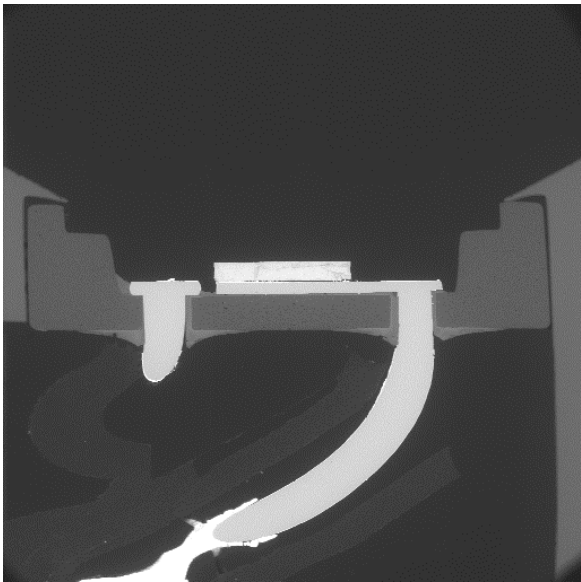
[12X, ref. 926A\_7] This is a custom LED package. There is significant lead (bending) strain and associated damage to the glass feed-through seals. This caused the die attach to fail.

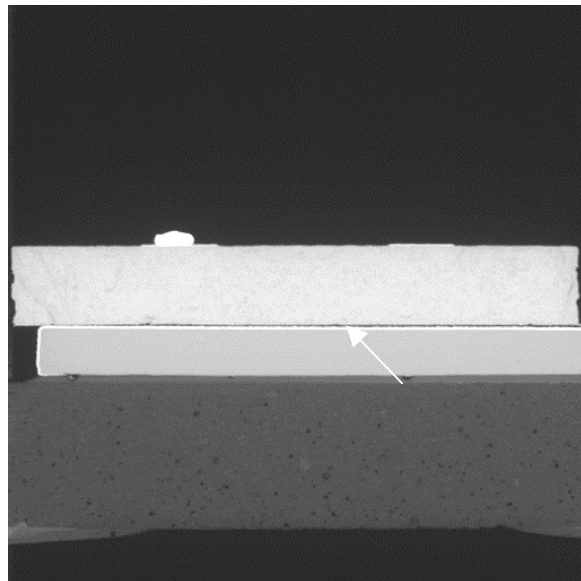
[45X ref. 926A\_2] The die attach failed due to mechanical stress caused by a lead bending operation.

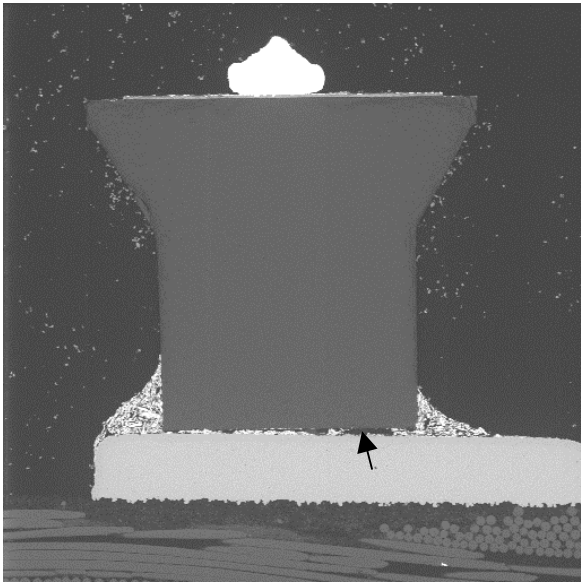
[ref. IFN 736B\_5] This LED exhibited degraded brightness after humidity and rapid decompression testing. It shows damage to the die/die-attach interface.

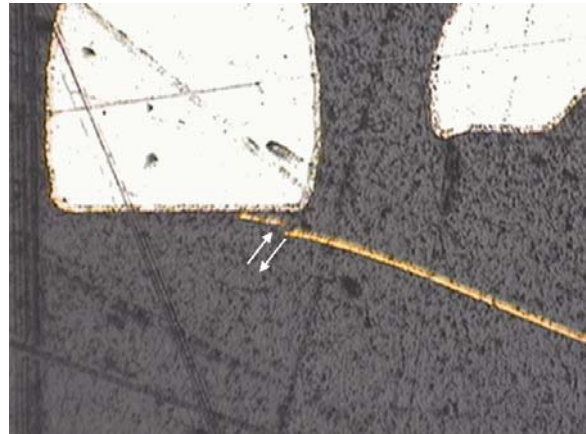
[96X ref. 245AO\_6] This is a bright-field optical image showing a broken bond wire at the wedge bond.

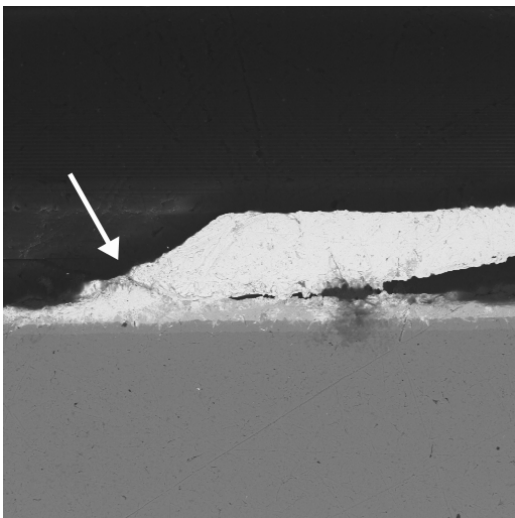
[405X ref. 140\_2] The wire bond apparently failed in shear at the heel of the wedge bond. The crack is very fine and is held together by the lens material. This explains the intermittent nature of the failure.

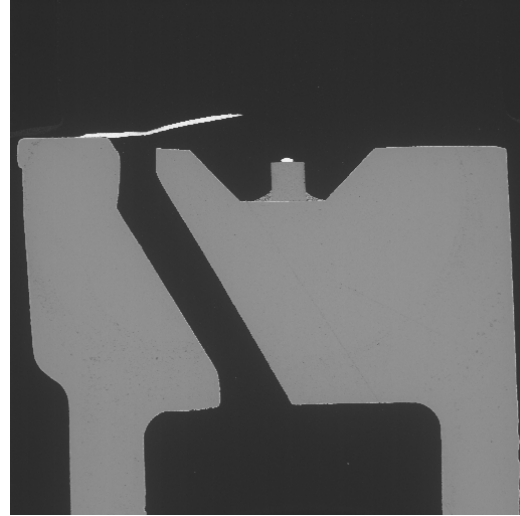
[21X ref. 140\_5] This BSE SEM image shows the LED construction including the geometry of the die, die cup and post.

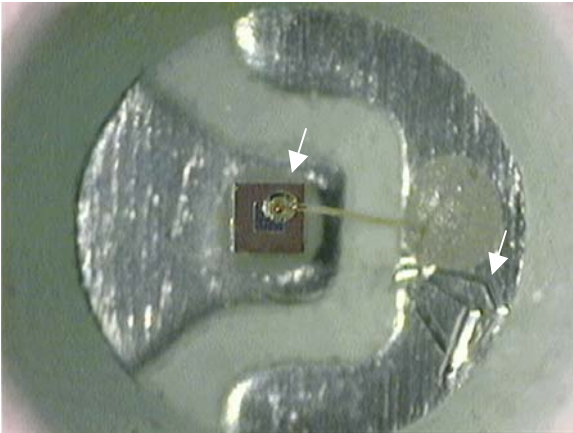
[28X ref. 186O\_3] Here the bond alignment to the pad is poor. The probe marks on the post (right) suggest that a problem was identified prior to encapsulation.

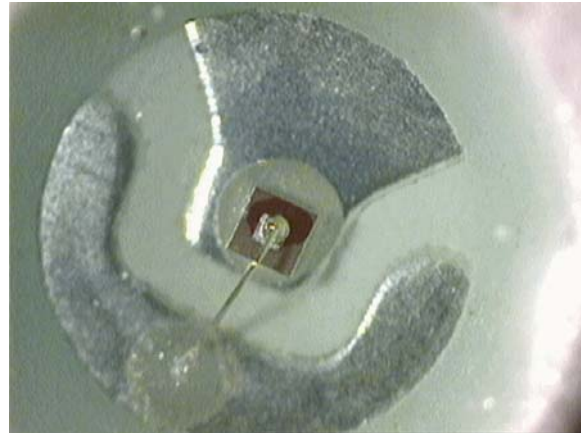
[28X ref. 186O\_4] This LED was verified as dim on the test fixture. The dark area on the die surface is an area of delamination of the encapsulant from the die. The delamination is evidence of displacement and is likely related to a high resistance bond.

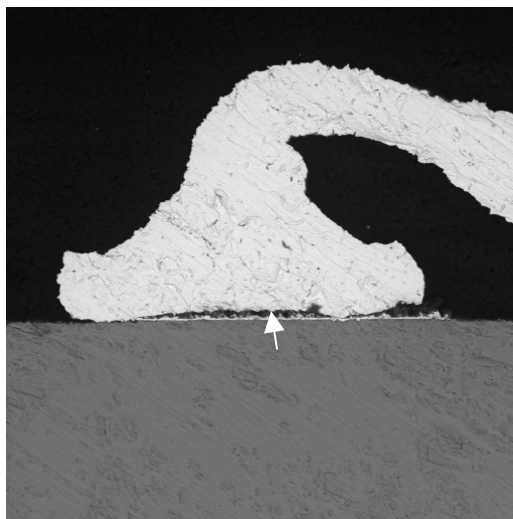
[405X ref. 201C\_1] This is a high magnification view of a ball bond failure caused by delamination of the encapsulant from the die surface.

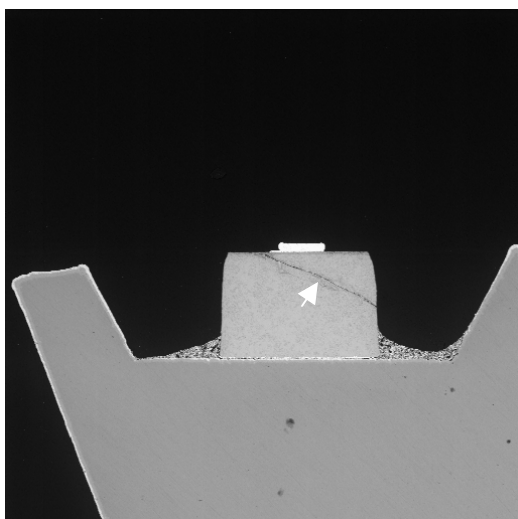
[65X ref. 220B\_1] This is a SEM image of the sectioned LED. A large die crack was the cause of this intermittent failure.

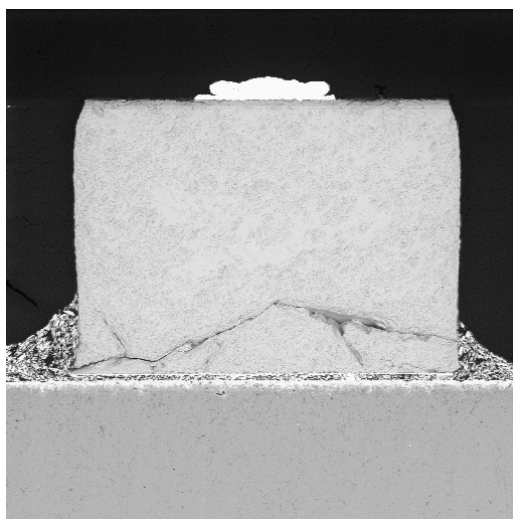
[162X ref. 305A\_2]. These die cracks are the cause of the intermittent LED failure.
