Images of Failures in Microelectronics Packaging and Assembly

Ed Hare, Ph.D./[SEM Lab, Inc.](http://www.semlab.com)

IMAPS NW - Feb. 11th 2004
Redmond, WA

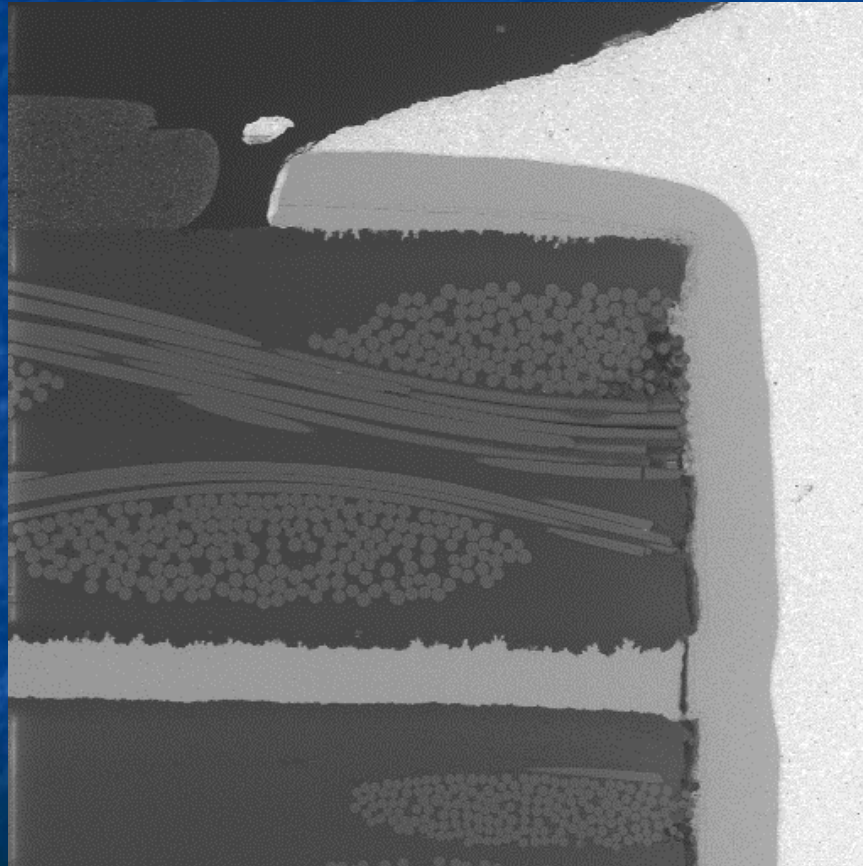
What is this?

Inner Layer Separation

- Between laminate copper and electroless copper
- Found Ca & S residues at failed interface

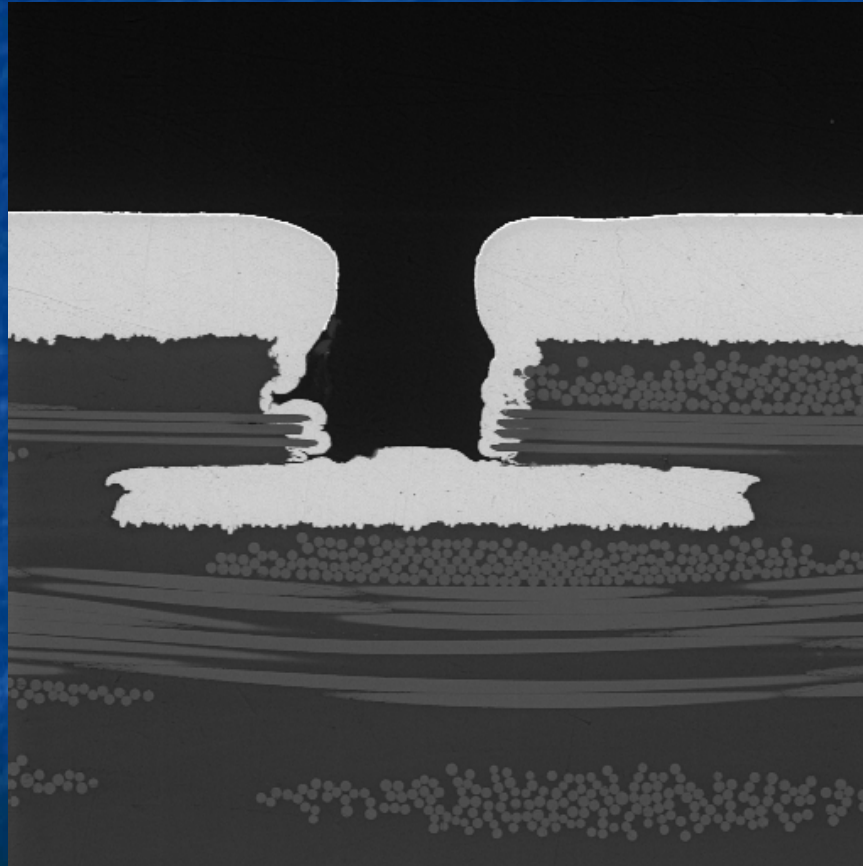
What is this?

Microvia

- This is a poorly fabricated microvia
- There is little or no copper plating connecting to the layer-2 pad

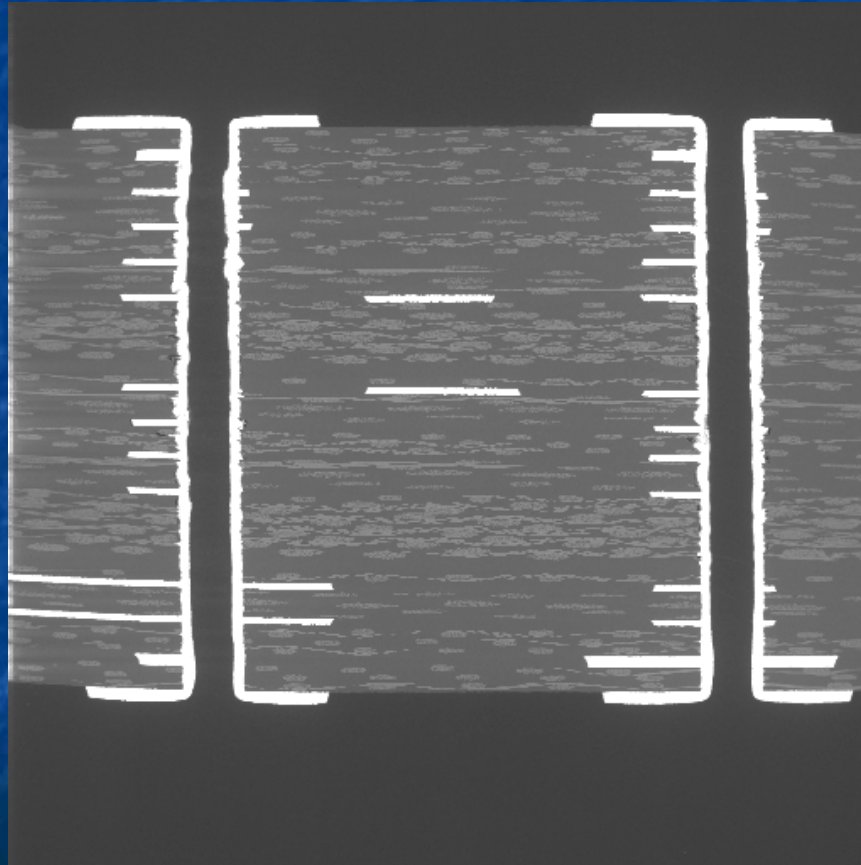
What is this?

Drill Breakout

- The inner layer lands probably should have been larger diameter in this design
- This condition fails Class 3 criteria in IPC-A-600 (min. annular ring 0.001 in)

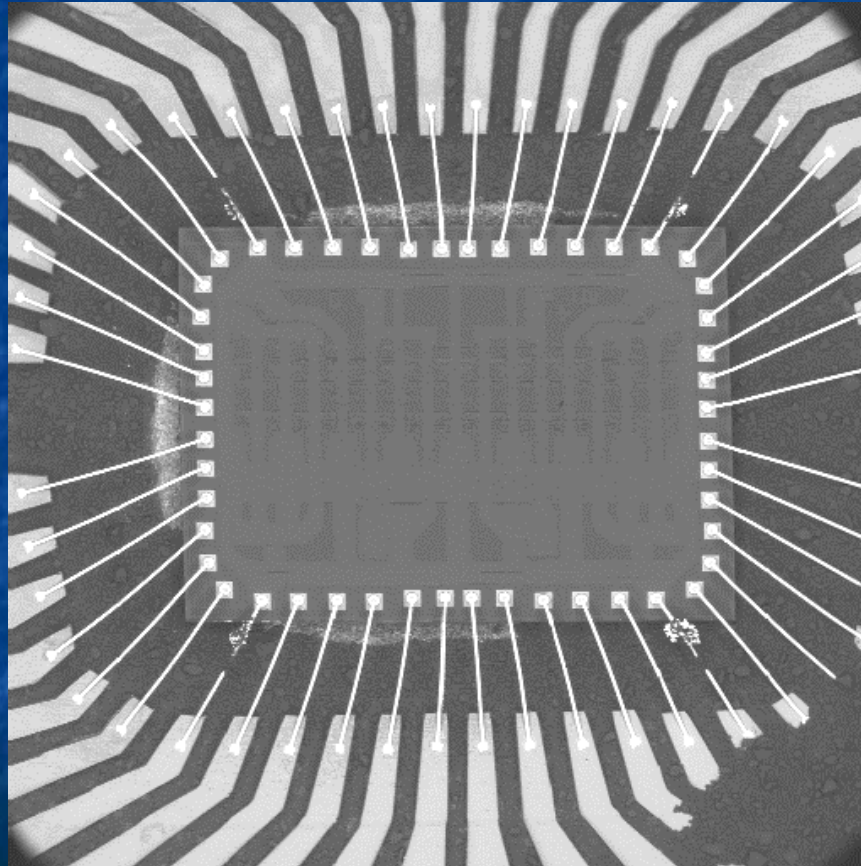
What is this?

EOS Failure

- All four Vcc wire bonds are fused open
- There is no damage on the die
- Excessive current failure likely due to latch-up

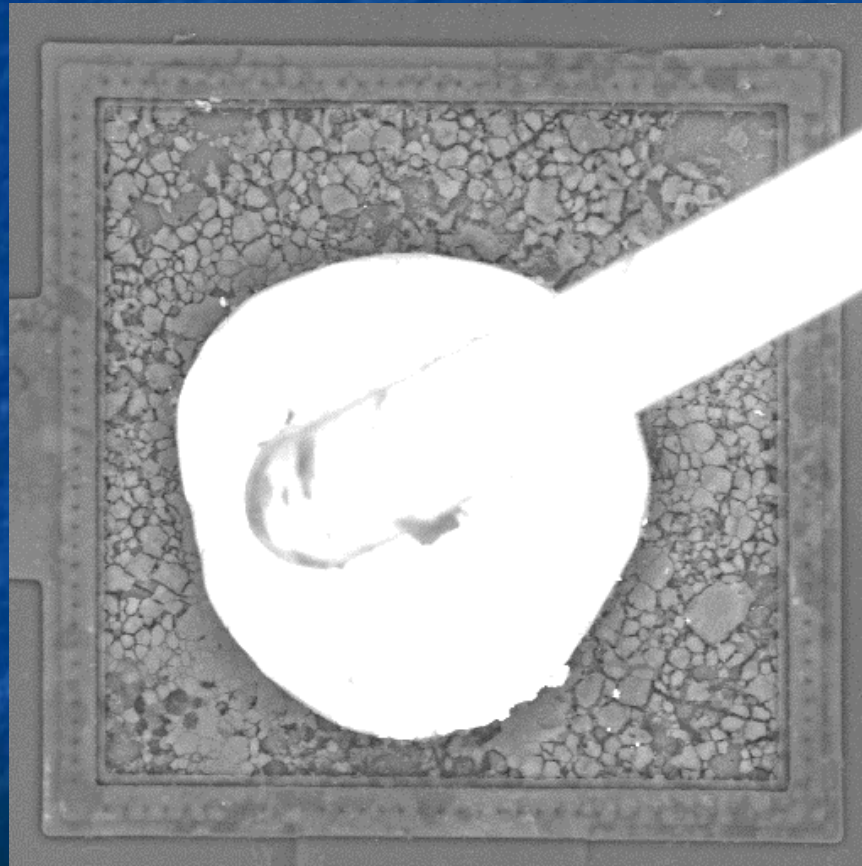
What is this?

Bond Pad Corrosion

- Contributing causes –
 - * moisture
 - * “pop-corn” damage
 - * internal delam
 - * P contamination

- How to avoid –
 - * MSD control
- Use CSAM imaging and F/A to diagnose

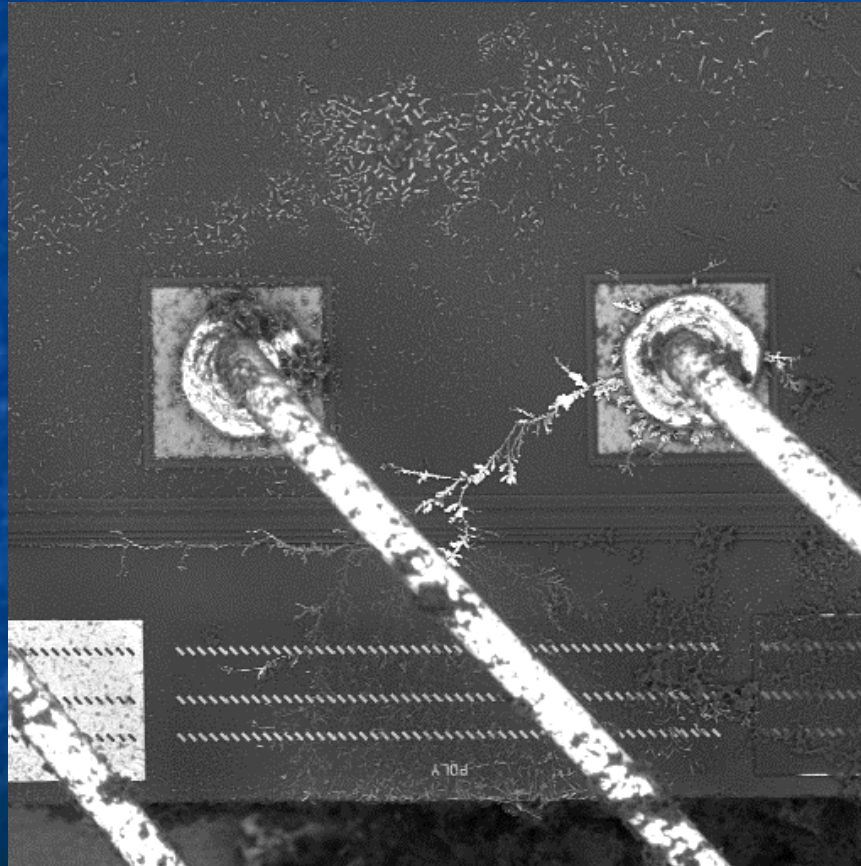
What is this?

Dendritic Growth on IC Die

- Silver and copper dendrites
- For all the same reasons as bond pad corrosion

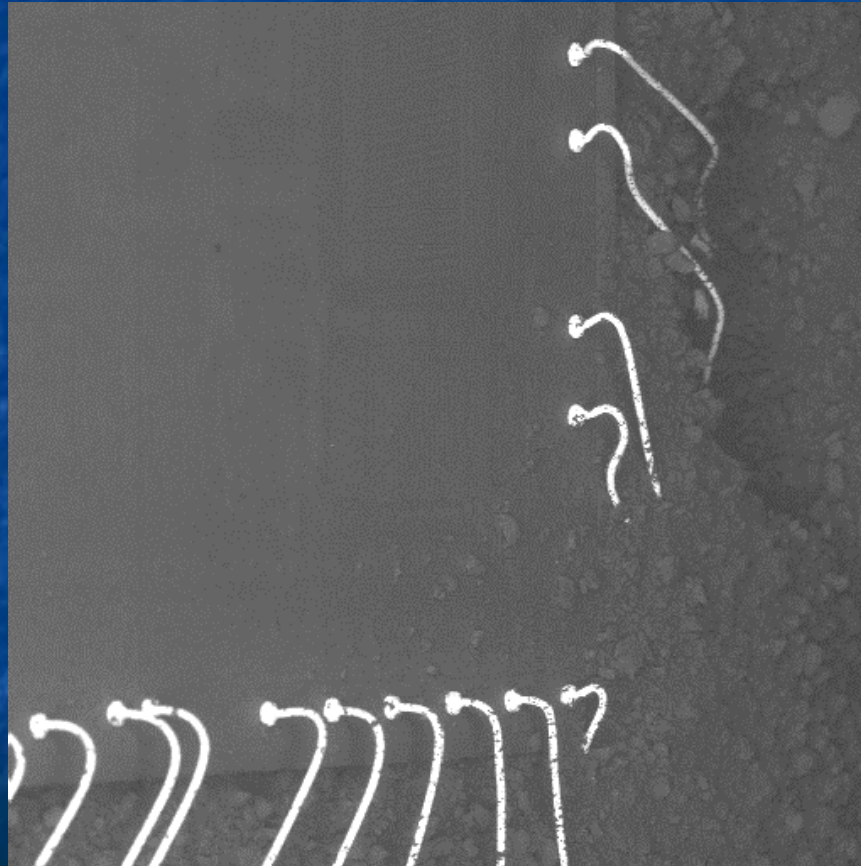
What is this?

Bond Wire Sweep

- Bond wires are swept by the injection molding compound

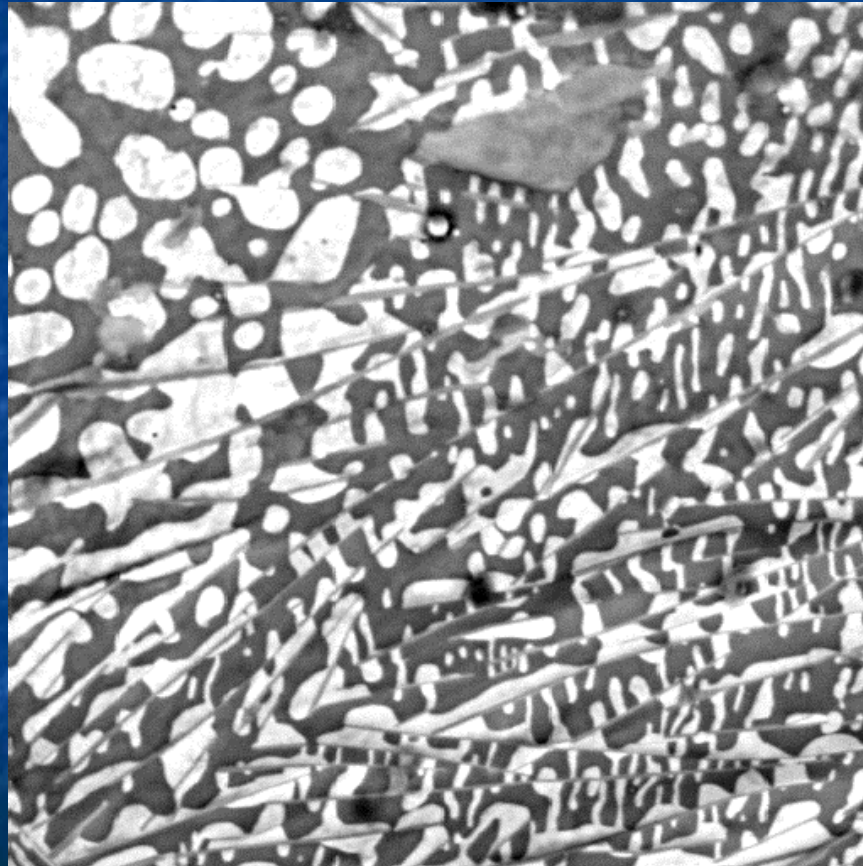
What is this?

Gold Embrittlement

- This is gold-embrittled eutectic Sn-Pb solder
- AuSn₄ & AuSn₂ platelets dispersed throughout the microstructure

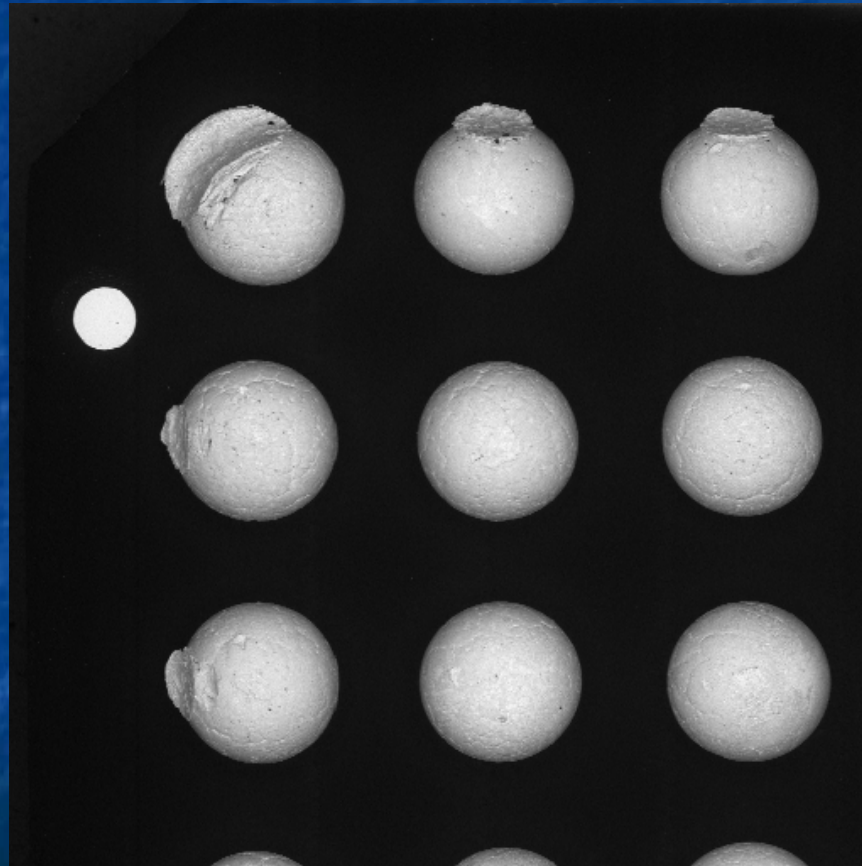
What is this?

BGA Mechanical Damage

- Probably tool damage
- Most extreme cases had missing balls

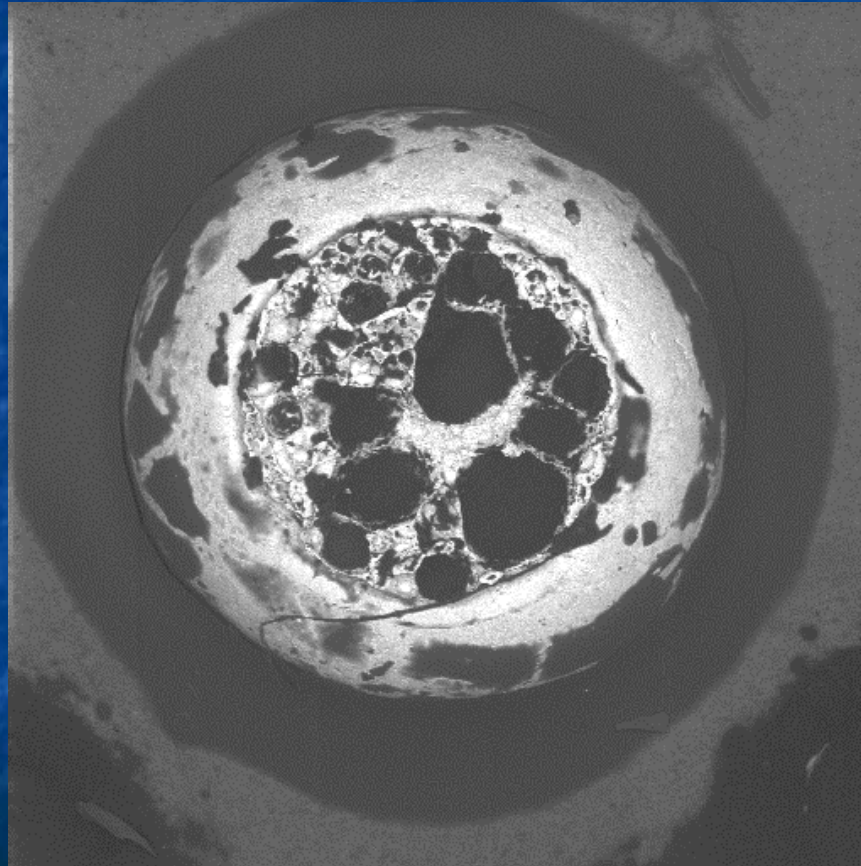
What is this?

BGA Solder Joint Failure

- BGA solder joint failed at the BGA substrate
- Entrapped material includes flux and mask constituents
- Probably flux and mask are chemically incompatible

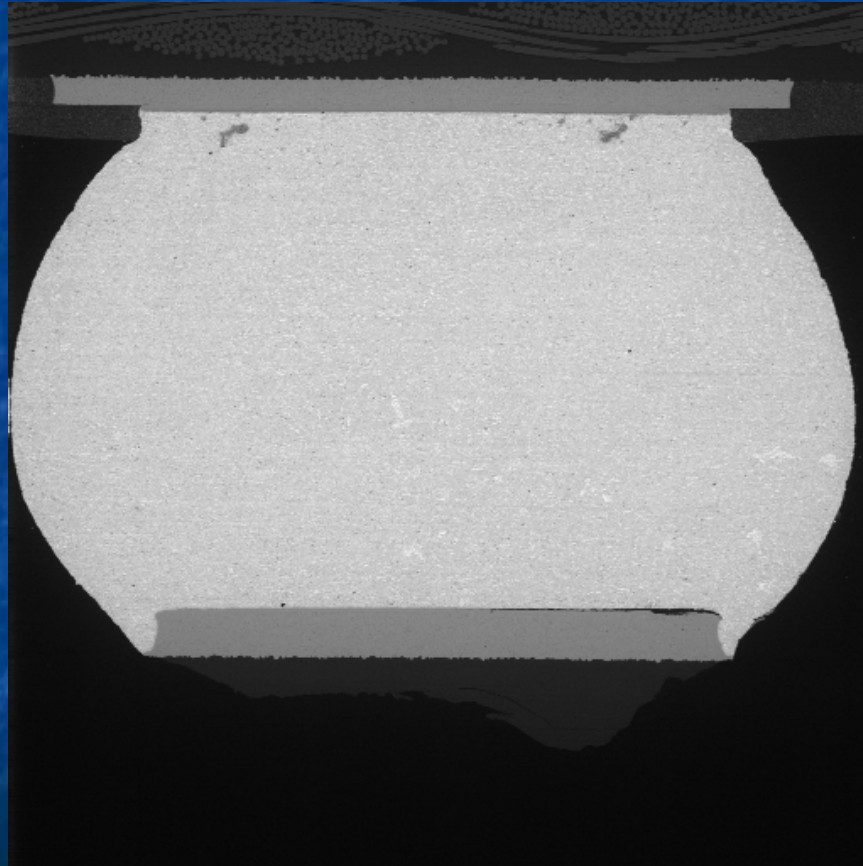
What is this?

ENIG Black Pad Syndrome

- Brittle fracture at the solder/PWB pad interface
- More specifically between the Ni_3Sn_4 IMC layer and the P-rich EN

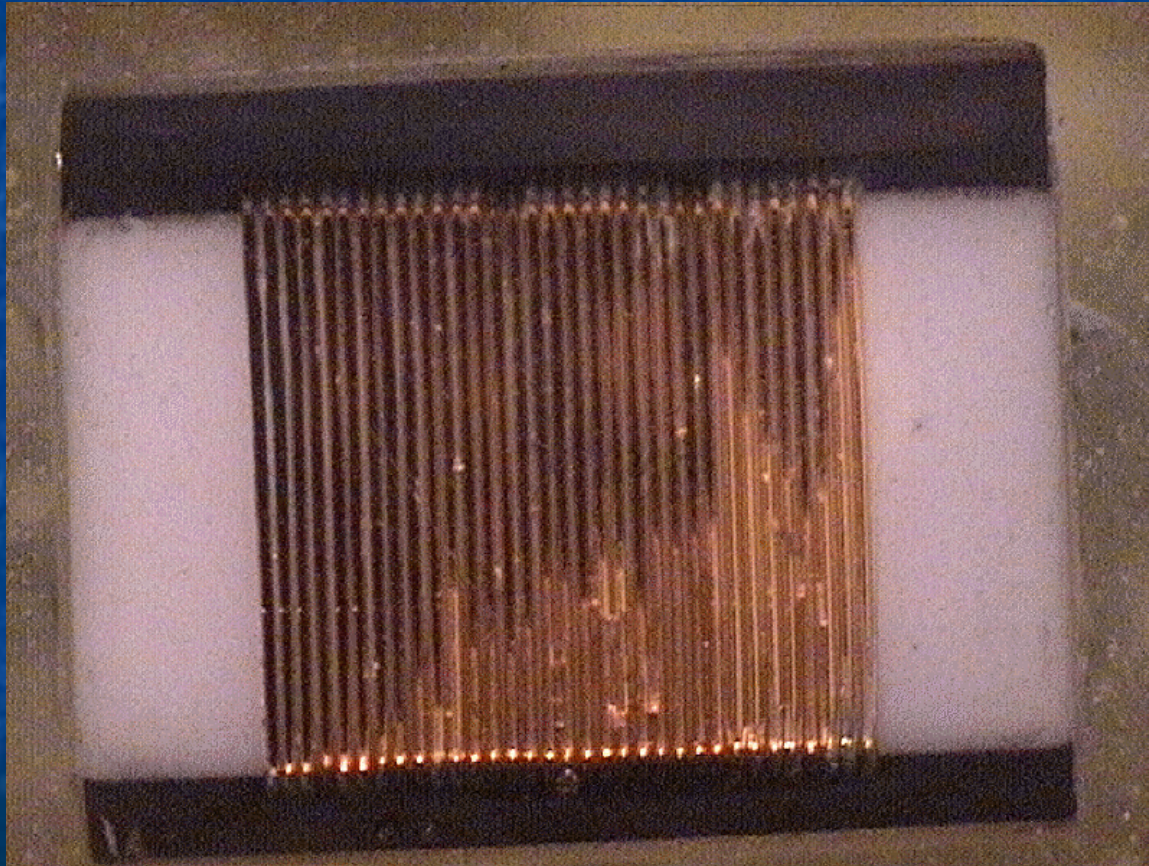
What is this?

Failed SMD Inductor

- Discoloration of magnet wire
- Open circuited coil

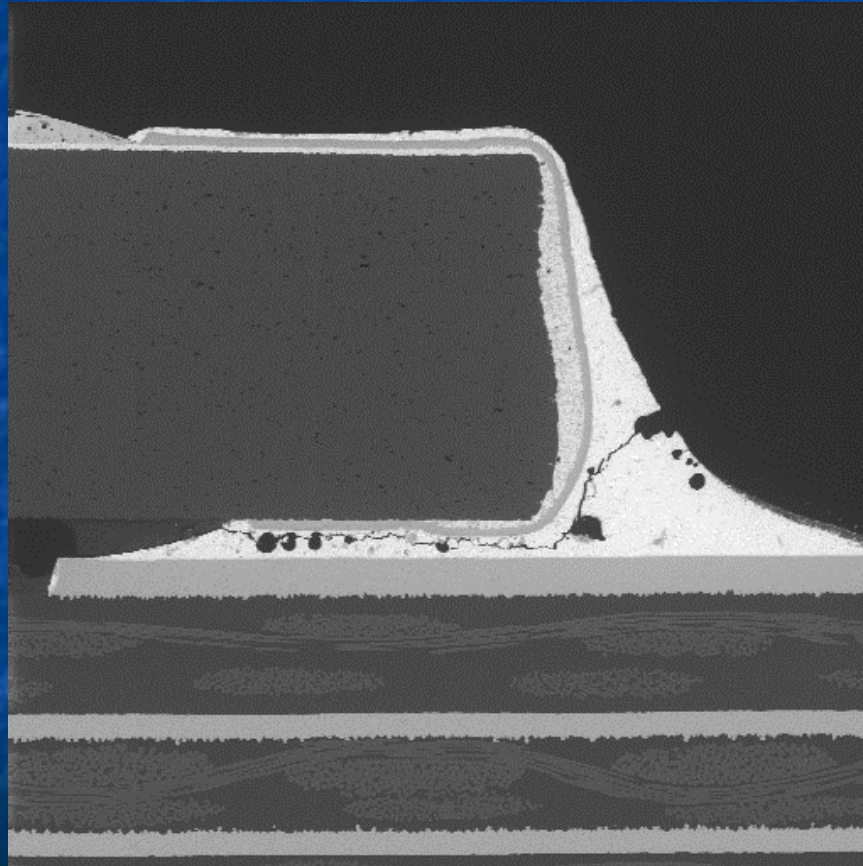
What is this?

Failed Resistor Network Joint

- Classic thermal fatigue failure
- Voids may be a contributing factor

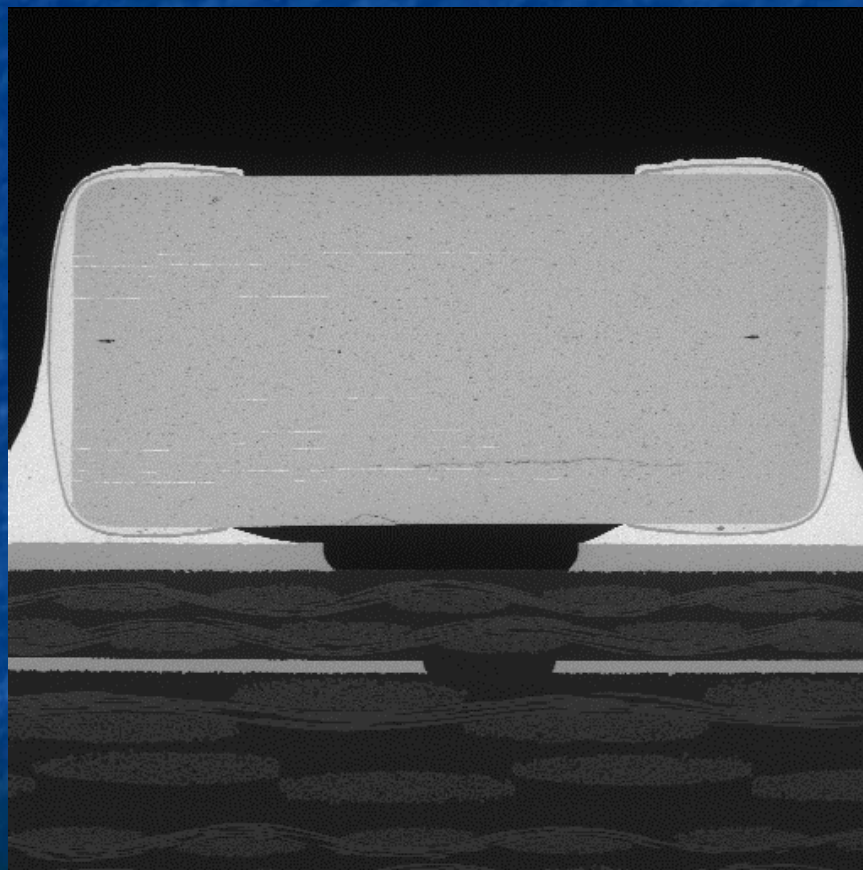
What is this?

MLCC Knit Line Failure

- MLCC manufacturing defect
- Crack propagates and crosses plates causing electromigration short

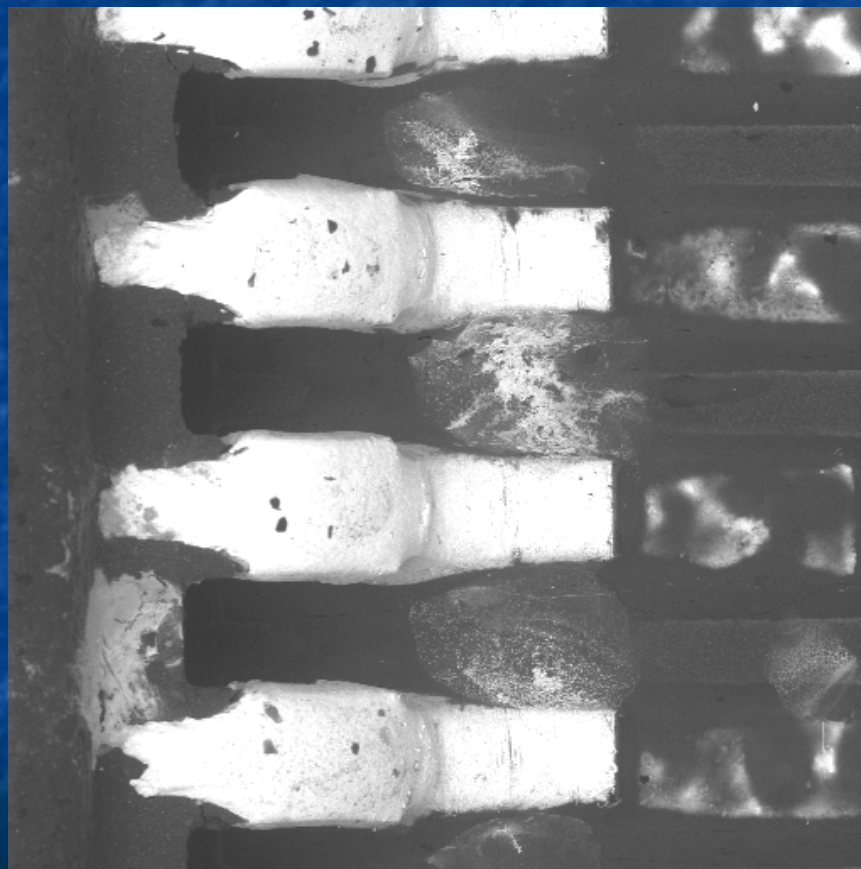
What is this?

TSOP Electromigration Failure

- Electrical leakage failures
- No Clean Flux, but likely activated flux used in touch up
