# HASL Finish on PWBs

# Poor Sn-Pb HASL

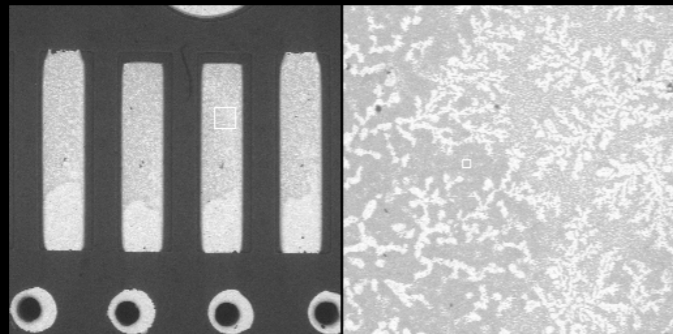
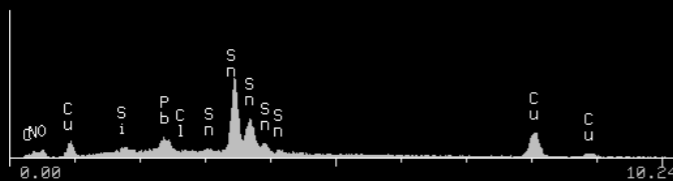
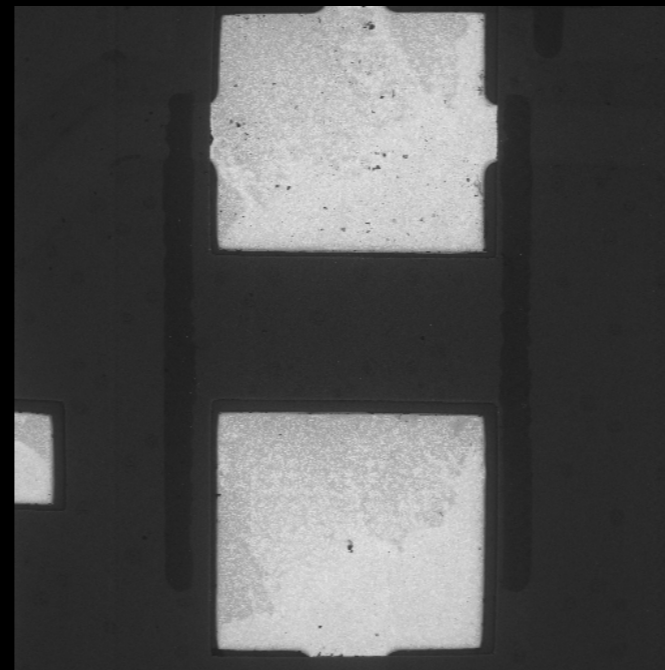
## Possible Factors

- knife air pressure
- plated copper solderability
- solder pot temperature
- velocity of extraction from solder pot

- **Check HASL finished PWB coupons/bare boards on new board lots**
- **SEM/EDS, microsections, and XRF are appropriate techniques**
- **Know that optical inspection can miss this type of condition**
